## **Dam Seepage Investigation of an Earthfill Dam in Warren County, Missouri Using Geophysical Methods**

**Stanley C. Nwokebuihe<sup>\*</sup>, Abdulrahman M. Alotaibi, Adel Elkrry, Evgeniy V. Torgashov, and Neil L. Anderson**

Missouri University of Science and Technology Rolla, Missouri

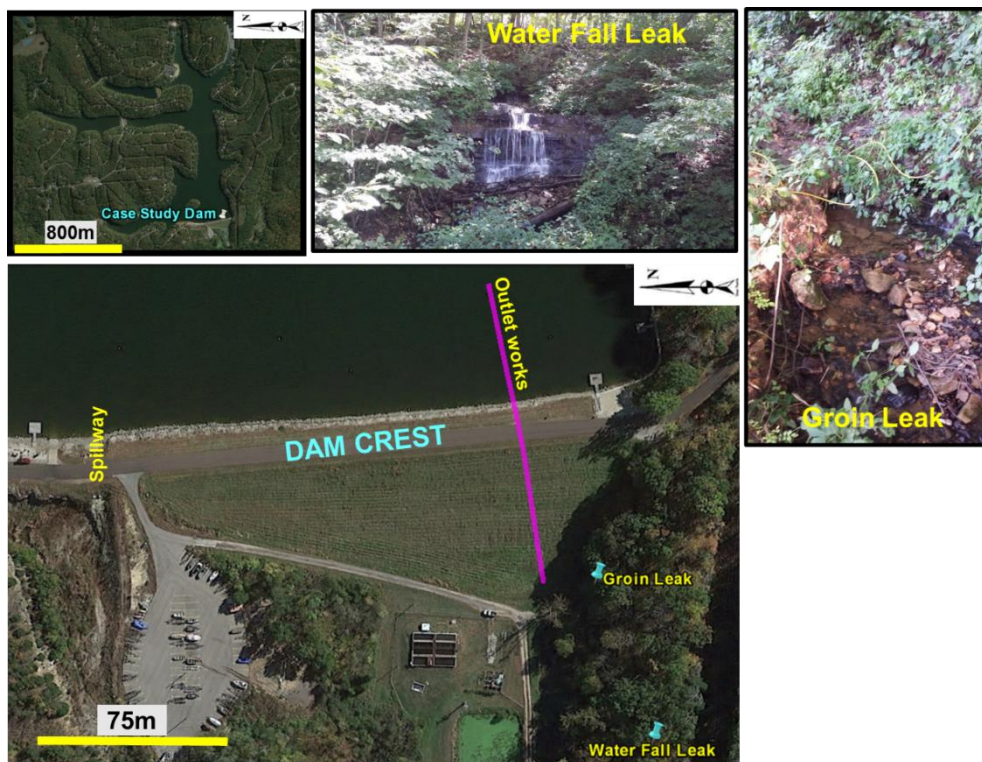
At the time of this investigation, there were two known seepage discharge locations downstream of the dam (Figure 1). These discharge locations are referred to as the Groin Leak and the Water Fall Leak, respectively. In 2012, the average flow rate from the Groin Leak was about 183 GPM (gallons per minute); there is no record of discharge rates from the Water Fall Leak. Discharge from the Groin Leak is continuous while flow from the Water Fall Leak terminates when the reservoir drops 3 meters below the designed maximum capacity. The owners of the dam have constructed catchment facilities to pump most of the Groin and Waterfall discharge back into the upstream reservoir. A primary objective of this investigation was to identify and map the probable seepage pathways from the upstream dam face to the Groin and Water Fall leaks so that an effective grouting program could be developed.

During site investigations, an area of moist soil and denser vegetation was identified on the downstream face of the dam above the outlet of the buried drainage pipe (outlet works). The

preliminary conclusion was that the outlet works, a buried drainage pipe installed during the construction of the dam, was also leaking. A secondary objective of this investigation was to determine if the outlet works drainage pipe is leaking.

Figure 1: Approximate locations of the Groin Leak, Water Fall Leak and outlet works (drainage pipe).

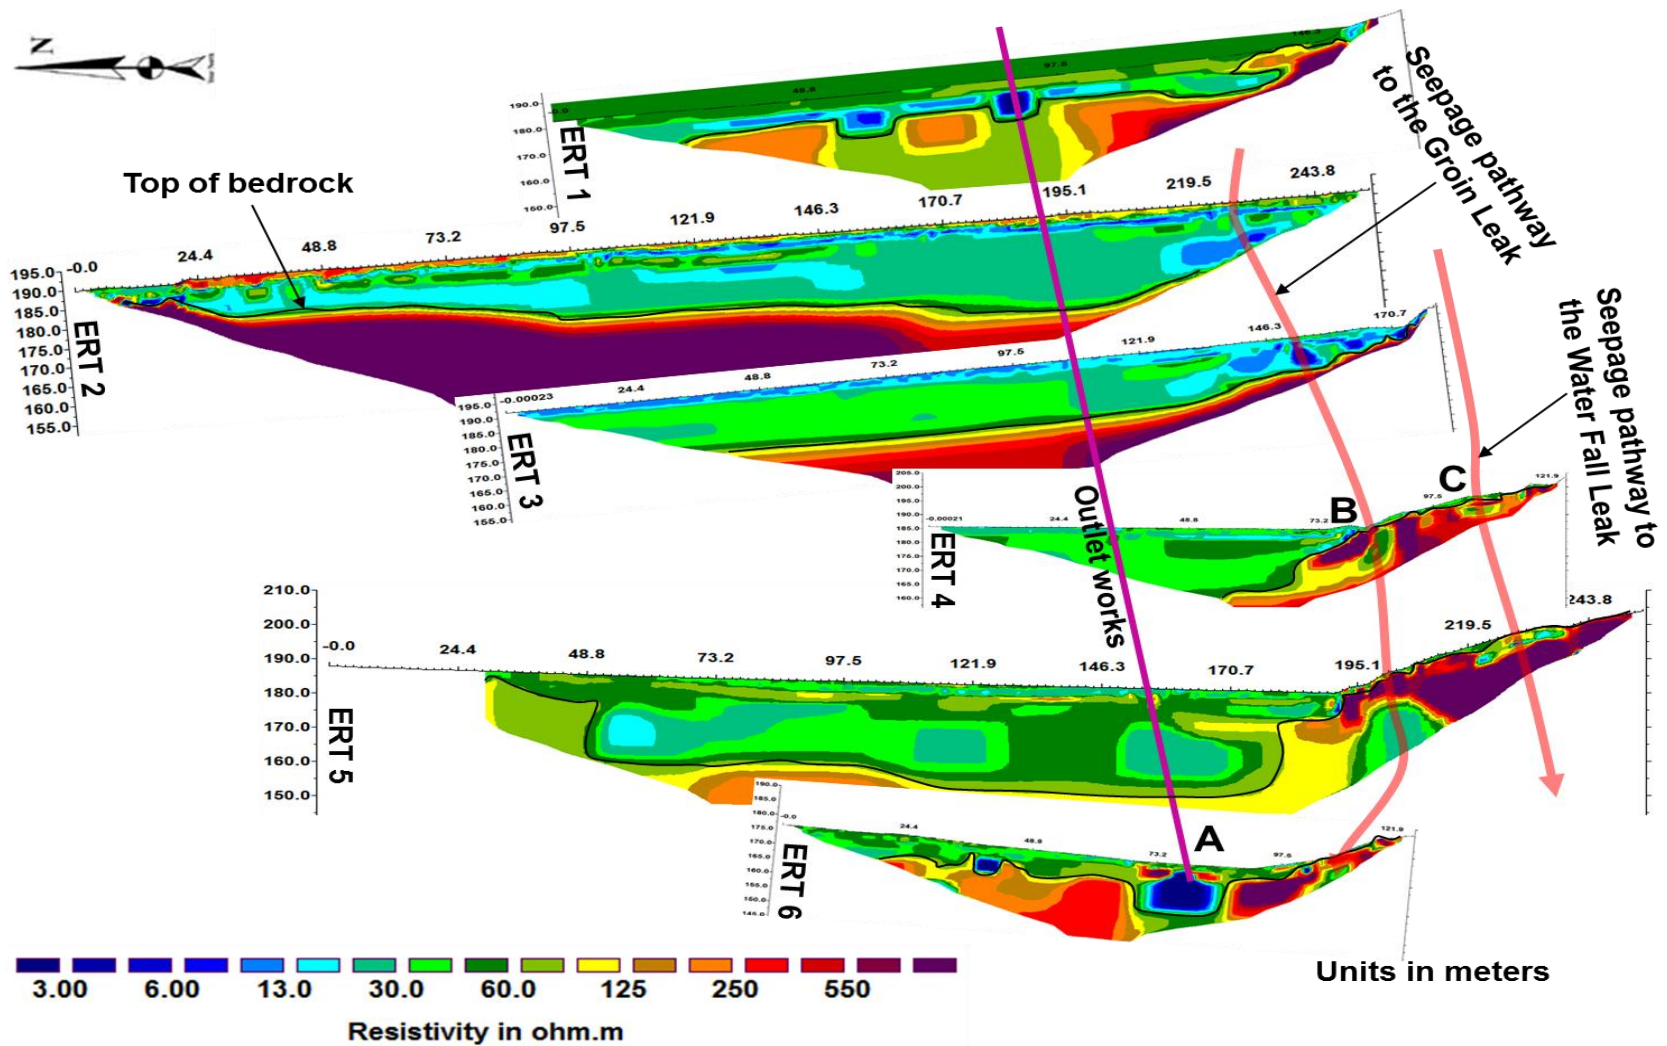
The six interpreted ERT profiles are shown in Figure 4. Interpreted moist soil is typically characterized by resistivity values of less than 20 Ohm.m; interpreted dry soil is typically characterized by resistivity values between 20 to 60 Ohm.m; interpreted moist fractured rock with possible clay infill is characterized by resistivity values of less than 125 Ohm.m; interpreted competent less moist rock is characterized by resistivity values greater than 125 Ohm.m. The

The interpreted top of bedrock has been superposed on the six ERT profiles and three seepage zones have been tentatively identified; namely, the Outlet Works Leak, the Groin Leak and the Water Fall Leak. These three interpreted seepage pathways are labeled A, B and C, respectively (Figure 4).

**Outlet Works Leak:** The location of the outlet works drainage pipe has been superimposed on the ERT profiles shown in Figure 4. Based on the interpretation of ERT profile 1, it appears that the ground surface upstream of the dam was excavated prior to the installation of the outlet works and subsequently backfilled with about 5 m of relatively conductive clayey sediment. At the downstream end of the outlet works, a prominent (about 18m by 18m) zone of low resistivity (less than 20 Ohm.m) is observed (ERT/IP profile 6; Figure 4). This anomaly is attributed to the outward and downward seepage of water and clay from the outlet works pipe. The most reasonable interpretation is that the outlet works drainage pipe is leaking.

**Groin Leak:** The interpreted seepage pathway through the Groin Leak is shown in Figure 4. Water flowing along the interpreted Groin Leak pathway, is interpreted as seeping through the dam-bedrock interface on profiles ERT/IP 2 and ERT/IP 3. On ERT profiles ERT/IP4 to ERT/IP 6, the Groin Leak seepage pathway is interpreted as mostly through fractured rock. Discharge through the Groin Leak is attributed to significant local lateral flow (to the north) through fractured rock from the interpreted seepage pathway to the discharge location. There appears to be significant vertical seepage along the interpreted Groin Leak pathway where it intersects ERT/IP traverses 5 and 6. We note that the shallow soil at the base of the hill on ERT profiles 4 and 5 is characterized by anomalously low resistivity values (less than 13 Ohm.m). The interpreted high moisture content is attributed to discharge from the Groin Leak seepage pathway and run-off along the top of bedrock. This moisture is interpreted as seeping vertically into the soil at the base of the hill.

**Water Fall Leak:** The interpreted Water Fall Leak seepage pathway is shown in Figure 4. The pathway (shown only on ERT profiles 4 and 5) is interpreted to be through shallow fractured rock. The interpreted elevated and shallow flow pathway is consistent with observation that discharge through the Water Fall Leak terminates when the reservoir level falls below 3 meters of design the maximum storage capacity.

Figure 4: Six ERT profiles shown in approximate relative locations and orientations. Interpreted seepage flows through the outlet works, Groin Leak and Water Fall Leak are shown and labeled as A, B and C respectively. The interpreted top of bedrock has been superimposed.

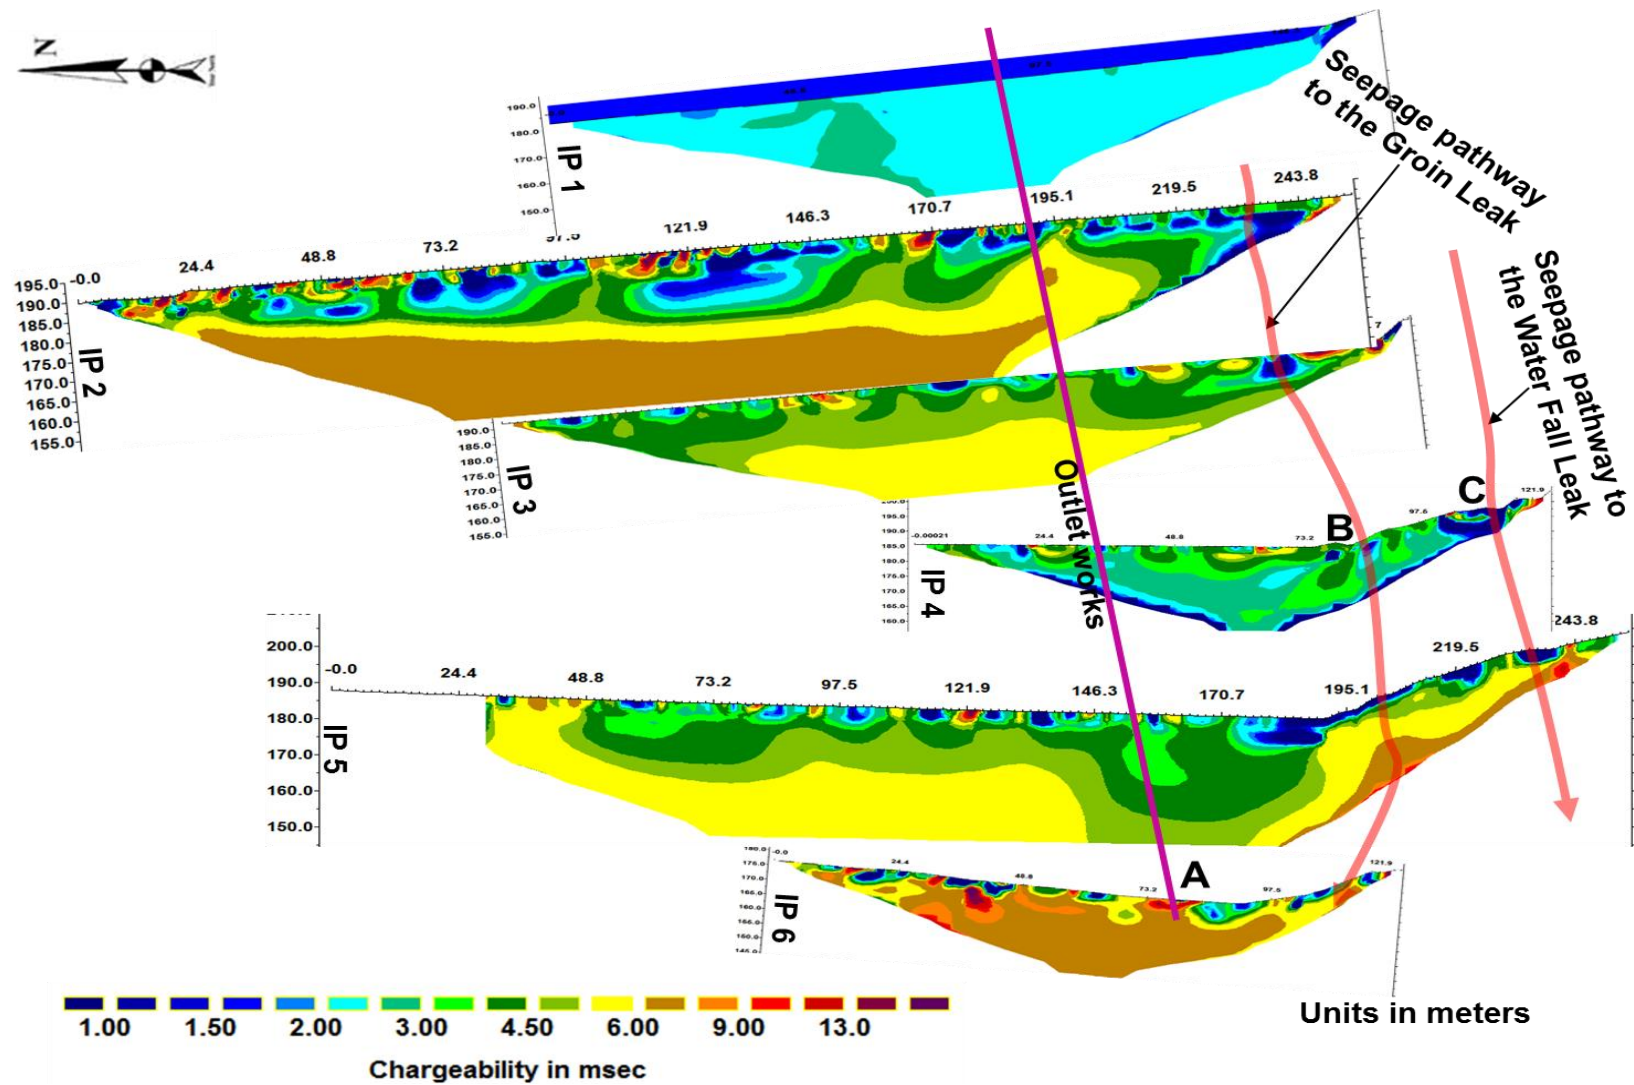
The six IP profiles are shown in Figure 5. The two seepage zones that were tentatively identified based on the interpretations of the ERT data are superimposed on the IP profiles (Figure 5).

**Outlet Works Leak:** The location of the outlet works drainage pipe has been superimposed on the IP profiles (Figure 5). The higher chargeability (> 6 m.sec) values) at the downstream end of the outlet works is attributed to the presence of the metal outlet works pipe and seepage clays. The presence of the higher IP values at the downstream end of the outlet works drainage pipe is consistent with the interpretation that the drainage pipe is leaking. This IP data interpretation is

consistent with the interpretation of the ERT data.

**Groin Leak:** The interpreted seepage pathway through the Groin Leak on the IP profiles (Figure 5) is labeled B. The relatively low IP values along the postulated Groin Leak seepage pathway is consistent with the interpretation that the seepage pathway is relatively free of clay. The slightly higher IP values observed at depth on IP profile 5 along the postulated Groin Leak seepage pathway is consistent with the interpretation that the vertical seepage of water at this location has resulted in the deposition of piped clay.

**Water Fall Leak:** The interpreted Water Fall Leak seepage pathway has been superimposed on the IP profiles and labeled C. The relatively low IP values along the postulated Groin Leak seepage pathway is consistent with the interpretation that the seepage pathway is relatively free of clay

Figure 5: Six IP profiles shown in approximate relative locations and orientations. Interpreted seepage flows through the outlet works, Groin Leak and Water Fall Leak are shown and labeled as A, B and C respectively.

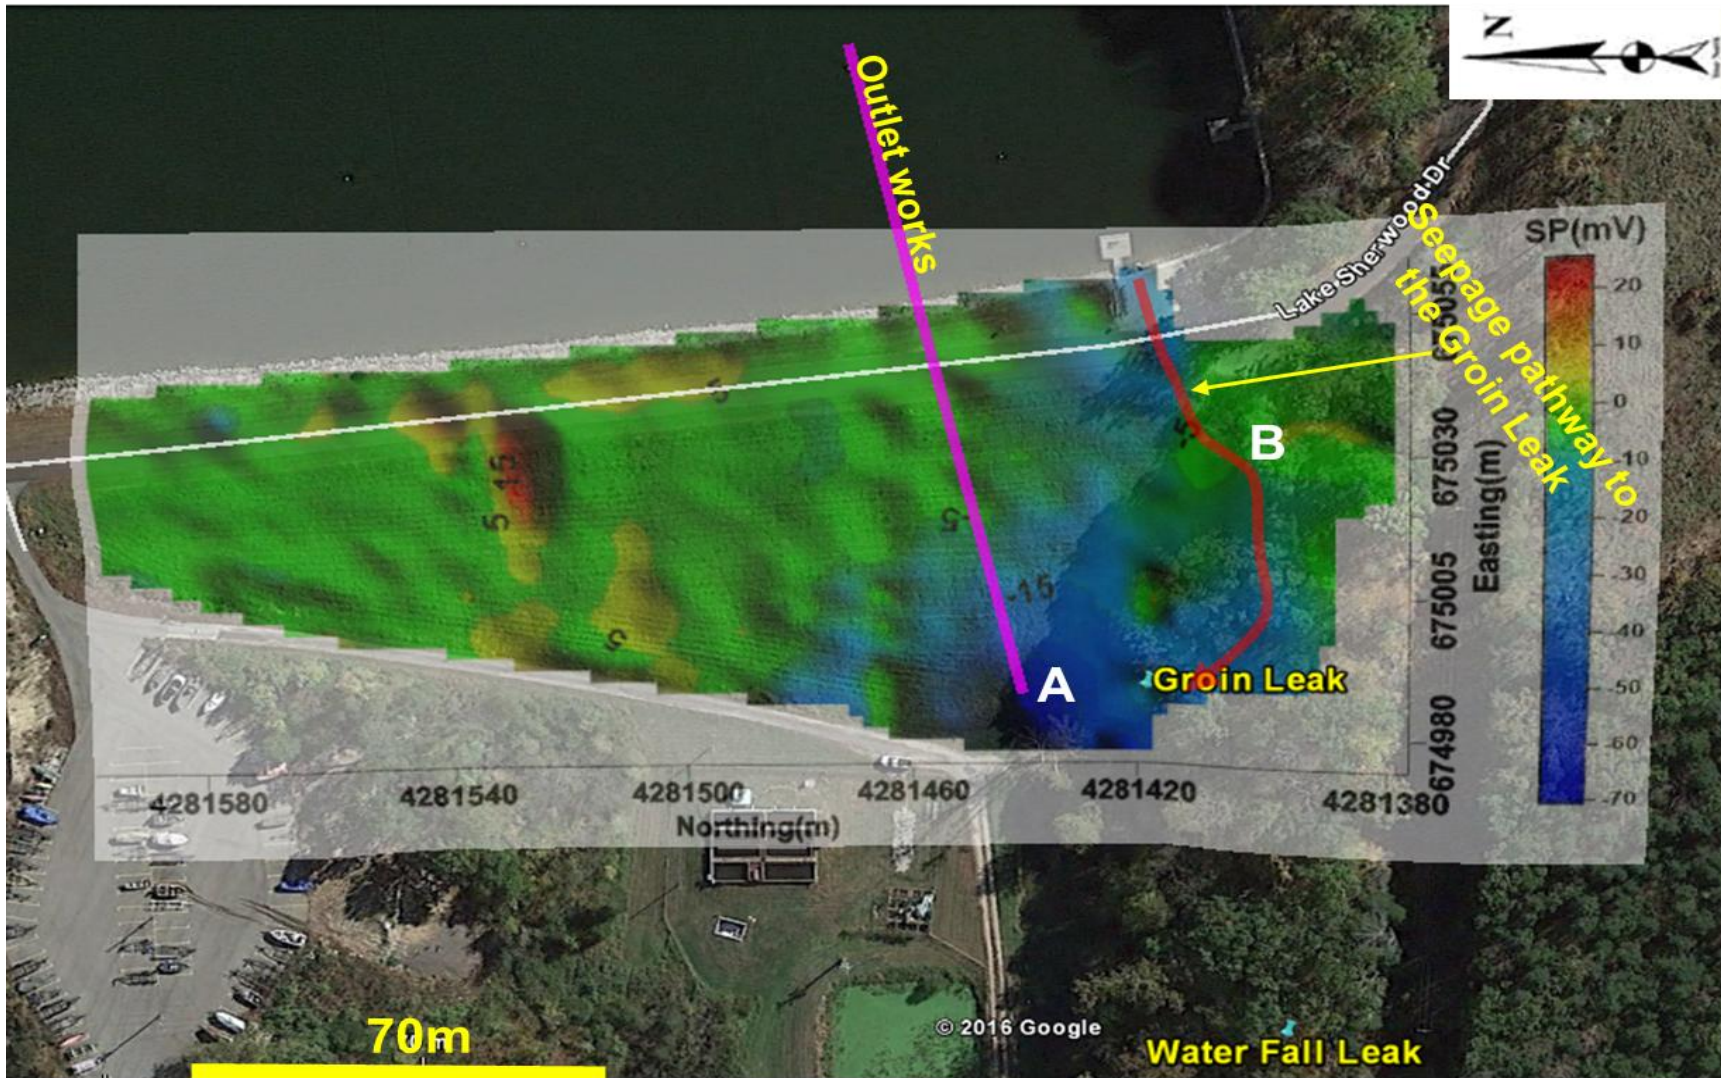
**Outlet works leak:** the outlet works drainage pipe has been superimposed on the contoured SP map (Figure 6). The end of the outlet works, an interpreted discharge location, is characterized by a prominent negative SP anomaly. This negative anomaly is consistent with the interpretation that the discharge from the outlet works drainage pipe seeps vertically into the underlying soil and rock and is consistent with the ERT and IP interpretations.

**Groin Leak:** The interpreted seepage pathway through the Groin Leak (labeled B) is shown in Figure 6. The areas to the north and south of the postulated Groin Leak pathway in proximity to ERT/IP traverses 4, 5 and 6, are characterized by prominent negative anomalies. This negative anomaly is consistent with the interpretation that the discharge from the Groin Leak and run-off from the steeply dipping bedrock surface seeps vertically into the underlying soil and rock and is consistent with the ERT and IP interpretations.

Figure 6: Google earth 3D SP contour map overlay indicating possible outlet works leak (labeled A) and seepage pathway to the Groin Leak (labeled B).
