Research article

Ductile fibre reinforced cementitious composites (DFRCC) for improved corrosion durability of reinforced concrete columns

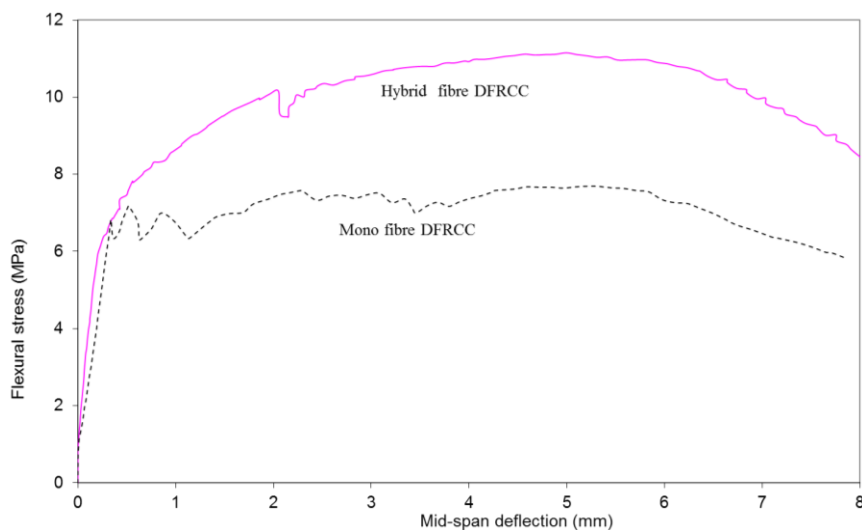
**Figure 2.** Deflection hardening behaviour of mono and hybrid fibre DFRCC materials.

The mix proportions for the OPC concrete and DFRCC are listed in Tables 1 and 2, respectively. Ordinary Portland cement was used for all specimens in this experimental program. Two different types of fibers were used in the casting of the two DFRCC specimens. They were PVA fibers and steel fibers. The properties of these two fibers are summarized in Table 3. The measured average 28-day compressive cylinder strength for the concrete, the hybrid fibre DFRCC and the mono fibre DFRCC were 25.8, 41.8, and 39.9 MPa, respectively. The yield strengths of the 13 mm diameter round deformed bars and 6 mm diameter spiral reinforcing bars were 462 MPa and 285 MPa, respectively. Deflection hardening and multiple cracking behaviour of DFRCC materials in four point bending is also evaluated in $20 \times 75 \times 300$ mm plate specimens for which detail can be found in [25]. Both DFRCCs exhibited deflection hardening behaviour as shown in Figure 2 with higher flexural stress in Hy-DFRCC than that of M-DFRCC due to presence of high modulus steel fibre in the former than the latter.

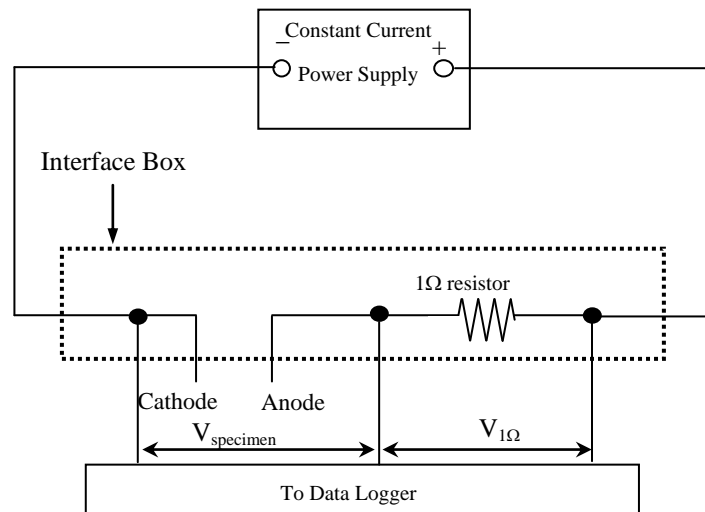
Figure 3 shows a schematic diagram of the circuit for the accelerated corrosion test. The circuit basically consists of a one-ohm ($1\ \Omega$) resistor and the specimen connected in series with the constant current power supply. The $1\ \Omega$ resistor and the wires connecting the specimen to the circuit are contained in a specially designed interface box. Wires were also connected from the top of the interface box to a data logger to measure the output voltage readings across the specimen and the $1\ \Omega$ resistor. After setting-up and closing the circuits for the accelerated corrosion tests, the voltages across the $1\ \Omega$ resistor were recorded on an hourly basis throughout the experiment for a period of about 48 days. According to Ohm's Law ($V = IR$), the current flowing in the circuit is effectively the same value as the voltage reading since the resistor has a resistance of $1\ \Omega$. By knowing the voltage readings across the specimens, it was also possible to monitor the resistances of all the specimens throughout the experiment since the currents flowing in various circuits were already known.

Figure 3. Schematic of the constant current test setup.

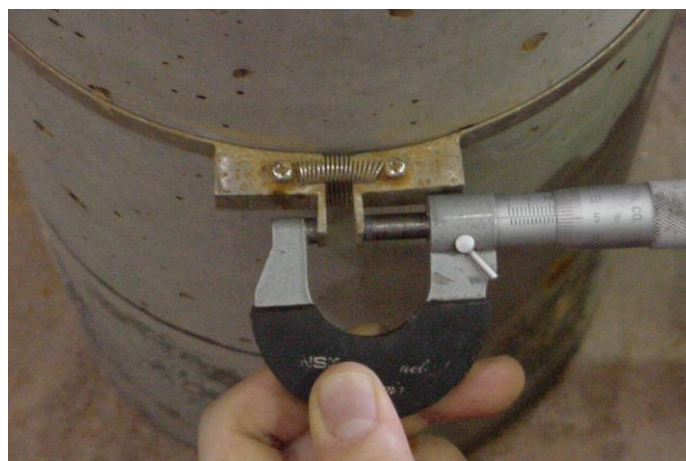
When the specimens are subjected to corrosion, the specimens will expand due to the formation of the corrosion products which are expansive in nature. To measure the circumferential expansion of each column, a specially fabricated mechanical expansion collar (shown in Figure 4) was placed at mid-height of each column. Each collar was made from 12 mm wide stainless steel sheets and included a small opening held closed by two stainless steel springs. A micrometre was used to measure the change in the opening size to the nearest one-hundredth of a millimetre, to determine the circumferential expansion of the column at mid-height.

Figure 4. A typical mechanical expansion collar.

Circumferential expansion of each specimen undergoing accelerated corrosion was determined using the specially fabricated mechanical expansion collar fitted at mid height of the column. The circumferential strains at mid height for various specimens over time are shown in Figure 6. From the graph, it can be seen that there was little circumferential expansion for the first 14 days. Subsequently, the OPC concrete columns (OPC-1 and OPC-2) began to show significant increases in the circumferential strain. For the two DFRCC columns, there was little change in the circumferential expansion indicative of minor corrosion activities in these columns. The higher fracture resistance of DFRCC materials than that of OPC concrete also contributed to the lower circumferential strain due to expansive corrosion products developed during accelerated corrosion which is evident from low surface cracking of DFRCC columns observed in this study.

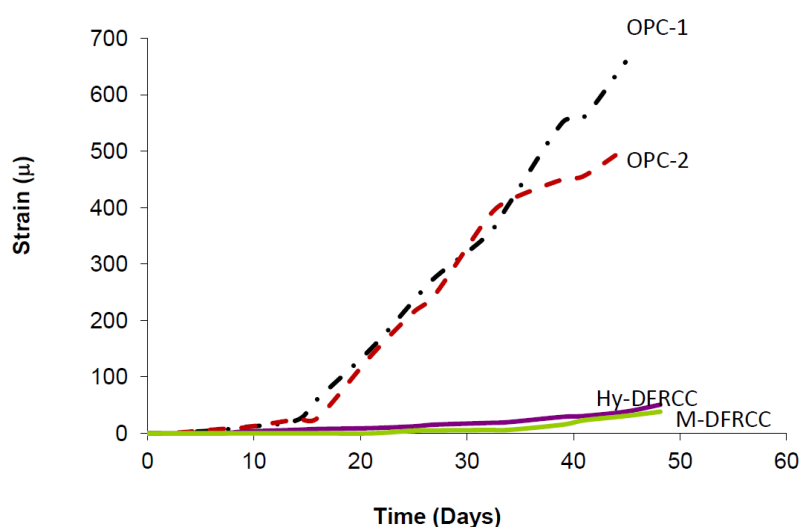
Figure 6. Circumferential expansion with time.

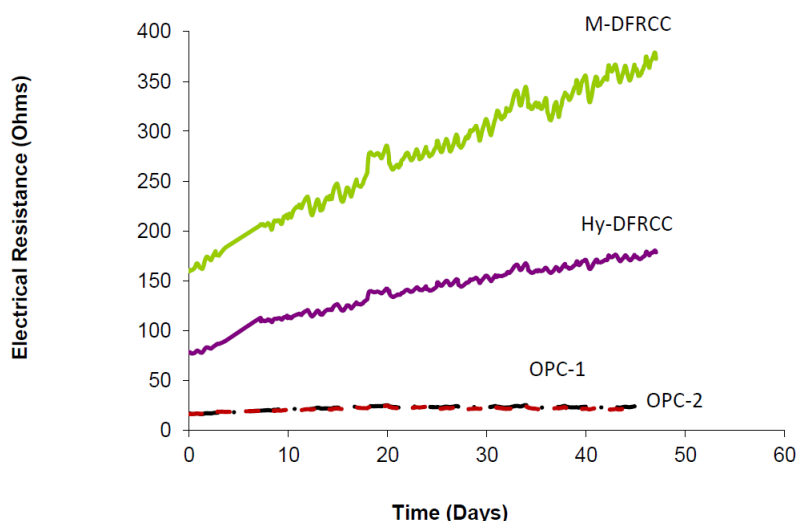
Figure 7 shows the electrical resistances of all specimens with time. It is calculated by dividing the measured voltage with applied current in respective specimens. It can be seen that the electrical resistances of the two DFRCC columns were much higher than those of the OPC concrete columns. This implies that the two DFRCC columns were much more resistant to corrosion than the OPC concrete columns (since corrosion is assumed to be proportional to the current). It was also observed that there were significant increases in the resistances of the two DFRCC columns over time during corrosion test when compared to those of the OPC concrete columns. This may be due to the fact that the cracks that form in the DFRCC columns due to corrosion stay small in width and prevent the corrosion products from escaping to the surface of the specimen. Consequently, the corrosion products slowly build up around the steel bars, preventing more steel from corrosion, which accounted for the increased resistances of the two DFRCC columns. It can also be seen that the electrical resistivity of M-DFRCC column is much higher than that of Hy-DFRCC column. The significantly lower electrical resistivity of Hy-DFRCC column than that of M-DFRCC column can be attributed to the higher electrical conductivity of steel fibre than that of PVA fibre. Similar higher electrical conductivity of steel fibres reinforced concrete is reported by others [30].

Figure 7. Electrical resistance of specimens with time.

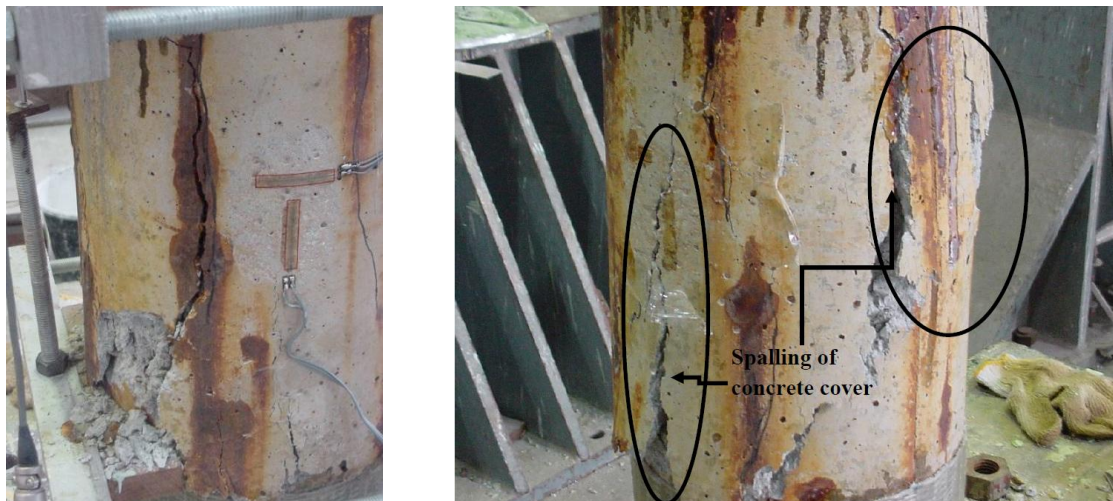
Failure behaviour of corroded OPC concrete and DFRCC columns during structural tests is shown in Figures 11–13. It can be seen opening of existing corrosion induced longitudinal cracks in corroded OPC concrete columns in Figure 11 which eventually formed spalling of concrete cover. However, in both DFRCC columns no such spalling of cover concrete is observed, instead multiple cracks are formed during increase in loading and formed few vertical cracks at failure loads which can be seen in Figures 12–13. This might explain the higher failure load of corrosion damaged DFRCC columns than the un-corroded RC column during structural test, which is evident from the spalling of concrete cover as shown in Figure 14. This clearly shows the superior corrosion resistance, corrosion induced damage resistance and structural behaviour of DFRCC columns than that its counterpart OPC concrete column.

Figure 11. Spalling of clear cover of OPC-1 and OPC-2 corroded columns after failure load.

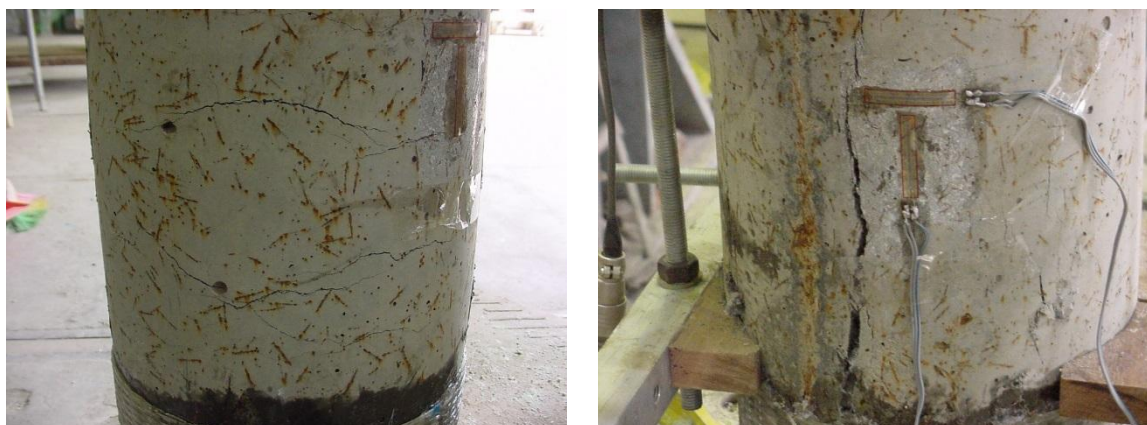
Figure 12. Cracking of corroded Hy-DFRCC column during structural test (left) and after failure (right).

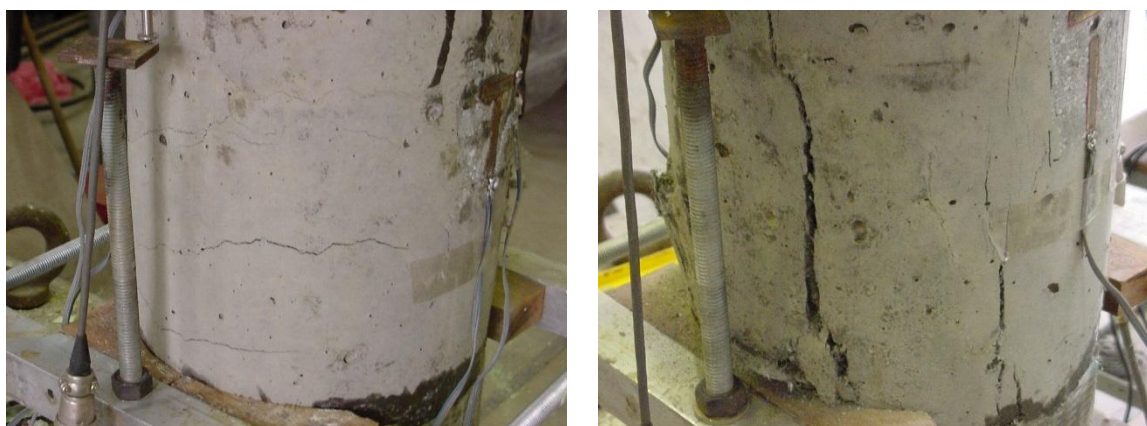
Figure 13. Cracking of corroded M-DFRCC column during structural test (left) and after failure (right).

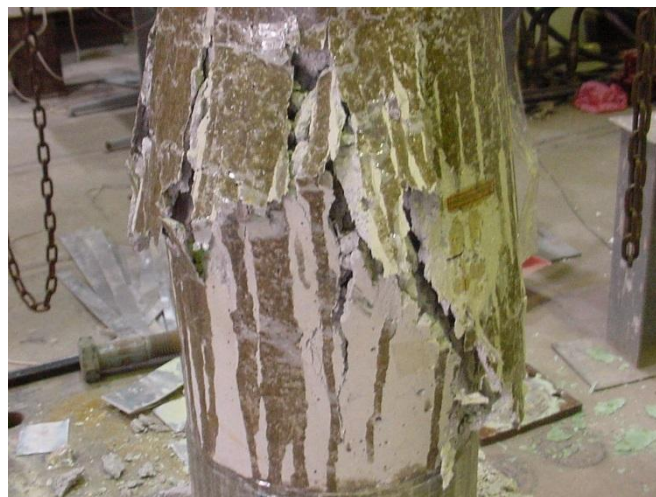
Figure 14. Spalling of un-corroded OPC concrete column at failure during structural test.
