Research article

Site Characterization during Bridge Foundation Construction Using Electrical Resistivity Tomography

Abstract: A shallow underground water-filled cavity was encountered in limestone bedrock during the construction of a new column footing for the Gasconade River Bridge over Interstate 44. Five electrical resistivity tomography (ERT) profiles and borehole control were acquired in immediate proximity to the existing and the new column footings in order to assess the integrity of the rock beneath the foundation columns and characterize the encountered cavity. Two parallel southwest-northeast trending fracture zones were identified on the acquired ERT profiles and competent rock was differentiated from more extensively fractured rock. The volumetric extent of the void was mapped based on the interpretation of the ERT, borehole and injected grout data. A conceptual model for the development of the water-filled cavity was proposed.

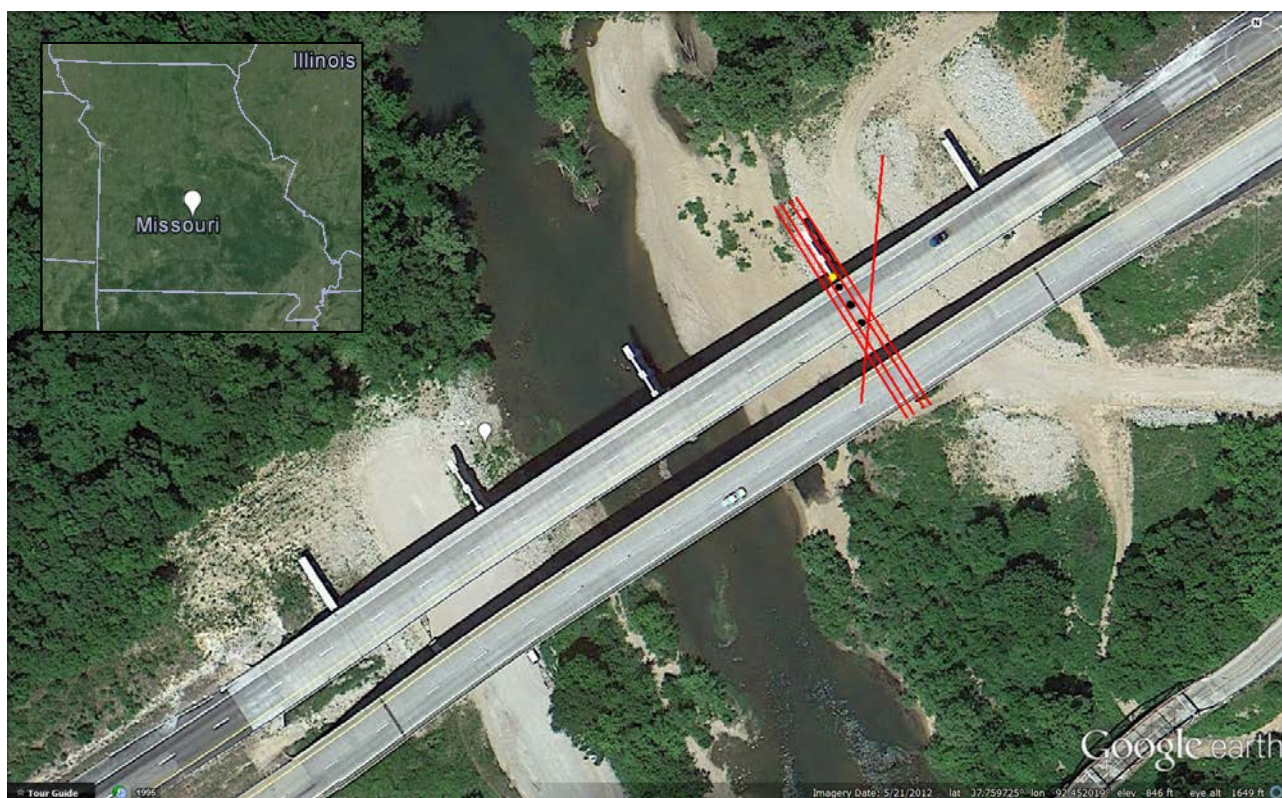
Figure 1. Aerial photograph of the Gasconade River project site (Google Earth) in Central Missouri with superposed ERT traverses (marked as red lines). The temporary structure is located northwest of the Gasconade westbound lane bridge. The black dots depict locations of the existing columns, yellow — the proposed column.

to constrain and verify the geophysical data interpretation. Boreholes B-3 and B-7 were adjacent to ERT Traverse 1; borehole B-5 was located between ERT Traverses 2 and 3; borehole B-6 centered on ERT Traverse 3; borehole B-9 was located between ERT Traverses 3 and 4; and boreholes B-4, B-8, B-10 and B-11 were located near or on ERT Traverse 4 (Figures 1 and 7).

Electrical resistivity profiles were acquired along five traverses (Traverses 1, 2, 3, 4 and 5, Figure 1) in an effort to determine the extent of the encountered water-filled cavity and map variations in rock quality in immediate proximity to the existing permanent bridge foundations. The ERT data were acquired using an AGI SuperSting R8/IP resistivity unit equipped with a dipole-dipole array consisting of 72 electrodes (Figure 6). Typical depth of investigation is 20 percent of the length of the electrical resistivity array. With 72 available electrodes and the required depth of investigation 11.0 m, a 0.76 m spacing between the electrodes was selected for this ERT survey in order to image any significant features in the subsurface that can affect the integrity of bridge foundations. The ERT data were acquired in February, after two days of rain. The acquired ERT field data were fair to good quality and were processed using the RES2DINV software. Percentage of noisy data points removed during processing was between 5 and 15 percent, the error after 7 iterations with the robust constrain gave the RMS as high as 13 percent. The ERT profiles imaged the subsurface to a depth of about 11.0 m, which is about 20% of the array length.

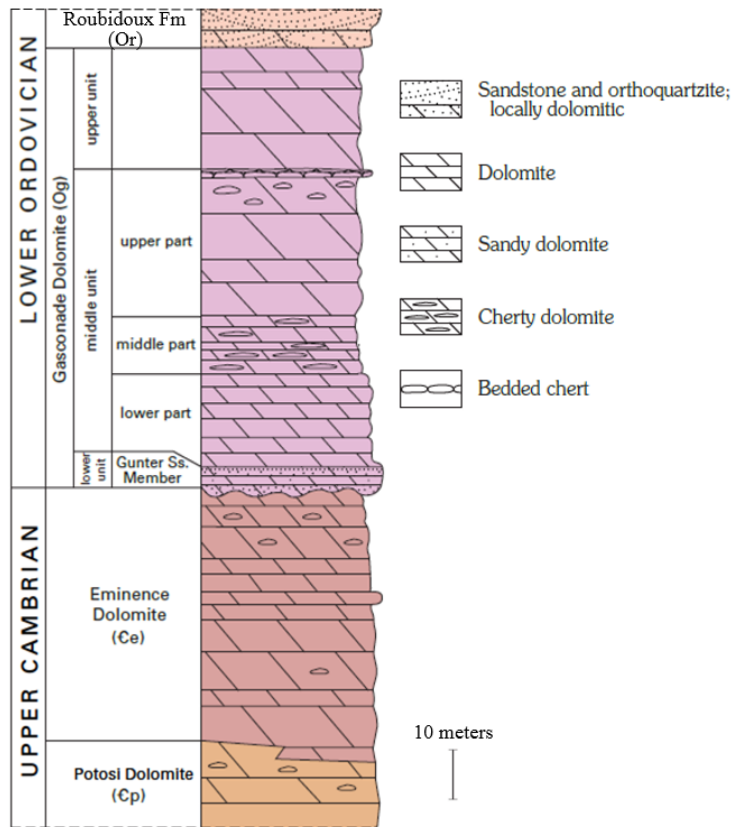
Figure 2. Generalized columnar section of outcropping formations in the project site is showing informal units of the Gasconade Dolomite (modified after Weary and Orndorff [2]). The soils are not shown.

The project site is located in the Salem Plateau region, near the contact between the Gasconade Dolomite and the overlying Roubidoux Sandstone (Figure 2 [2]). Gasconade Dolomite was encountered in all the project boreholes. The rock in the area is susceptible to karst.

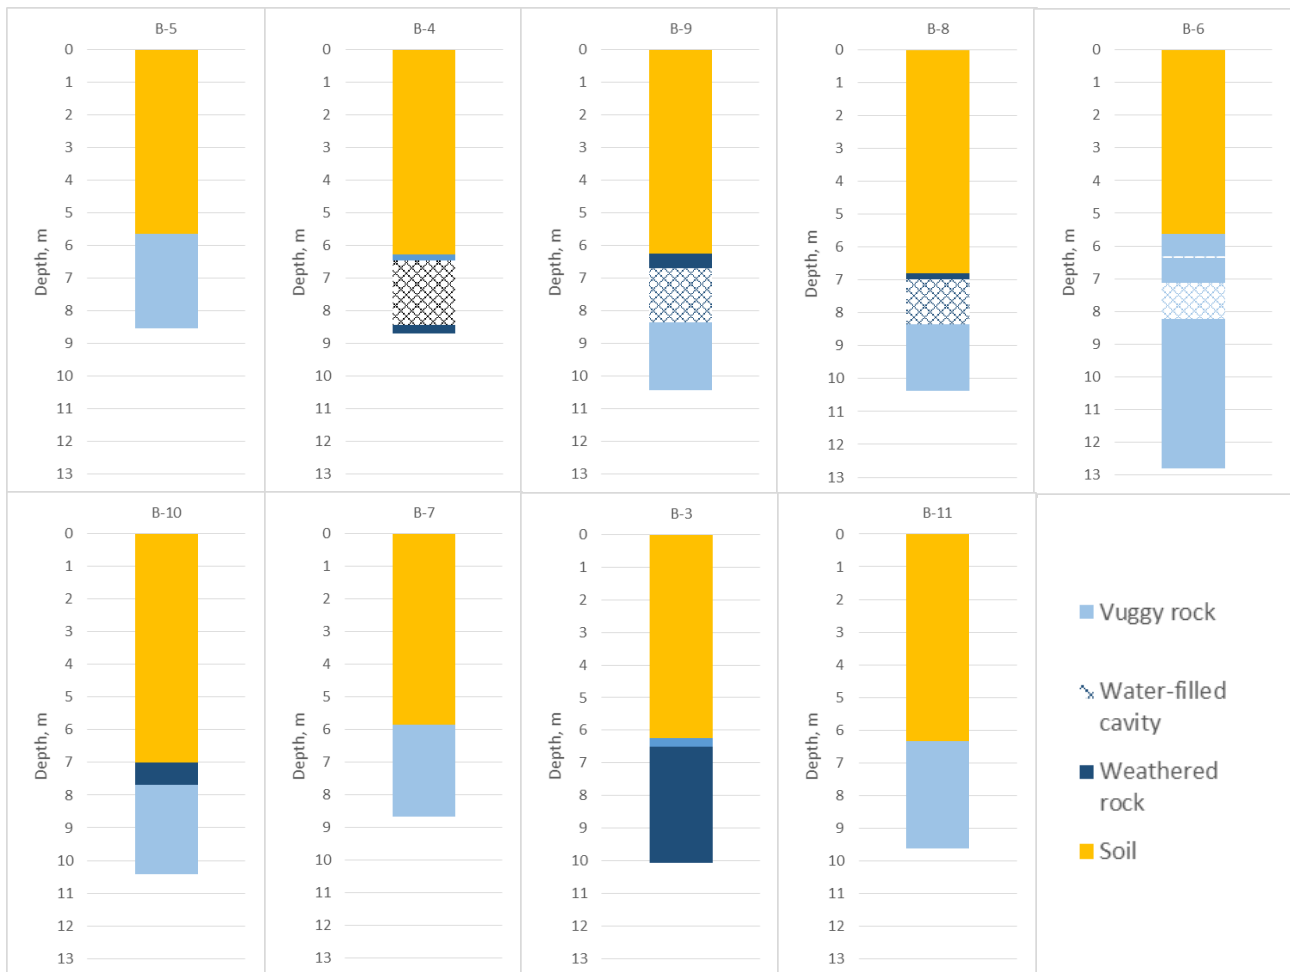
Figure 5. Boring summary (per driller's log). Water-filled cavity was encountered in boreholes B-4, B-6, B-8 and B-9.

During the drilling program, competent Gasconade Dolomite was encountered in the boreholes B-3 and B-4 adjacent to the foundation of the east bound lane bridge (Figures 1 and 7). The extensive water-filled cavity of interest within the Gasconade Dolomite was encountered in Boreholes B-4 (6.5 to 8.4 m), B-6 (6.3 to 6.4 m and 7.1 to 8.2 m), B-8 (6.9 to 8.4 m), and B-9 (immediately adjacent to Bent 6 Bridge L-0698; 6.7 to 8.4 m). Vuggy dolomite was encountered in Boreholes B-7 (at a depth of 5.9 m), B-5 (at a depth of 5.6 m), B-11 (at a depth of 6.3 m). Weathered rock encountered in Boreholes B-6 (at a depth 5.6 m) and in B-9 (at a depth of 6.2 m). The overlying soil consisted of soft brown lean clay and gray silty clay, with gravel fragments. Boring summary is presented in Figure 5.

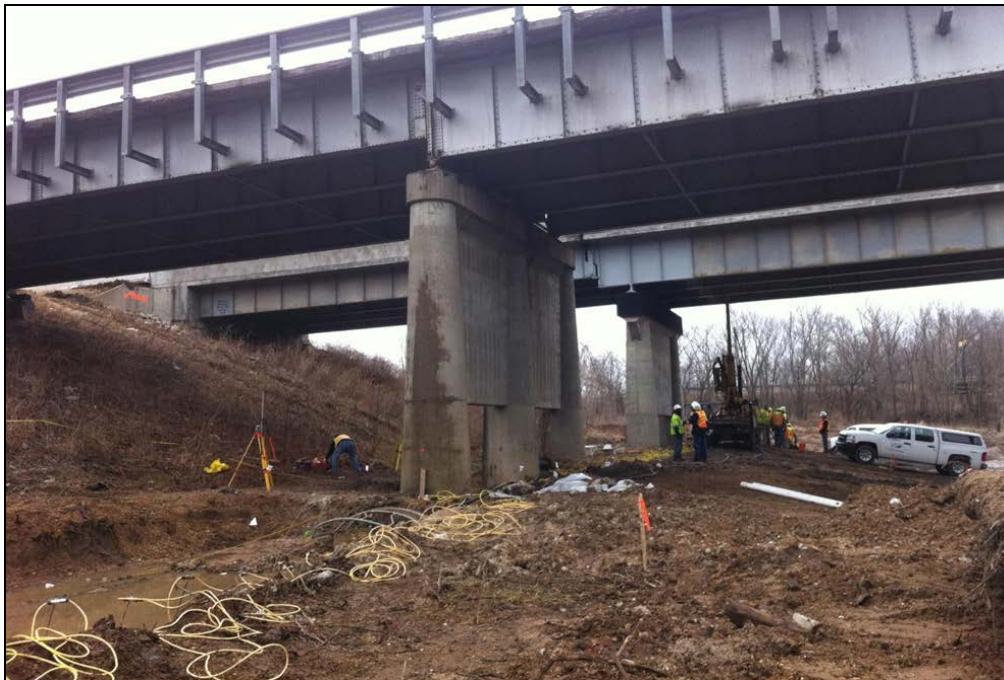
**Figure 6. Photograph of the project site (looking southeast).
ERT data are being acquired along Traverse 3.**

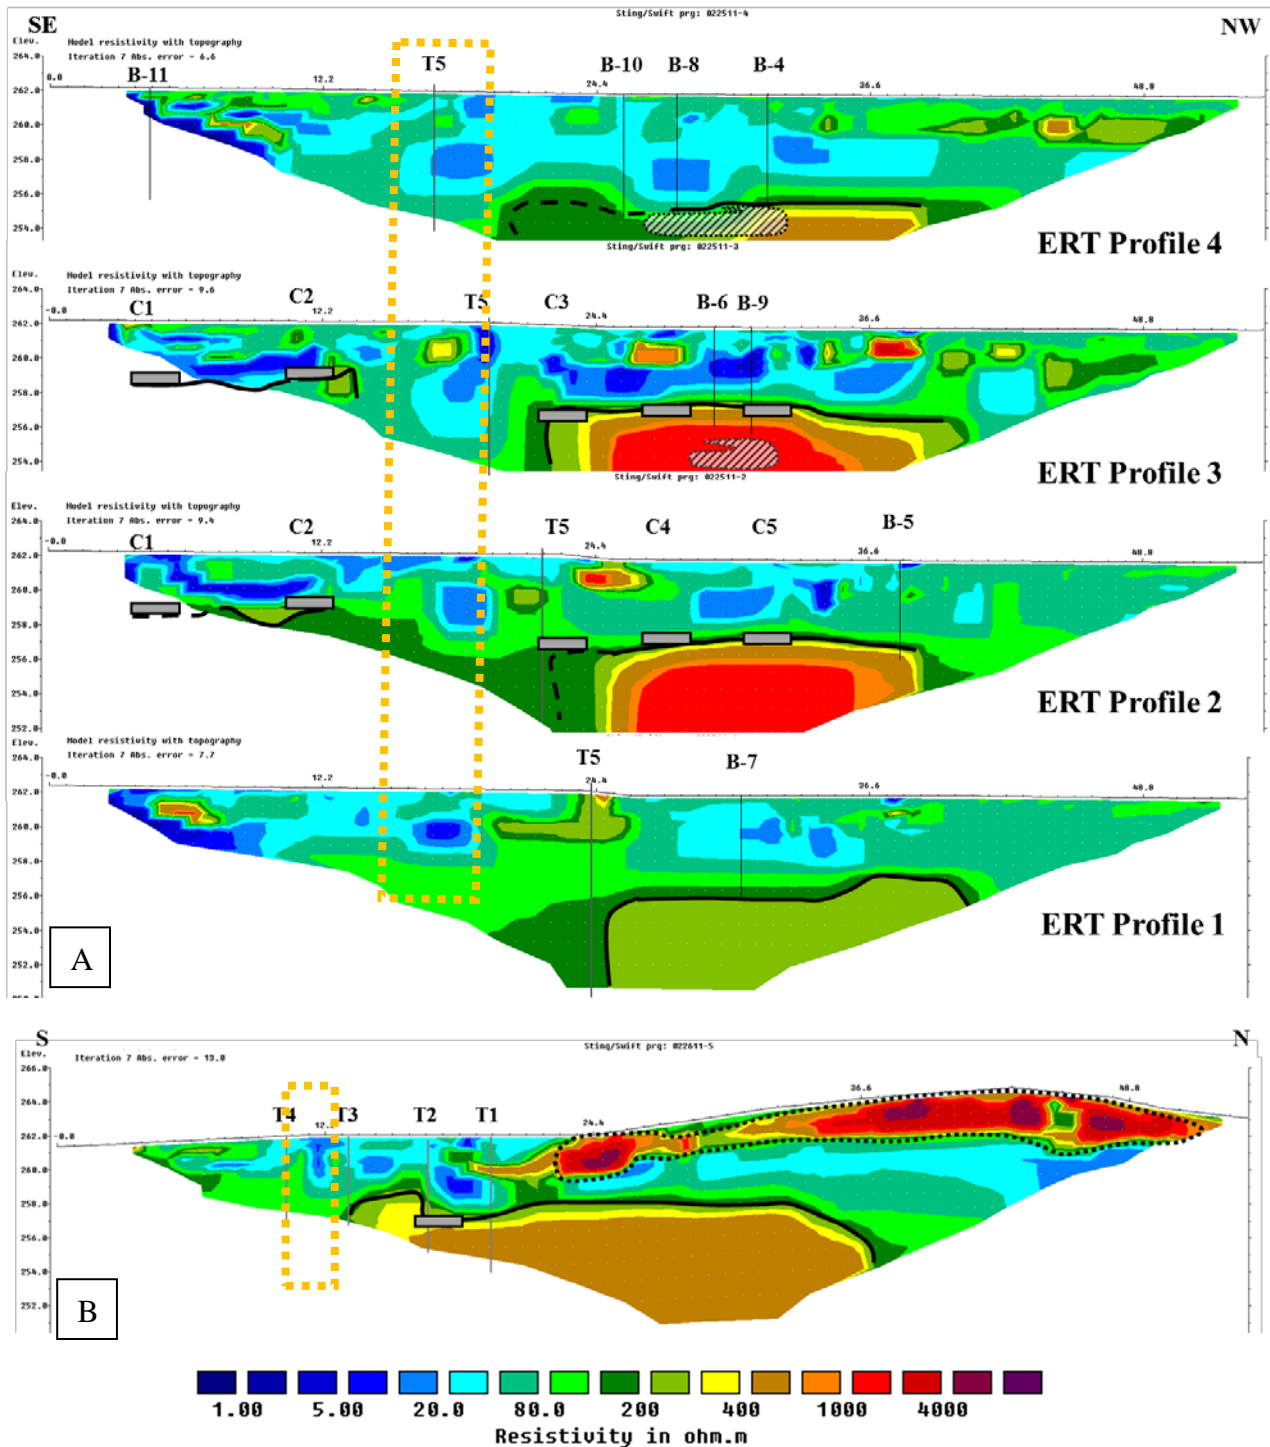
Figure 7. A) Side-by-side comparison of ERT Profiles 1–4 with mapped solution-widened joint. Anomalous low bedrock resistivity zone interpreted as a set of solution-widened joints with clay infill, trending west-southwest-east-northeast. This zone, with marked boundaries as orange dotted rectangular, extends from about 16.0 m to 21.0 m marks. B) Interpreted ERT Profile 5 with mapped solution-widened joints. Anomalous low bedrock resistivity zone interpreted as a set of solution-widened joints with clay infill, trending west-southwest-east-northeast. This zone, with marked boundaries as orange dotted lines, extends from about 11.0 m to 13.0 m marks.

Top of rock in proximity to the foundation of the eastbound lane bridge (location marked as C1 and C2 in Figure 9 and 13) was interpreted at a depth of approximately 3.0 m immediately to the east of the structure (Figure 1), to 4.9 m immediately to the west of the structure (Figures 1 and 7). Top of rock in proximity to the foundation of the eastbound lane bridge (location marked as C1 and C2 in Figure 7) was interpreted at a depth of approximately 3.0 m immediately to the east of the

Interpreted ERT Profiles 1–5 are shown in Figure 7. Solid black line represents an interpreted top of bedrock, dashed black line shows estimated depth to top of rock based on the borehole control and bridge footings depth. Crossing locations of Traverse 5 are marked as T5 in Profiles 1–4 (Figure 7A). Crossing locations of Traverses 1, 2, 3 and 4 are marked as T1, T2, T3 and T4 in Profile 5 accordingly. Foundations (Columns 1 and 2) of eastbound lane bridge are marked as C1 and C2. Foundations (Columns 3, 4 and 5) of westbound lane bridge marked as C3, C4 and C5.

Interpreted embankment fill (marked as black dotted line, Figure 7B) in the top part of the profile characterized by resistivity values of 200 ohm·m and higher. The southern part of the profile (16-m to 21-m mark) has lower resistivities (140 ohm·m or less) compared to the surrounding rock with the values of 200 ohm·m or higher.

This prominent geologic feature is characterized by an approximately 5-m wide low resistivity zone (compared to surrounding resistivity values at comparable depths in the study area), imaged on the ERT profiles 1–4 at about 16.0 to 21.0 m marks (Figure 7A) and on the ERT profile 5 at about 11.0 to 13.0 m marks (Figure 7B).
