Case report

Bryozoan limestone experience—the case of Stevns Klint

Nataša Katić*, Joakim S. Korshøj and Helle F. Christensen

Geo, Maglebjergvej 1, 2800 Kgs. Lyngby, Denmark

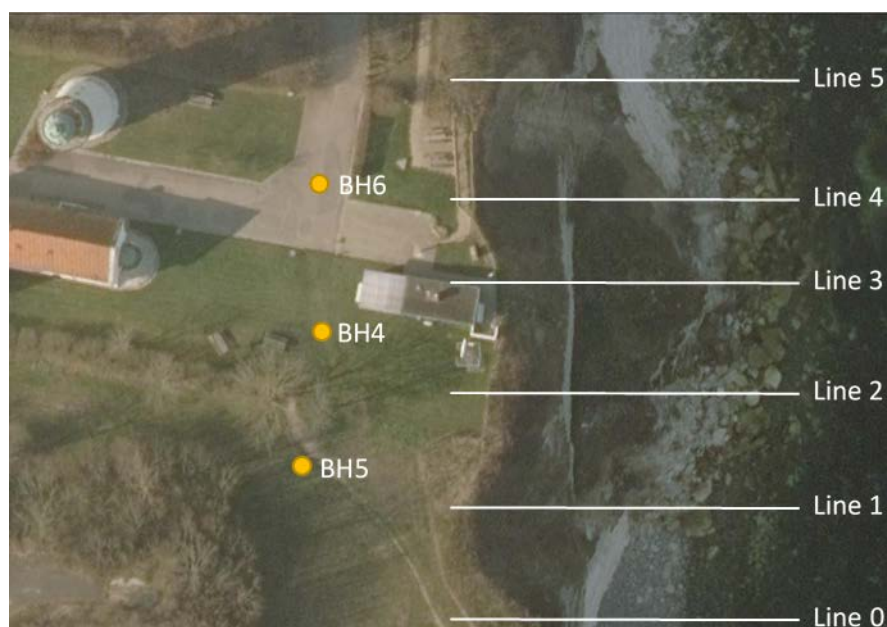
Figure 4. Layout of the present investigations (including boreholes BH4–BH6 and face logging lines 0–5).

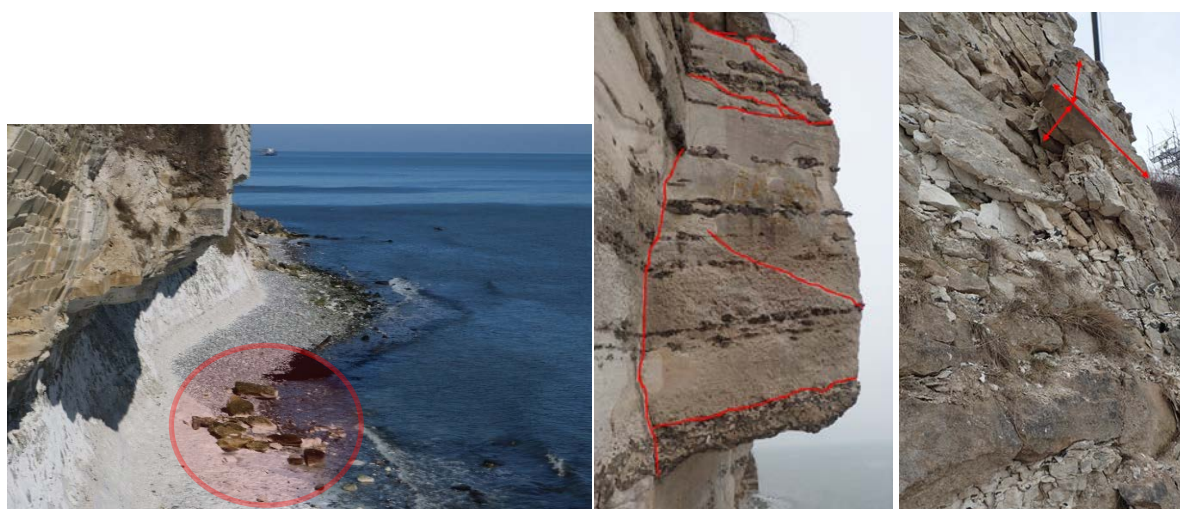
Figure 5. Overhang; rock fall and fractures on the slope (outlined with red; block group $40 \times 50 \times 150 \text{ cm}^3$ of about 800 kg). Photo J. Korshøj.

Falling debris (Figure 5) increased the difficulty of executing the site investigation. This was particularly important during midday when the sun shining on the cliff for some hours was thawing the frozen cliffside. Smaller landslides of the overlying quaternary deposits and chipping of the smaller blocks of rock occurred in a few places during the investigation.

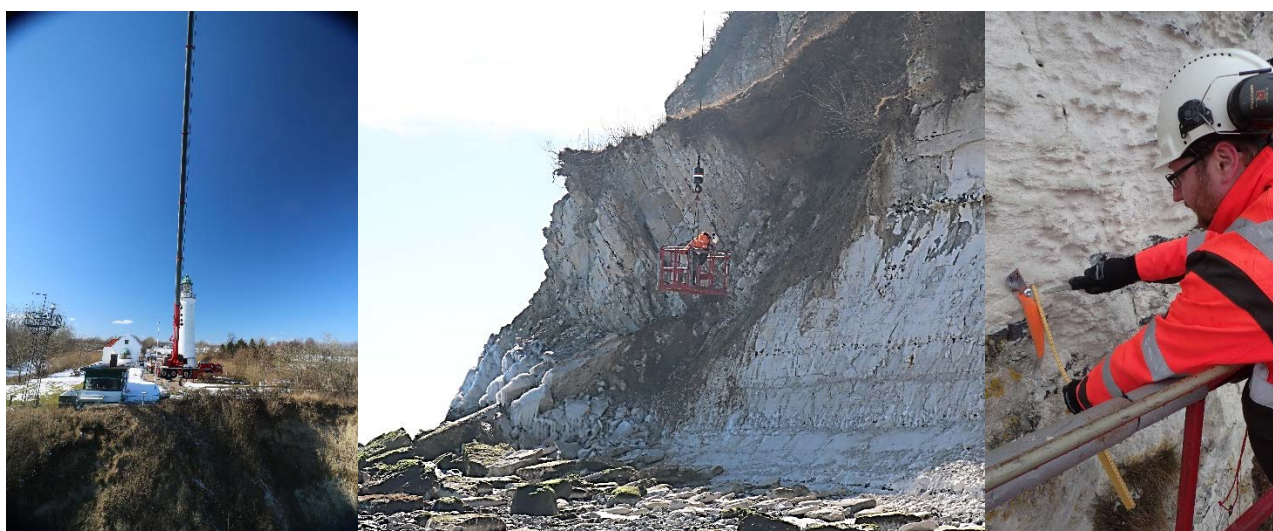
Figure 6. Face logging. Project photos (J. Korshøj on the right).

The face logging was carried out from a mobile crane. Due to its load, the crane had to stand 40 m from the edge of the cliff—roughly the distance equal to the height of the cliff—maintaining the ratio of 1:1 for safety reasons. At some points it was difficult to get close enough to the cliff because of the overhang. This affected the measurement of the induration, as the basket could be pushed away from the cliff in case the grip was not sufficiently strong.

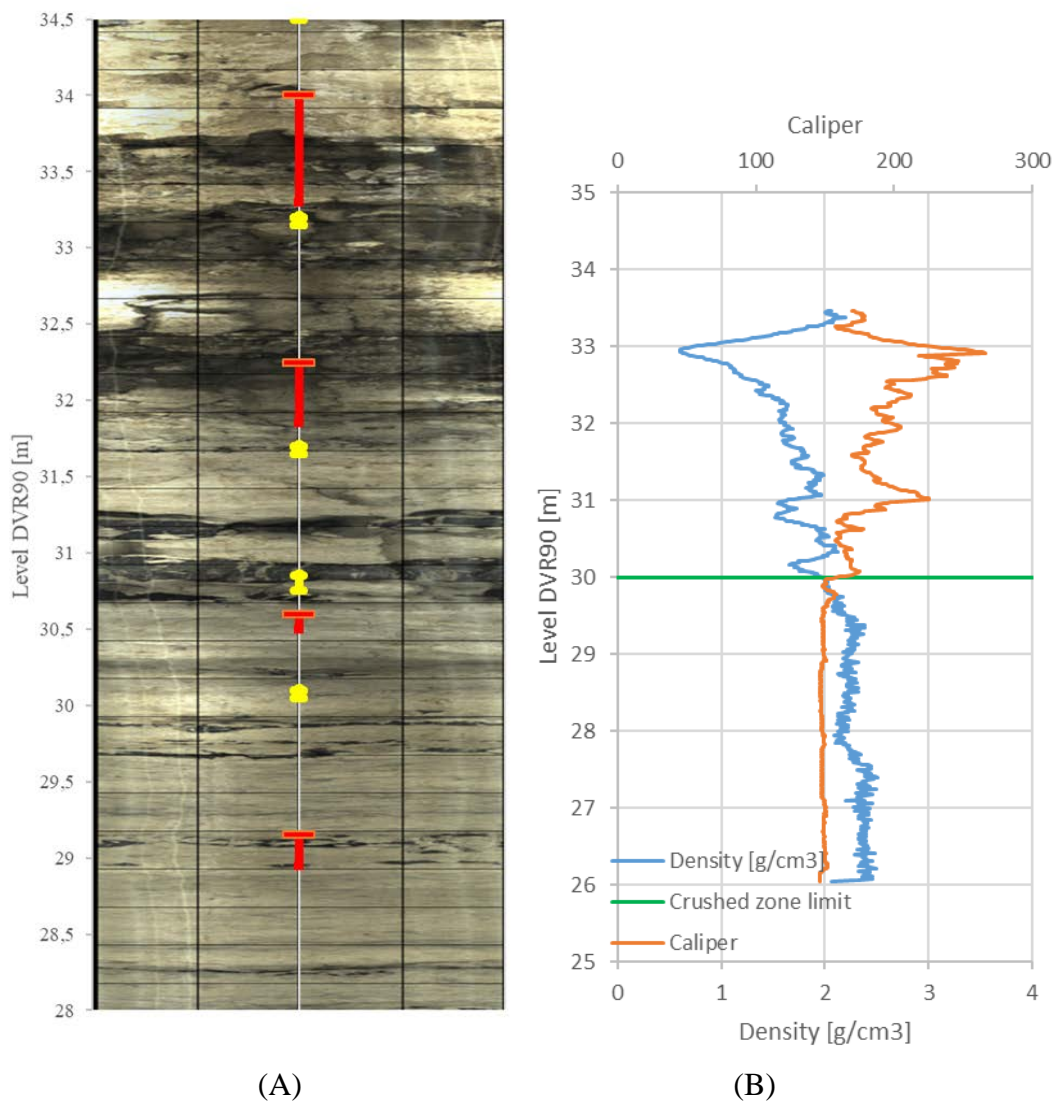
Figure 7. A: Optical televiewer log (part). Yellow: induration H5; Red: core loss)
B: Geophysical log (selection).

The percentage of H5 induration varies between the logs. This is partly a consequence of variation of the H5 concentration along the depth of the rock vs. the difference in lengths between the borehole logs and the face logs, and partly a consequence of the mentioned core loss during drilling of the boreholes illustrated in Figure 7b.

The lower sections of the rock seem generally more indurated than the upper sections, which is also confirmed by geophysical logging (Figure 7, right side), where an abrupt increase of the formation density on the presented log is marking the change towards the higher induration. Such variation is not observed on the other side of the planned construction site. Based on this and on the variation of indurations, forming “discrete zones with quite clearly different characteristics” [1], it

The above conclusion naturally extends to the analysis of fractures. At the present site, the upper crushed zone identified based on the borehole logs and geophysical logging, including the televiewer logs (Figure 7) is found in the top 4 m. The variation between the RQD evaluated on the face logs and on the cores is about 3 to 5 times, showing the effect of the coring process. This variation is larger in the upper zone. From the lower, fairly intact, zones of the rock, large pieces of core without fractures are retrieved. Thus in the lower part of the rock, the RQD based on the optical televiewer, face logging and cores scatters less.

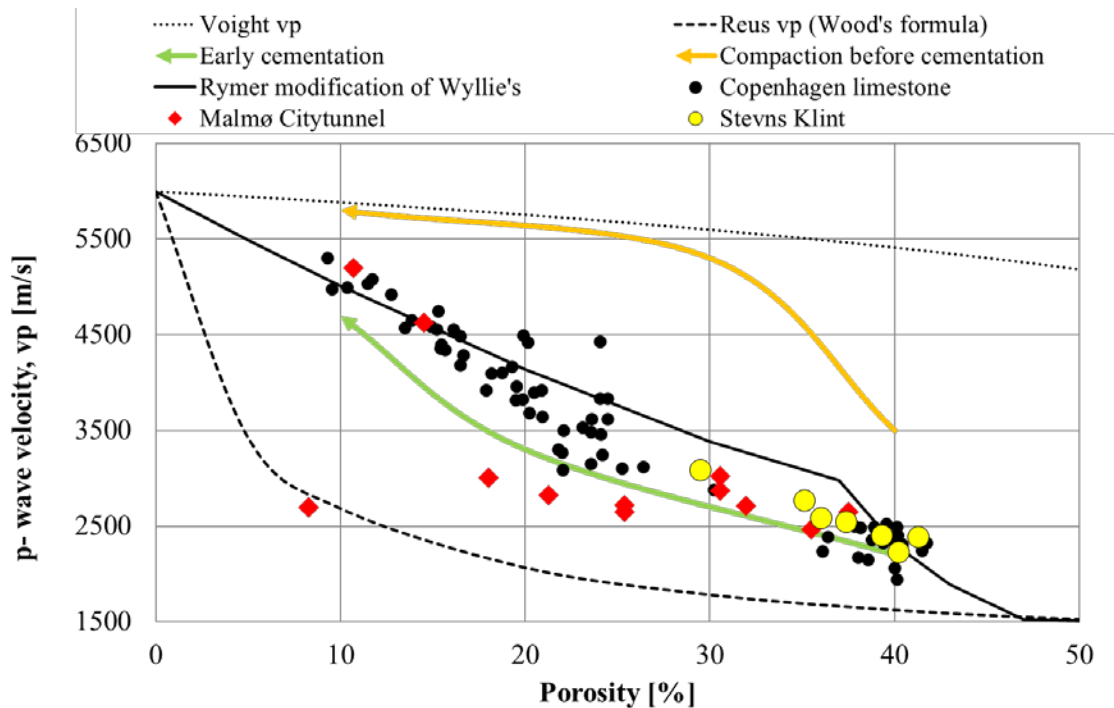
Figure 9. P-wave velocity vs. porosity.

In order to get an idea about the mechanism through which the rock has obtained its strength, the p-wave velocities measured on specimens for testing the unconfined compressive strength (UCS) are plotted versus the porosity in Figure 9. The data from Stevns Klint are plotted together with the laboratory data from the Malmø Citytunnel and the Copenhagen limestone data gathered primarily on Cityringen project (cf. [8]).

Rules of mixtures provide theoretical bounds for the stiffness of composite materials [8]. Voigt and Reuss bounds relate to axial and transversal loading, thereby defining the uppermost and the lowermost bounds presented in Figure 8, respectively. Following Eberli et al. [20], Katić & Christensen [8] and Brigaud et al. [21], the anticipated trends of data for processes involving cementation with and without initial compaction are sketched in Figure 9. The laboratory data, plotting above the trend for compacted mud [20], indicates that the development of rock strength of the Danian limestone, and especially of the Bryozoan limestone, is dominated by cementation process. The lower bound (Reus v_p line in Figure 9) p-wave measurement from Malmø indicates remoulded carbonate material. Ultimately, it is worth mentioning that the registered porosity of the matrix material on the site varies between 20 and 40%, while the testing was only conducted on the samples with a porosity between 30 and 40%.

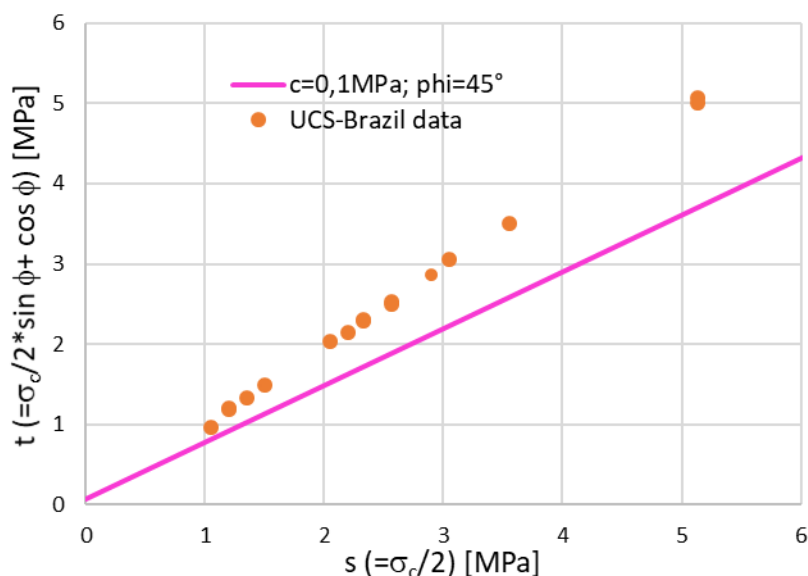
Figure 12. Intact strength in s-t space.

In order to check that this database information is suitable for a small structure, such as an anchor head, it is considered that a small structure may not engage the response from a combination of indurations and may be embedded in the weakest rock matrix detached from the mass by a system of fractures. Due to this, the confinement conditions for the anchor head may not exceed the in situ stresses, and influence of preconsolidation is expected to be minimal.

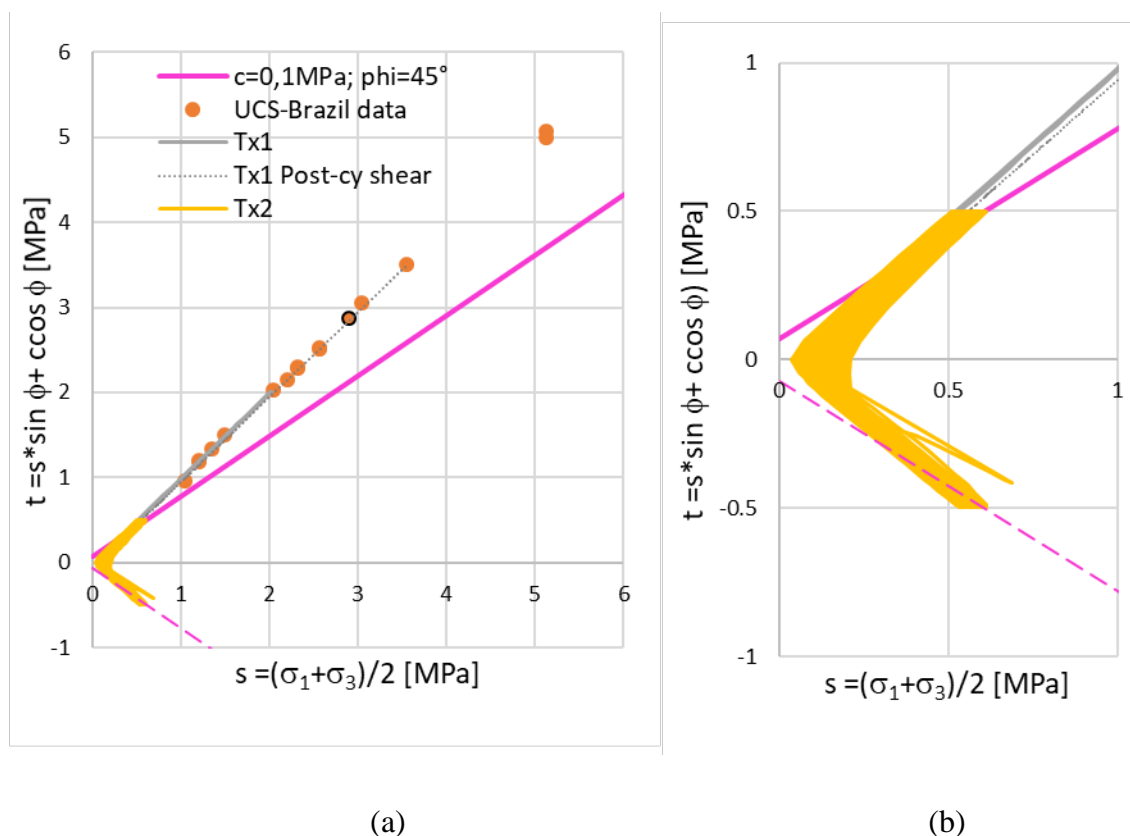
Figure 13. Strength test results in s - t space. a: all strength tests. b: detail of the second cyclic test.

The cyclic tests have been carried out on saturated specimens. The end platens were rough. The specimens were anisotropically consolidated to in situ stress following radial to axial stress ratio of about 0.3. The subsequent cyclic phases are carried out in undrained conditions, with a frequency of 0.1 Hz. The results of these tests are presented in Figure 13.

The first cyclic test has been carried out with two phases of 100 cycles each, with average stress ratio of about 0.19, and the cyclic stress ratio about 0.17 in the first phase, and 0.37 and 0.33 in the second phase. The stated stress ratios are referring to the strength of the UCS specimen cut out from the same sample, assuming that for the neighboring specimens, the same apparent bulk density would result in the same compression strength. However, as a variation of the UCS strength could occur at the same bulk density (cf. Figure 11), the stress levels were cautiously chosen, so that the maximum shear stress during the cyclic phase would not exceed about 70% of the shear stress based on UCS test, in order to ensure observation of the post-cyclic shear strength. See the outlined UCS-Brazil data point in Figure 13 obtained by combining the test results on the accompanying specimens from the same sample. In the post-cyclic shear phase, the specimen exceeded the estimated shear strength.

The second test has been carried out with the average stress ratio of 0 and the cyclic stress ratio of ~ 0.18 . This was a maximal cyclic stress ratio that could be applied for the average stress ratio of 0, as higher ratios required backpressures beyond the equipment capability. The sample reached 37 cycles, upon which it split orthogonally to the coring direction. This is interpreted as fatigue along a plane of weakness parallel to the bedding plane. The failure incidentally occurred along the failure locus defined for friction angle of 45 degrees and c' of 100 kPa.
