Research article

Geotechnical characterization of the Saint-Jude clay, Quebec, Canada

Ariane Locat^{1,*}, Pascal Locat², Hubert Michaud², Kevin Hébert¹, Serge Leroueil¹ and Denis Demers²

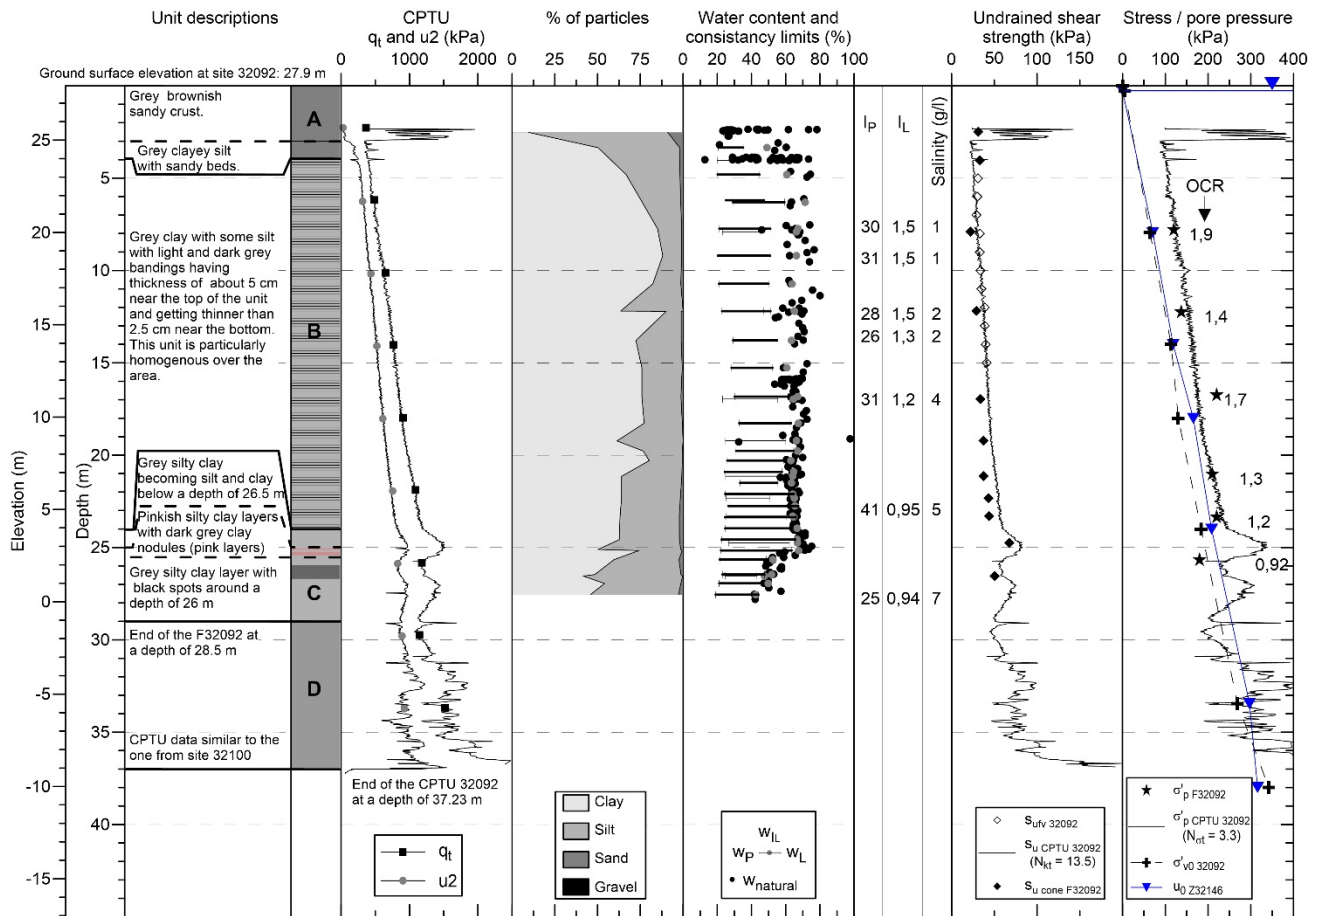
From the surface (elevation 28 m) to an elevation of 24.2 m, unit A is made of a dense, grey-brown, sandy fissured crust. This unit is composed of layers of sand and silt with only small amount of clay. Soil from this unit consists of 81% of silt (between 2 and 80 μm), 10% of clay (CF, < 2 μm), and 9% of sand (between 80 μm and 5 mm), see Figure 5.

Figure 5. Geotechnical profile at site 32092 (see Figure 3 for location, modified from Locat et al. [2]).

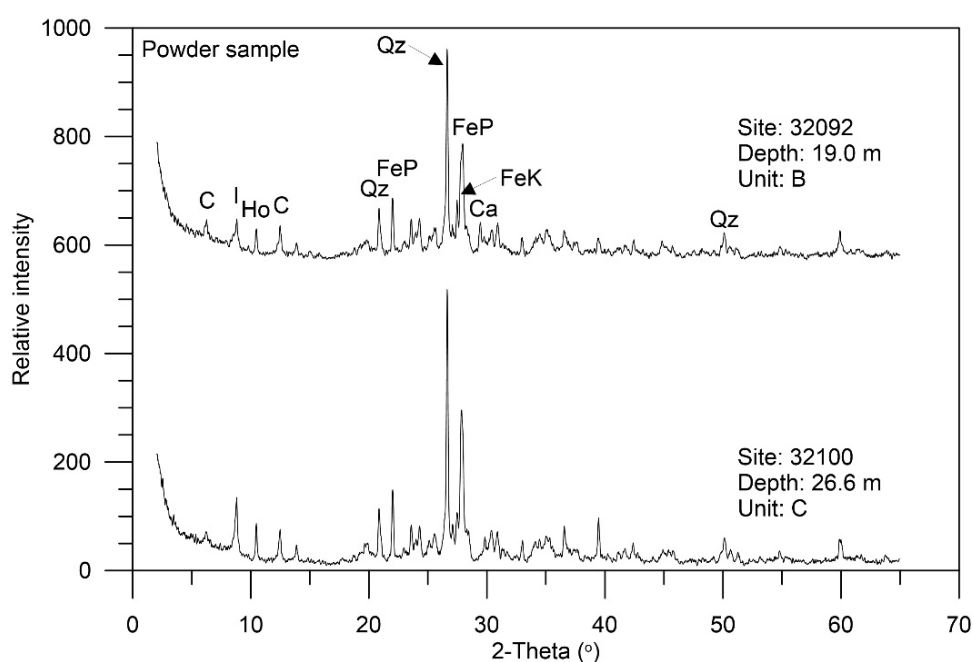
X-ray diffraction spectra obtained on powder samples from unit B and C are presented on Figure 7. Both spectra are similar, except for peak intensity, and show that both samples contain quartz (Qz), plagioclase feldspars (FaP), hornblende (Ho), potassium feldspar (FeK) and calcite (Ca). Illite (I) and chlorite (C) are also identified.

Figure 7. X-ray diffraction results on powder sample from units B and C.

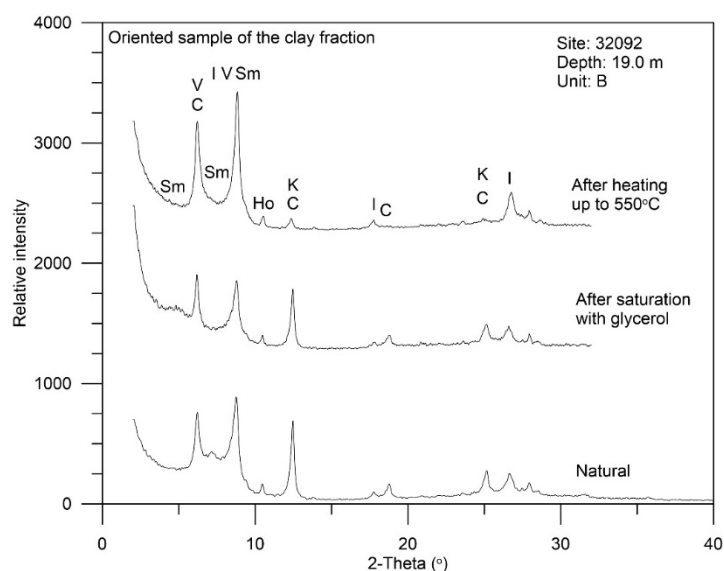
X-ray diffraction spectra of oriented clay fraction of samples from unit B and C are presented on Figures 8 and 9. These figures show the spectra for the natural clay fraction, after saturation with glycerol, and after heating up to 550 °C. Samples from unit B and C show similar results. Analysis of these spectra shows that the clay fraction of samples from both units contains illite, chlorite, kaolinite (Ka), and detectable amount of mixed-layers clay minerals or smectite (Sm), vermiculite (V) and hornblende. Peak at 7.5° (~ 12 Å) on the natural spectrum and more diffuse peak around 5° (~ 18 Å) on the saturated glycerol spectrum show the presence of expandable clay mineral (mixed-layer mineral or smectite). These expandable clay minerals all contract upon heating to a value close to the

Figure 8. X-ray diffraction results on oriented sample of the clay fraction from unit B in its natural condition, after saturation with glycerol, and after heating up to 550 °C.

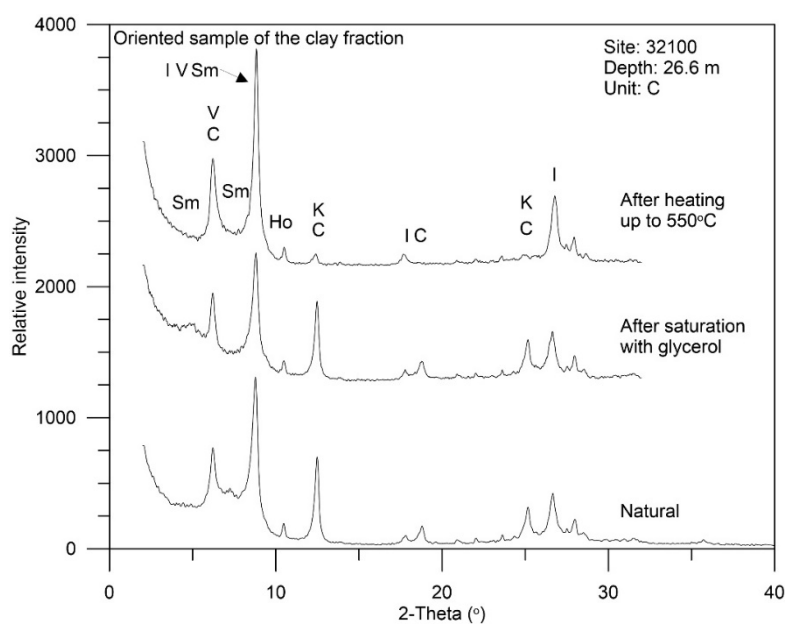
Figure 9. X-ray diffraction results on oriented sample of the clay fraction from unit C in its natural condition, after saturation with glycerol and, after heating up to 550 °C.

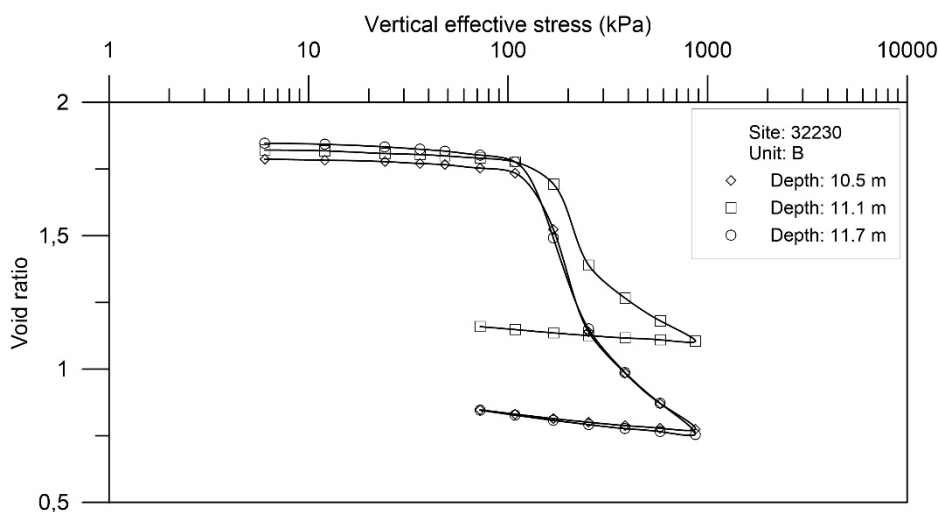
Three oedometer tests were performed on 200 mm diameter high quality Laval samples taken at site 32230, in unit B. These tests performed at depths of 10.5, 11.1 and 11.7 m are shown on Figure 13 (elevations of 17.5, 16.9 and 16.3 m). It can be observed that the preconsolidation pressure (from Casagrande construction) is well defined at values of 140, 156 and 132 kPa respectively for each depth. Maximal compression indexes (C_c) of 2.18, 1.72, and 1.94 are respectively obtained. C_c is maximal after the preconsolidation pressure and decreases at larger stress and lower void ratio. Given initial void ratios (e_0) of 1.79, 1.83, and 1.86 for each of the samples respectively, the C_c obtained from these tests follow correlations between e_0 and C_c for Champlain Sea clay discussed by Leroueil et al. [22]. Oedometers tests from ~70 mm diameter thin-wall tubes samples taken at various depth at sites 32100 and 32092 are also presented in Figures 4 and 5 and will be discussed in the following section.

Figure 13. Oedometer tests results on samples from unit B at site 32230, taken with the Laval sampler.

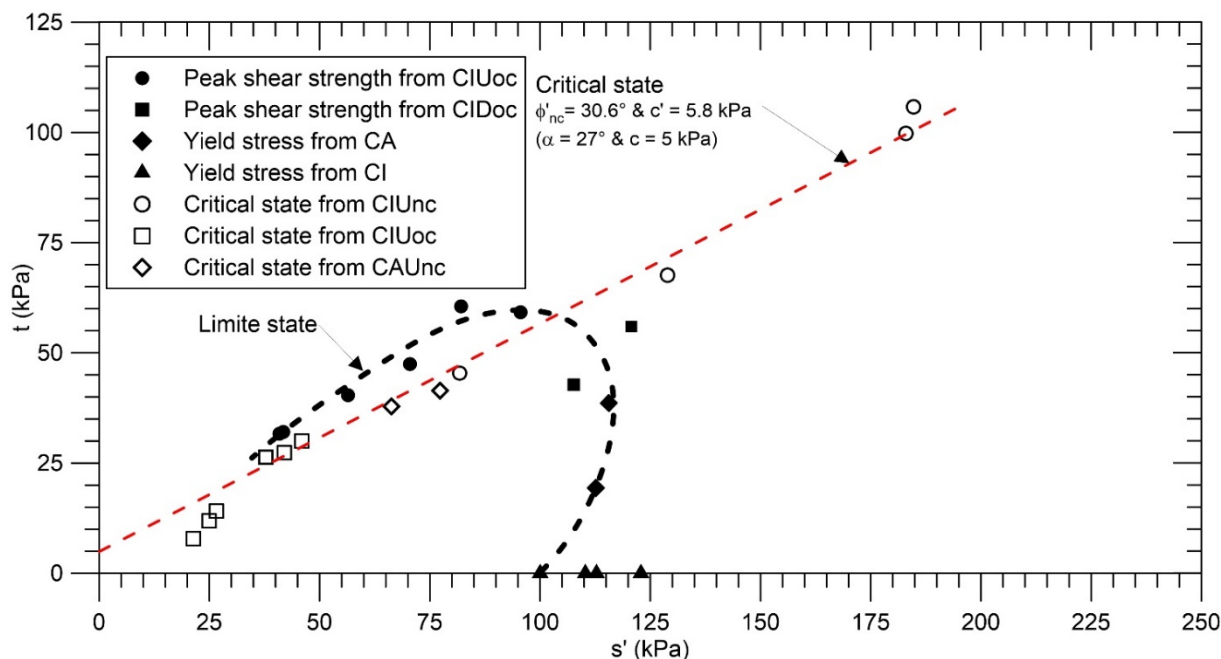
Figure 17. Limit state curve and critical state line for the Saint-Jude clay determined from tests shown on Figures 15 and 16.

Combining the last data points of the CIUnc tests (white circles on Figure 17) the critical state line was defined for the Saint-Jude clay (dashed red line). Effective friction angle (ϕ'_{nc}) and cohesion (c') are estimated at 30.6° and 5 kPa respectively. This ϕ'_{nc} value is consistent with the typical I_p of 29 at a depth around 10 m and is similar to other Champlain Sea clays having similar plasticity [22].

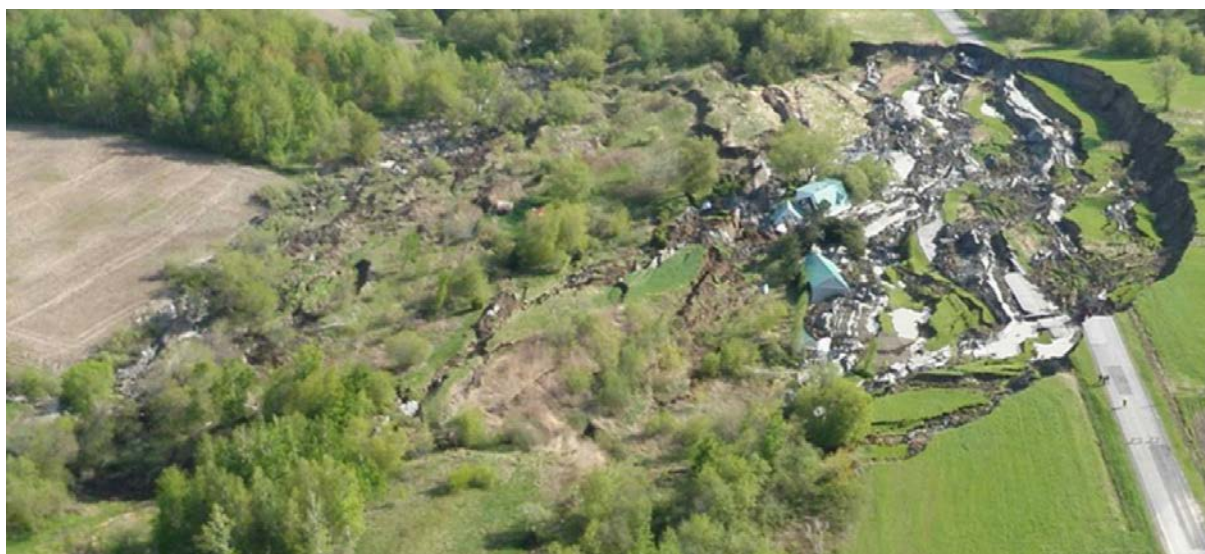
The landslide occurred along the Salvail River, tragically killing a family of four as their residence was destroyed. A general view of the landslide is presented on Figure 18, showing the house and section of the road displaced by the ground movement. The area was thoroughly investigated after the landslide which occurred on May 10th 2010.

Figure 18. General view of the 10th May 2010 landslide at Saint-Jude.

As can be seen on Figures 18 and 19, the debris mainly stayed in the crater of the landslide, with little flow downstream in the river. It was mainly constituted of blocks of more or less remolded clay having graben and horst shapes, forming ridges inside the landslide scarp. Figure 20 shows a photograph of the debris of this landslide and an example of these blocks. Horsts are triangular blocks with tip pointing upward with horizontal stratification and grabens have flat horizontal surface covered with grass or trees, confirming that their movements are mostly horizontal. These debris are typical of spread, a landslide type that occurs in Eastern Canadian Sensitive clay [34–36].

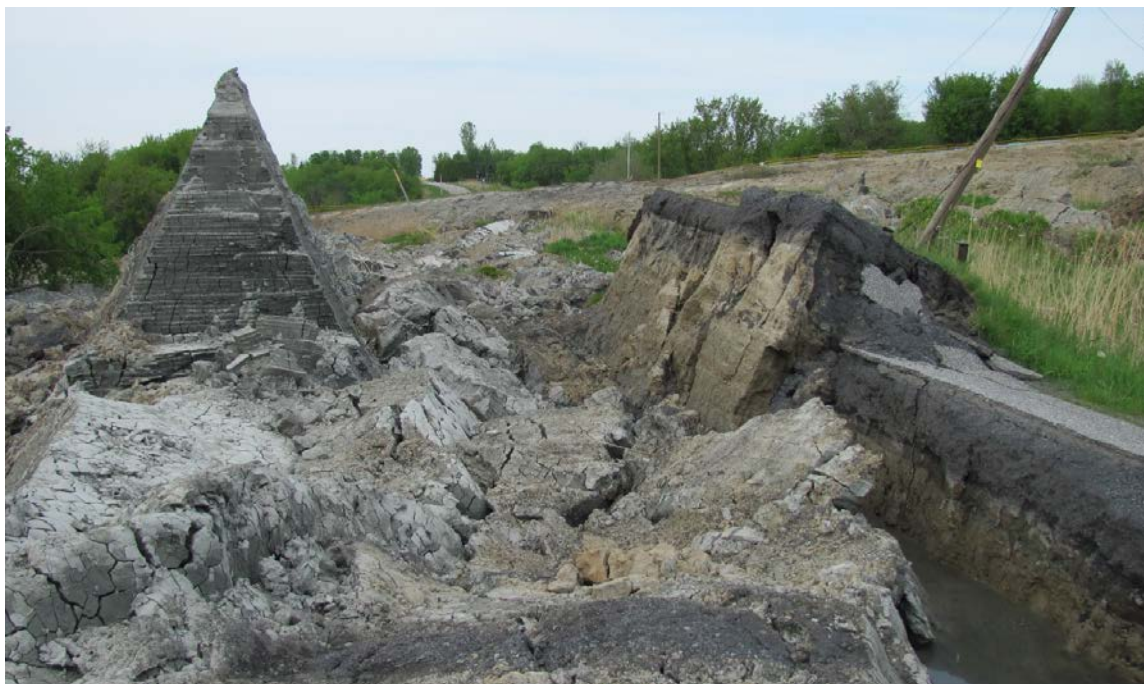
Figure 20. Photograph of a horst, on the left with horizontal stratifications, and a graben on the right, covered with pieces of road and grass, in the debris of the Saint-Jude landslide.
