## **Auburn University National Geotechnical Experimentation Site in Piedmont Residuum**

**Abstract:** In 1995, a geotechnical experimentation site was established in rural Lee County, Alabama near the area often referred to as Spring Villa. The Auburn University National Geotechnical Experimentation Site (AUNGES) site is situated near the southern terminus of the Appalachian Piedmont Physiographic province. The site consists of two sub sites, one that is a thick profile of residual soil and the other is an outcrop of fractured weathered quartzite. Extensive site investigation has been conducted at the site by many agencies and researchers using a wide array of in-situ soil tests. Foundations, excavations, and retaining structures have been constructed and load tested at the AUNGES. This paper summarizes all the work conducted at the site since its inception. Maps that detail the location of all in-situ tests and structures tested were generated. Representative profiles are included that relate early site investigation, between 1995 and 2005, and contemporary work done after 2010 are generated based on the results of piezocone, dilatometer, standard penetration, and shear wave vel

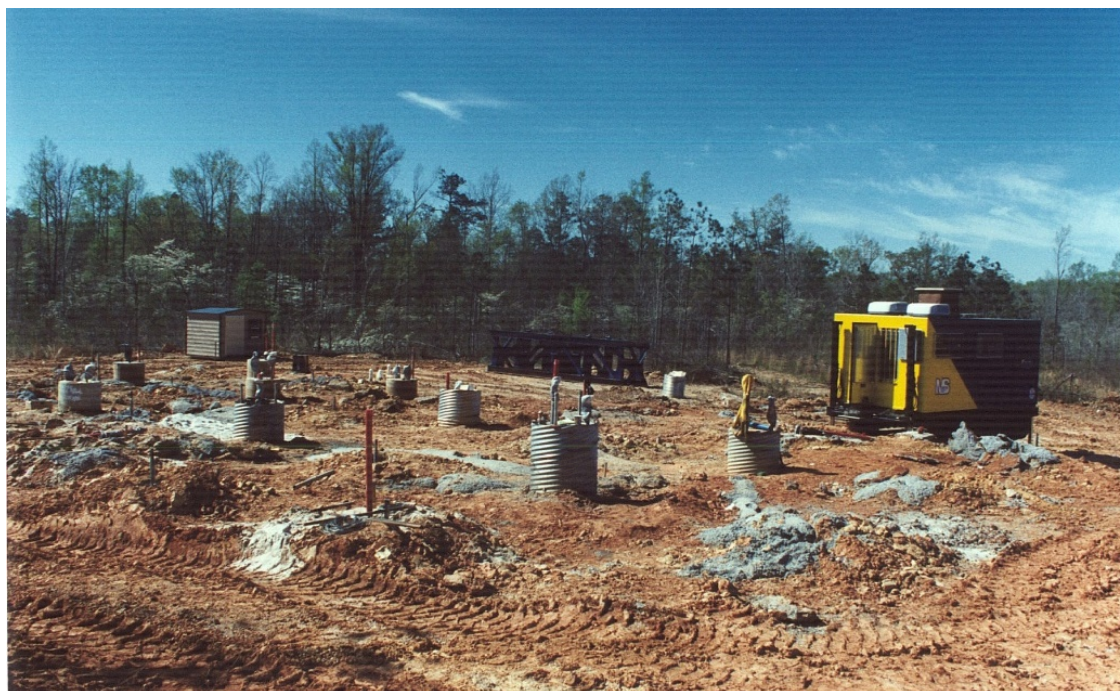
**Figure 4.** Early cone penetration testing at the AUNGES (photo courtesy of Dan Brown).

The initial geotechnical exploration program for the AUNGES began around 1995 and consisted of three borings with standard penetration tests. Not long after, a broad CPT program was conducted by Morris Shea (CPT rig shown in Figure 4). Subsequent characterization efforts focused more on the AUNGES location as it exists today. The results of the initial investigations and the follow-up studies conducted up until 2000 were summarized by Vinson and Brown [9], Mayne et al. [10], and Mayne and Brown [11]. Following these summary papers, several authors have published results from additional investigation at the site. Georgia Tech has continued to use the site for CPT research. A dissertation by McGillivray [12] provided a database of CPTs conducted by Georgia Tech through 2004. Investigation of the rock zone in the form of SPT and rock cores was documented by Kahle and Brown [7]. More recently, CPT and SPT investigations were performed on the western edge of the site as documented by Burrage [13]. Skinner [14] described new SPT and DMT testing conducted in 2015. Hebler et al. [15] reported the results of multi sleeve CPT conducted in 2016. Shi [16] and Montgomery et al. [17] compiled a GIS database of in-situ tests performed at the site. Results from these in-situ tests are discussed in later sections of this paper.

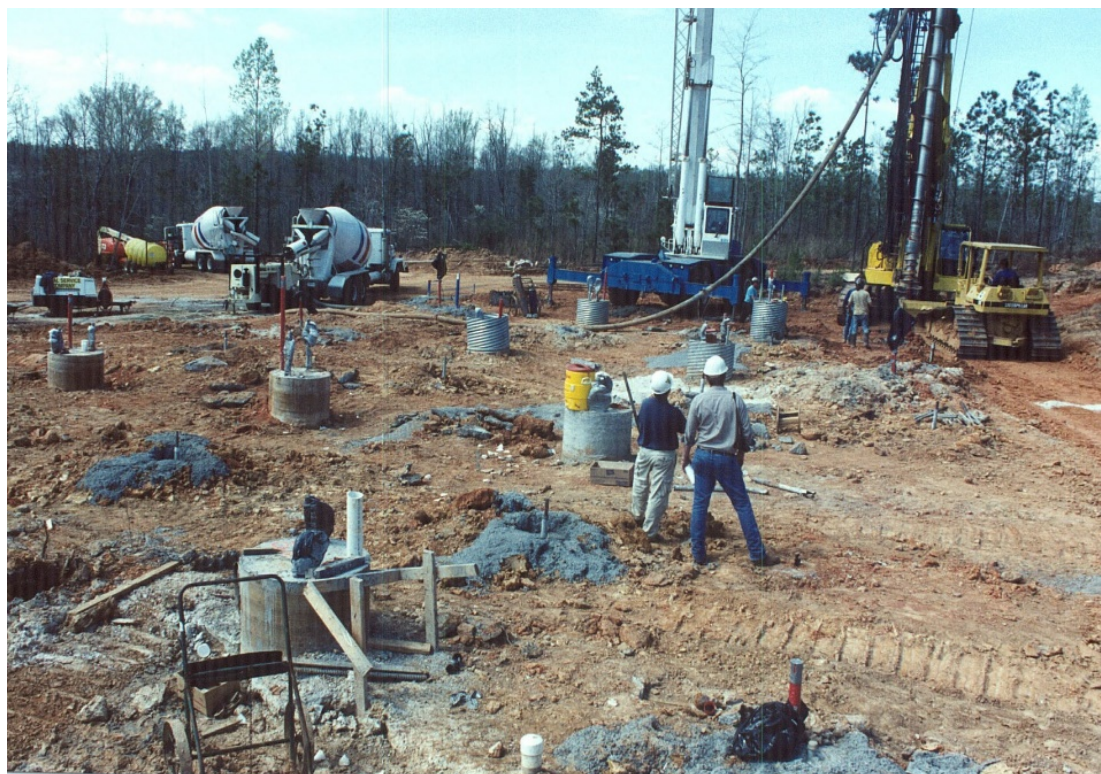
**Figure 5.** Installation of drilled shafts and displacement piles (photo courtesy of Dan Brown).

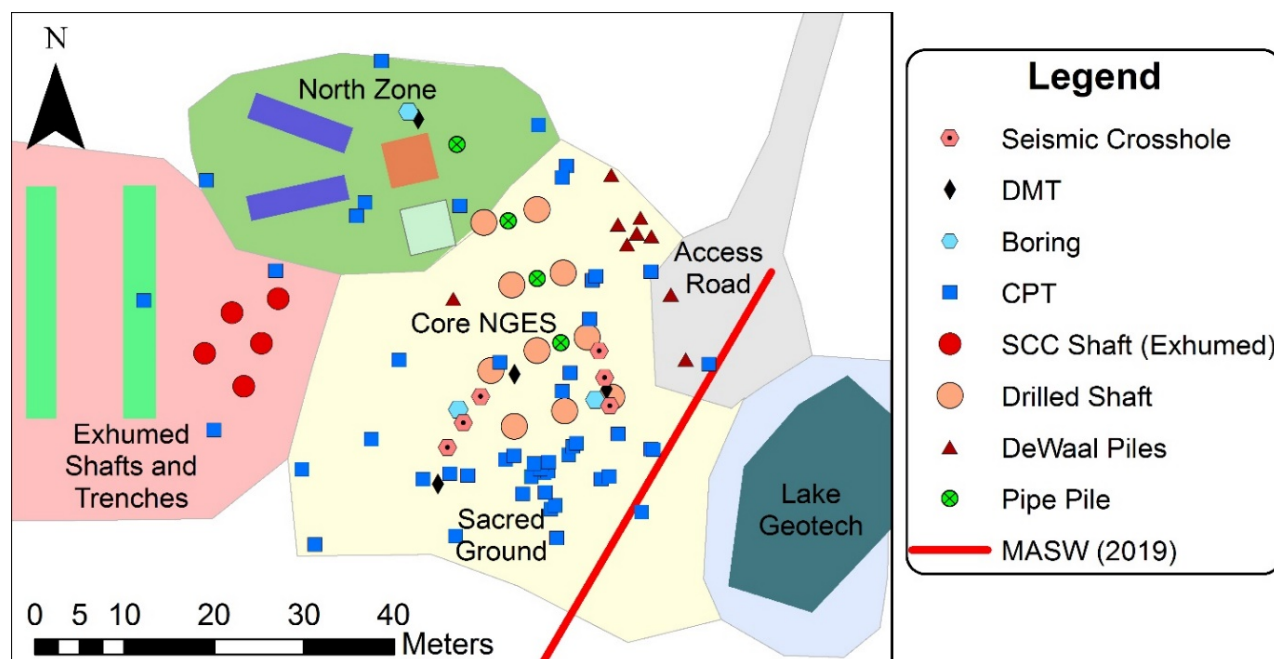
**Figure 7.** Locations of in-situ tests performed at the AUNGES, along with the different focus areas defined for this study.

Recently, an effort was made to collect as much of the previous testing information from the site and establish a GIS database to index the information by location. Shi [15] collected much of the past in-situ test and load test locations into a GIS database. Based on this database, the current study has delineated the overall AUNGES Main Site into four zones (Figure 7): (1) the core NGES, (2) Lake Geotech (anchor tests), (3) exhumed shafts and excavations area, (4) north zone. The core of the AUNGES site is located around the drilled shafts where a significant amount of testing has been performed. The southern half of the core NGES is considered the “sacred ground” of the site. A large concentration of penetration tests have been conducted in that area, which provides a valuable zone for comparison with future tests. Therefore, no additional foundation installation or excavation is allowed in this area in order to preserve the profile. Lake Geotech describes the small water body left behind after the anchor work performed in 2012. On the western edge of the core NGES, the exhumation of drilled shafts in 2004 and the installation of the test excavations in 2010 resulted in a

large disturbed area. This area is considered unusable for future studies seeking to perform tests in undisturbed material. The north zone represents the north central boundary of the site where the NCHRP and ALDOT pile groups and bents are installed. The foundations remain in this area and the soil profiles in this area are undisturbed, save a meter give or take of excavation. Outside of these four zones, the soil profile is undisturbed and mostly uncharacterized. These undisturbed areas are available for future expansion of the site should the need arise.

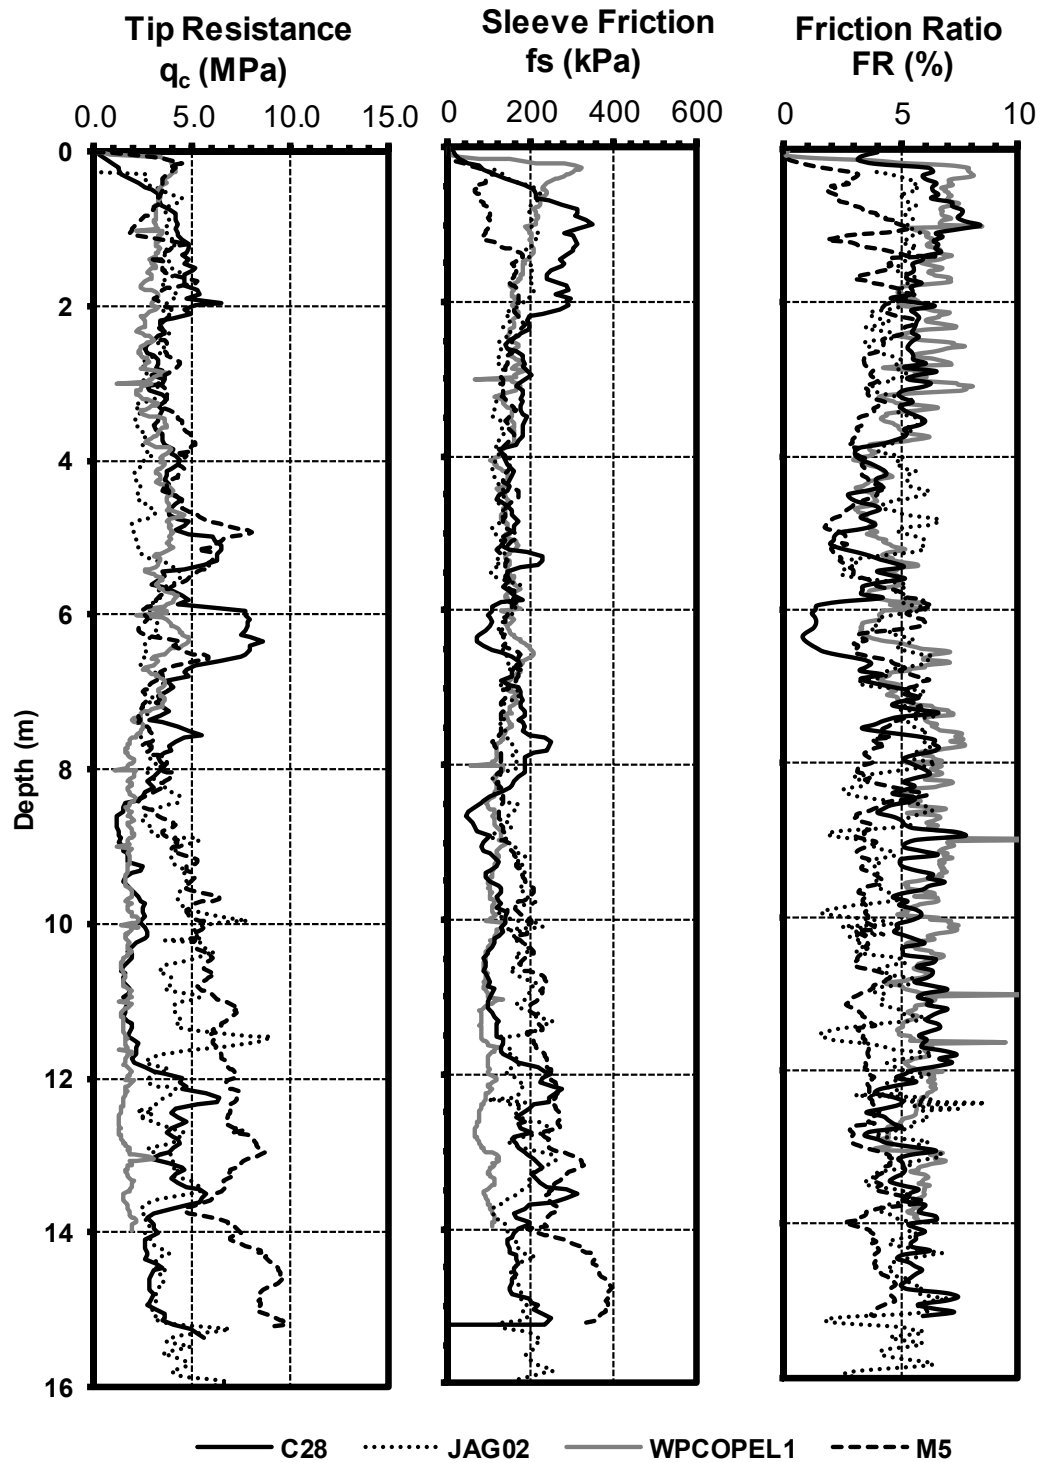
Figure 8. CPT soundings from the core area of the AUNGES.

For this study, representative profiles of in-situ test data were compiled for each of the three of the four zones defined previously. No in-situ tests have been performed within the Lake Geotech area. The first of these zones is the core area of the NGES. CPT soundings from the area around the drilled shafts are shown in Figure 8, while soundings from the sacred ground area are shown in Figure 9. JAG02 and WPCOPEL1 were performed by Georgia Tech and are documented by Mayne [37] and McGillivray [12], respectively. C28, C32 and C44 were performed by Morris Shea and documented by Vinson and Brown [9]. T4, T5, and T6 were conducted by Lankelma, LTD. in 2010 [13]. The remaining soundings (M5 and M6) were performed by ConeTec with Georgia Tech in 2016 [15]. The CPT soundings support a typical residual profile, as described by Sowers and Richardson [38]. The upper 2 meters is variable and consists primarily of a weathered crust. This is underlain by approximately 6 to 13 meters of saprolite presenting as a residual clay-silt-sand mixture. Below this saprolite, the tip resistances begin to increase as the profile transitions to weathered rock. Pore pressure measurements from the soundings are provided, but a substantial portion of the profiles exhibited negative pore water pressure with spikes that likely correspond to the saprolite. The negative pore pressures are expected as much of the profile is above the water table. This also may lead to problems with saturation of the cone tip which may have influenced the results.

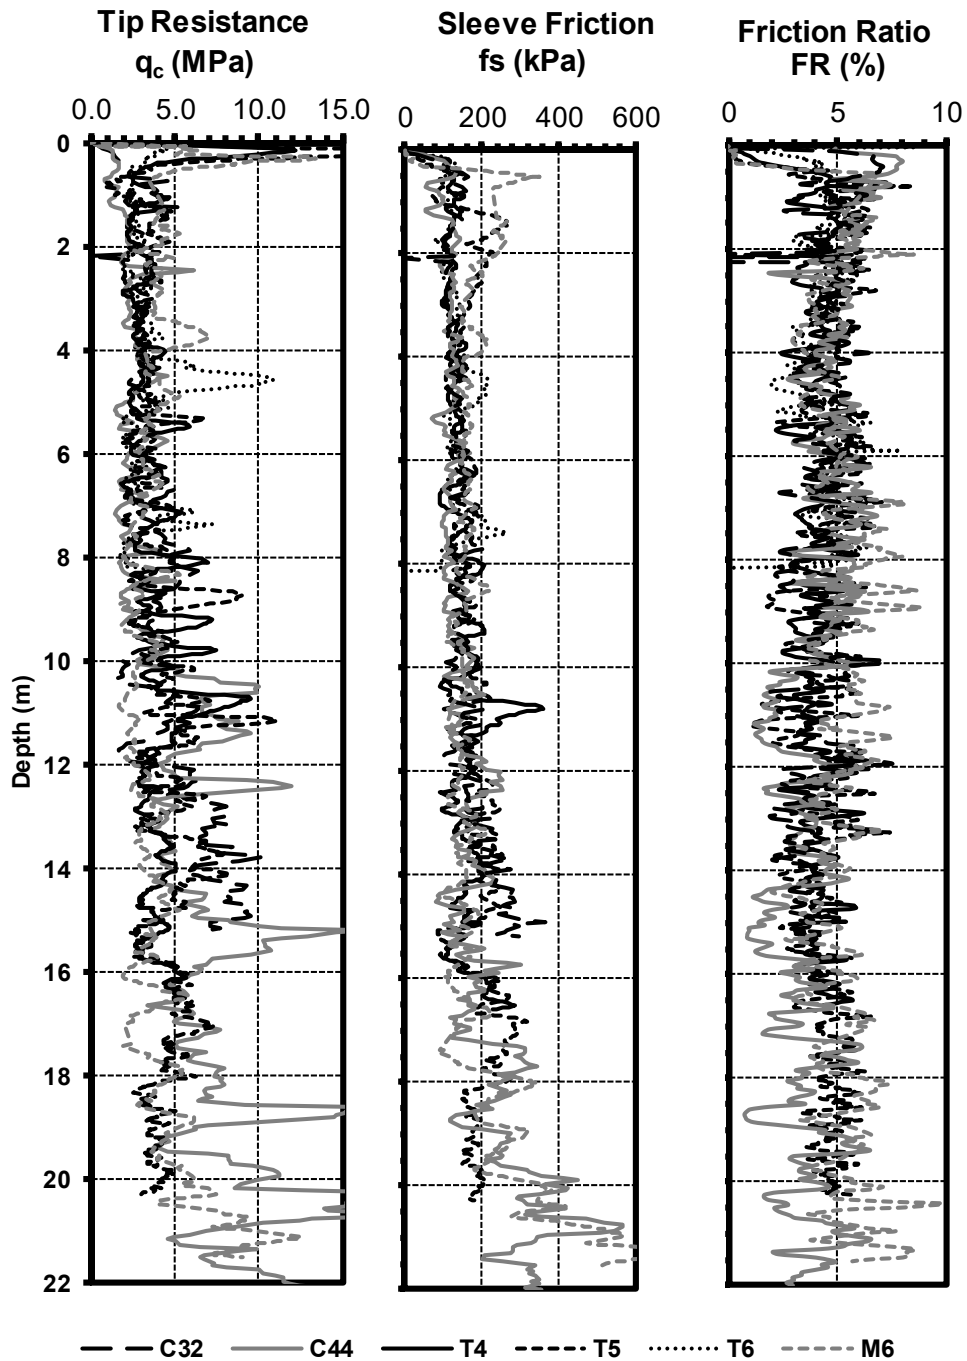
**Figure 9.** CPT soundings from the Sacred Ground area of the AUNGES.

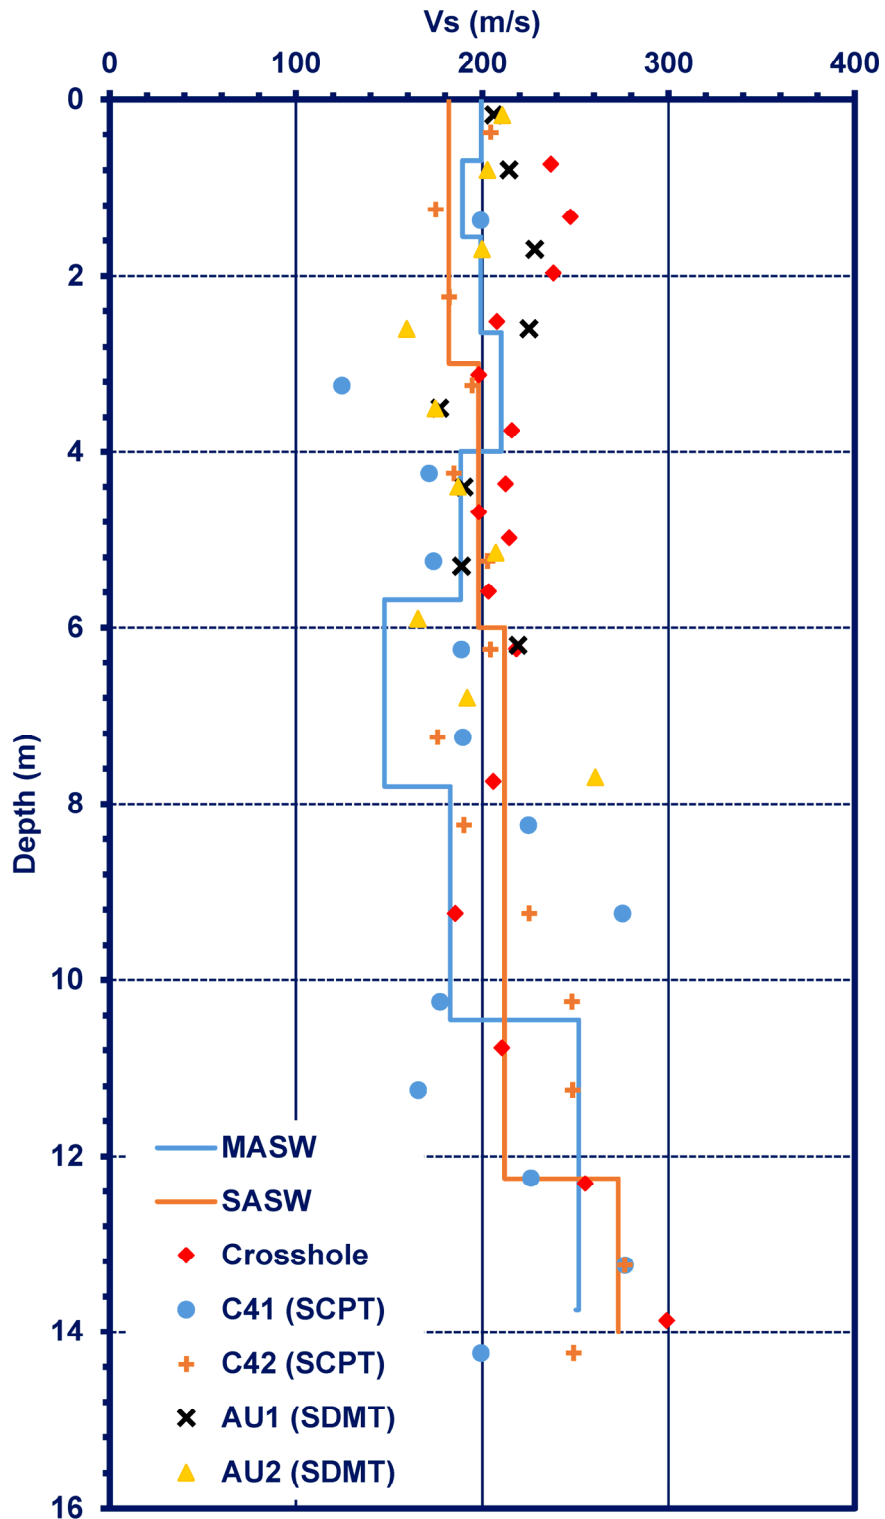
**Figure 10.** Shear wave velocity profiles from the AUNGES. The SASW and crosshole results were presented by Mayne et al. [10]. The SCPT and SDMT results were documented by Vinson and Brown [9] and Martin and Mayne [40]. The MASW results were collected as part of this study.

The core area of the site has also been characterized using shear wave velocity. Mayne et al. [10] presented results from both cross-hole and Spectral Analysis of Surface Waves (SASW) tests that had been performed within the core area of the AUNGES. The authors recently used multichannel analysis of surface waves (MASW) [39] to determine the shear wave velocity profile along the eastern portion of the core area (location shown in Figure 7). The MASW survey was performed using 48 vertical 4.5 Hz geophones spaced 1 meter (3.28 feet) apart. A 90 N (20 lb) sledgehammer was used as a source with an offset of 24 meters (79 feet) from the geophone array. Five shots were taken in this location and stacked during processing. The data was processed using SurfSeis 6.0, a software developed by the Kansas Geological Survey. The resulting profile is shown in Figure 10, along with shear wave velocity measurements published by Mayne et al. [3]. Downhole shear wave velocity testing has also been performed around the site using both seismic CPT (SCPT) and seismic DMT (SDMT). Results from these tests have been presented by Vinson and Brown [9] and Martin and Mayne [40] and selected profiles are shown in Figure 10. The MASW results show reasonable agreement with the previous measurements, and discrepancies are likely due to lateral variability at the site.

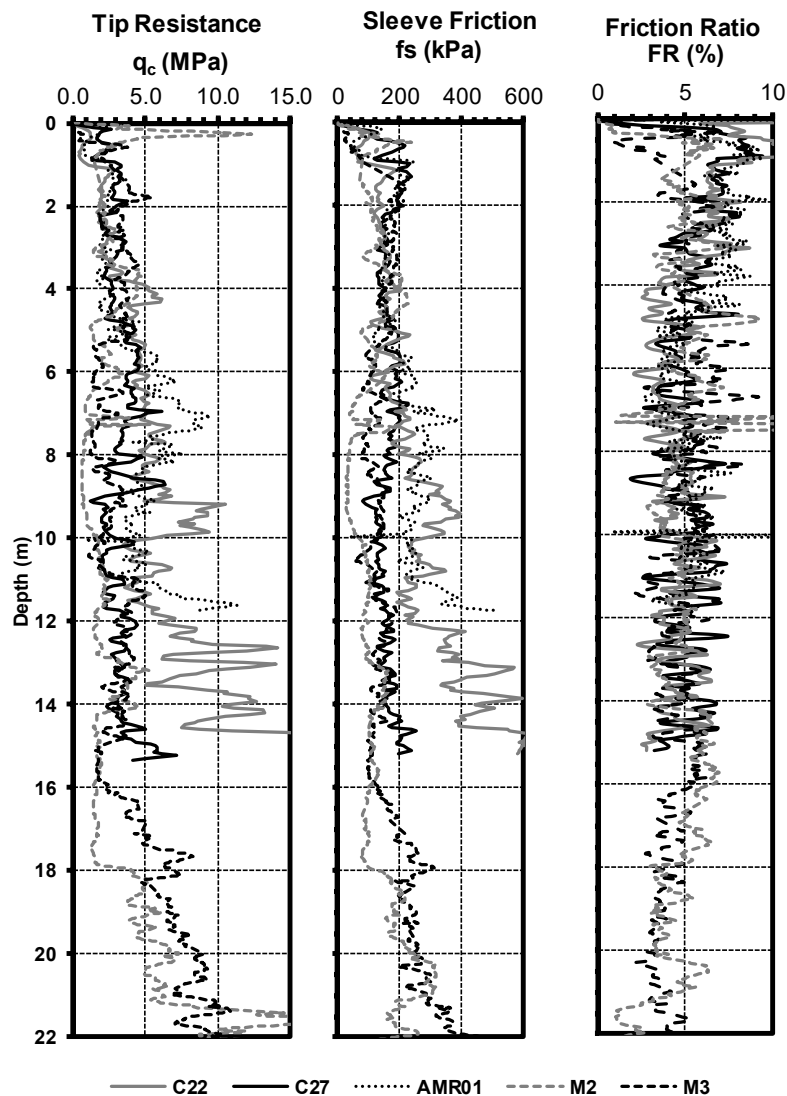
**Figure 11.** CPT soundings from the north zone of the AUNGES, near the pile groups.

Figure 11 shows results from a cluster of CPT soundings in the north zone of the site, near the pile groups. AMR01 was performed by Georgia Tech in May 2002 [12]. C22 and C27 were performed in 1996 by Morris Shea and documented by Vinson and Brown [9]. The remaining soundings (M2 and M3) were performed by ConeTec with Georgia Tech in 2016 [15]. As before, these soundings are relatively consistent despite the large time lag between the tests, changes in the water table, and differences in equipment.

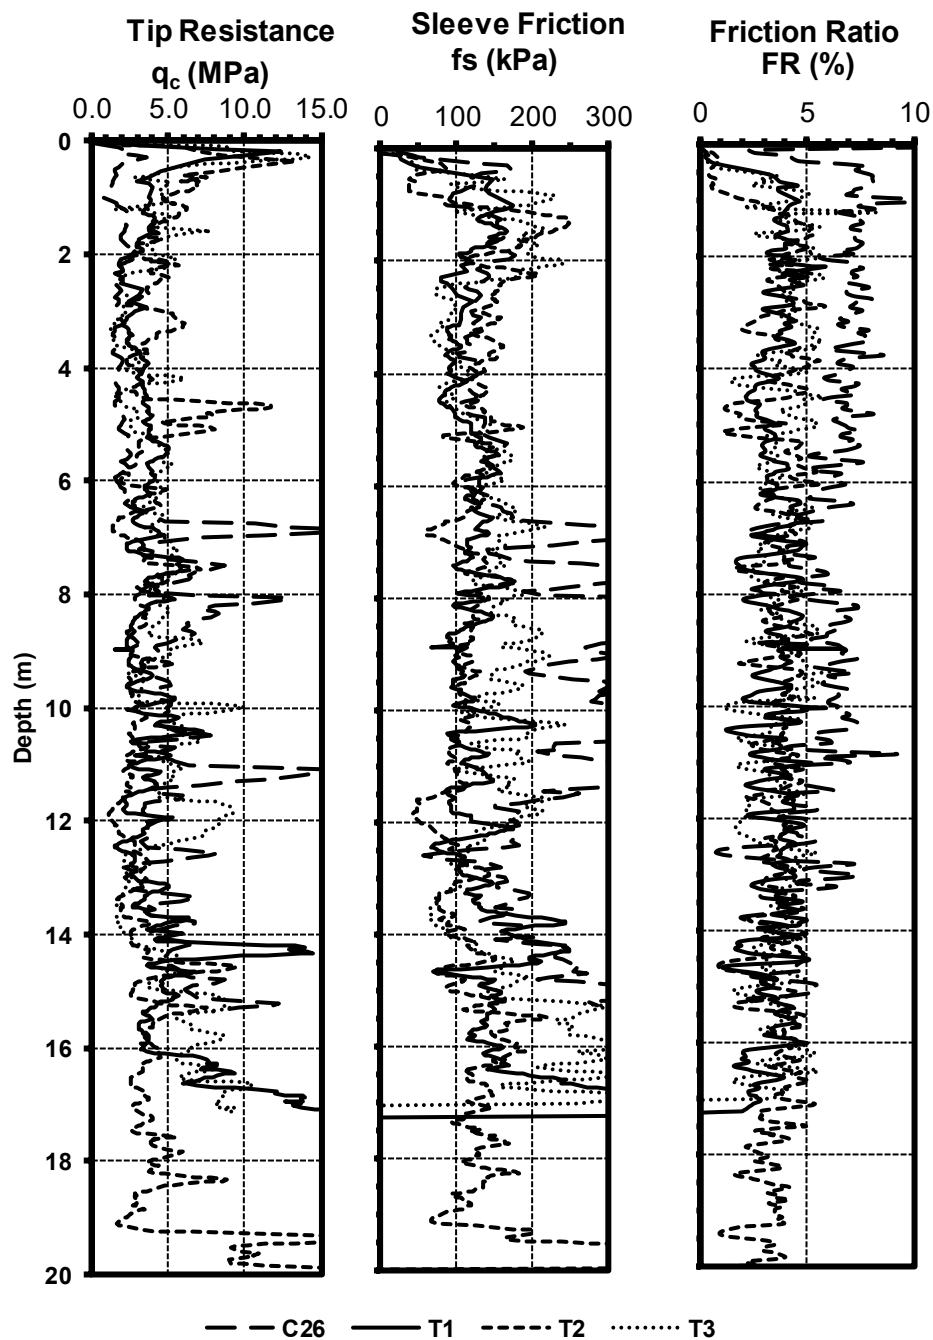
**Figure 12.** CPT soundings from the area near exhumed shafts and excavations performed before the area was disturbed.

CPT soundings conducted before the excavations were performed on the western side of the site are shown in Figure 12. Soundings C22 and C27 were performed by Morris Shea and documented by Vinson and Brown [9], while soundings T1, T1, and T3 were conducted by Lankelma, LTD in 2010 [13]. The area where these soundings were performed has since been excavated and recompacted, so the data is no longer representative of the in-place soil. These soundings are valuable to support analysis of the self-consolidating concrete (SCC) drilled shafts and excavations in their vicinity.

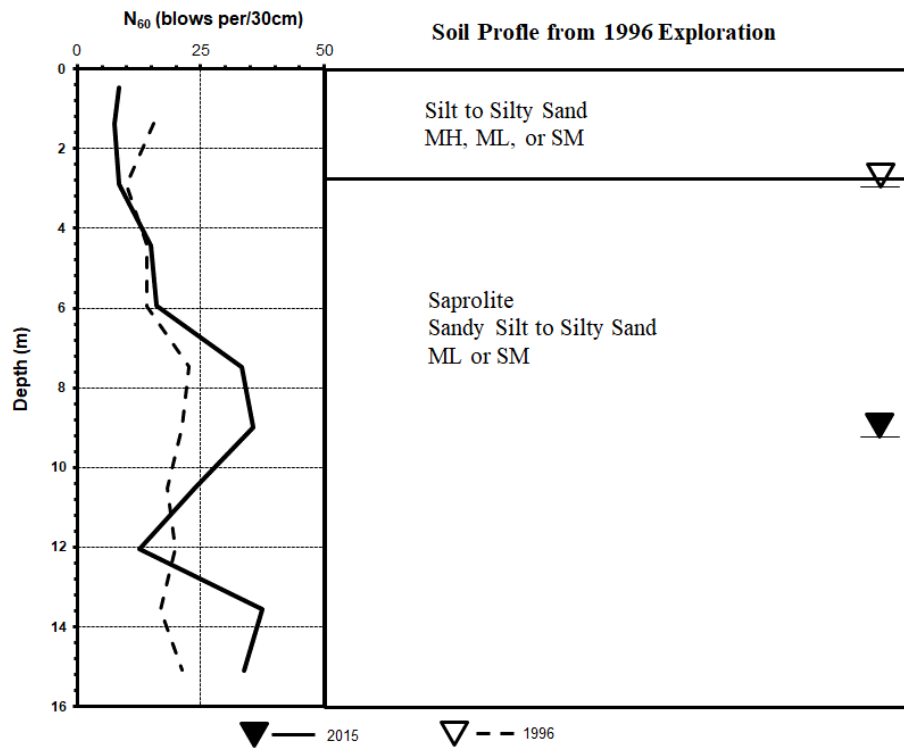
**Figure 14.** Comparison of SPT results from two borings in the North Zone of the AUNGES.

In addition to CPTs, both SPTs and DMTs were performed at the AUNGES as part of both the initial characterization [9] and recent load testing of H-Pile bents [14,35]. Figure 13 compares one of the original dilatometer results (AU-1) with a more recent test (AU-D2) performed in the north zone of the site in terms of insertion force or thrust, dilatometer modulus  $E_D$ , material index  $I_D$ , horizontal stress index  $K_D$ , and constrained modulus  $M$ . Figure 14 compares the results of SPT tests performed

in this same area in 1996 and 2015 along with a generalized profile determined from samples retrieved in 1996. Differences in the tests may be due to variability at the site, changes in equipment, and changes in effective stress due to the lower ground water table in 2015.
