Research article

Unsaturated behavior of excavations in residual soil at the Auburn University National Geotechnical Experimentation Site

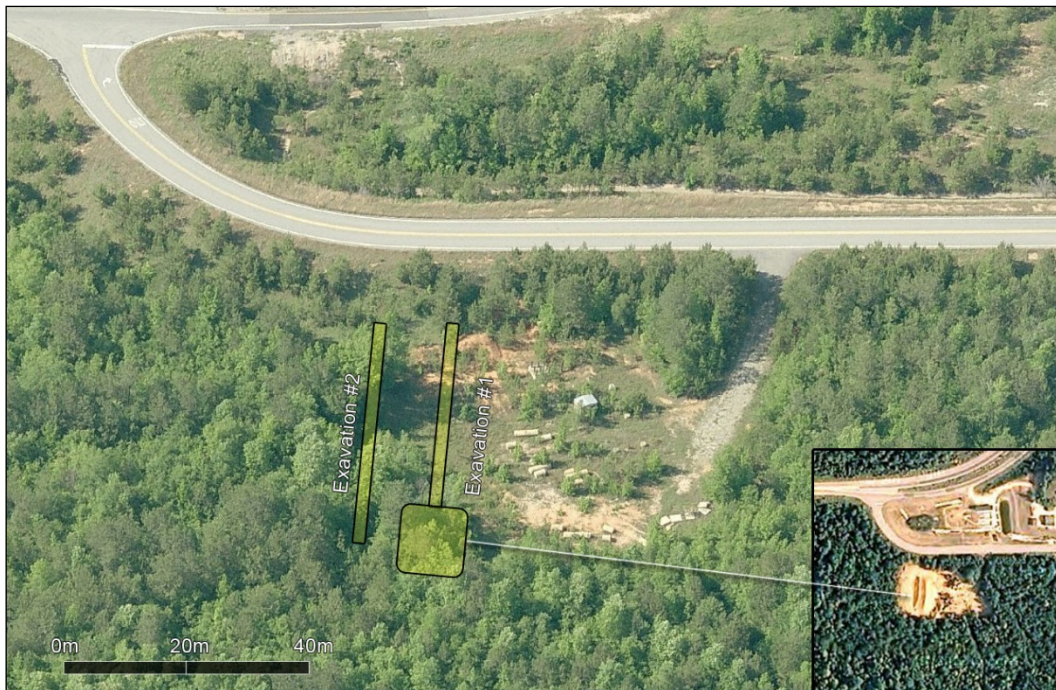
Figure 3. NGES aerial with approximate excavation locations [2].

The first excavation included additional boreholes so that the pore pressure sensors were each installed in separate boreholes, and the depth of the borehole was made so that the sensors were located in the bottom (partially in contact with the residual soil). However, because the failure surface observed in Excavation #1 intersected the boreholes closest to the excavation, Excavation #2 was modified to minimize the number of boreholes within 2 meters of the excavation, therefore minimizing the disturbance of the soil in that region. It was determined that installing the sensors in re-compacted soils as shown in Figure 2 would not introduce significant error in the measurements, because the small diameter of the borehole would result in a relatively low fluctuation in pore pressure with respect to the soil surrounding the borehole (i.e. the pore pressure would equalize with the soil surrounding the borehole at each depth). This same concept is the basis for the Watermark sensor design, and the filter paper method for determining suction [1]. Also, to better see the site conditions at failure, a time lapse camera was installed for the second excavation to take photographs every hour. The approximate locations of the two test excavations are shown in Figure 3.

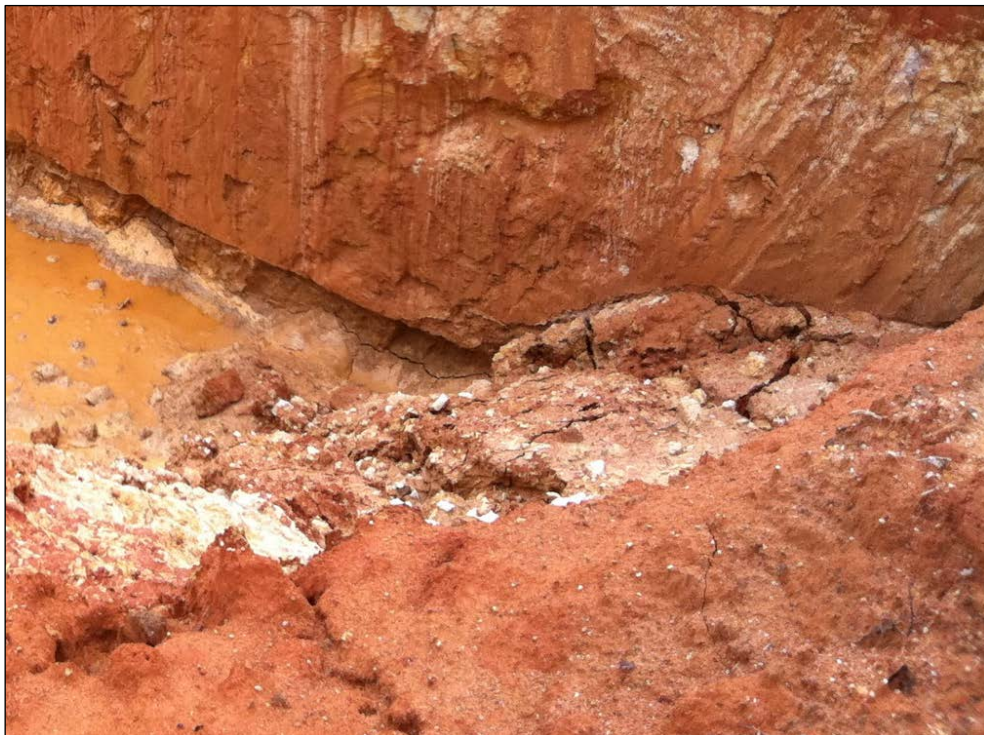
Figure 7. Undermining from water in bottom of trench.

- It appeared that most failures started at the bottom of the trench with some type of undermining caused by water entering the trench during a rain event, and eventually propagated to the surface approximately 1.5–2 m behind the excavation face (along the tension crack). The undermining that had occurred in Excavation #2 along the toe of the slope just before failure is shown in Figure 7.

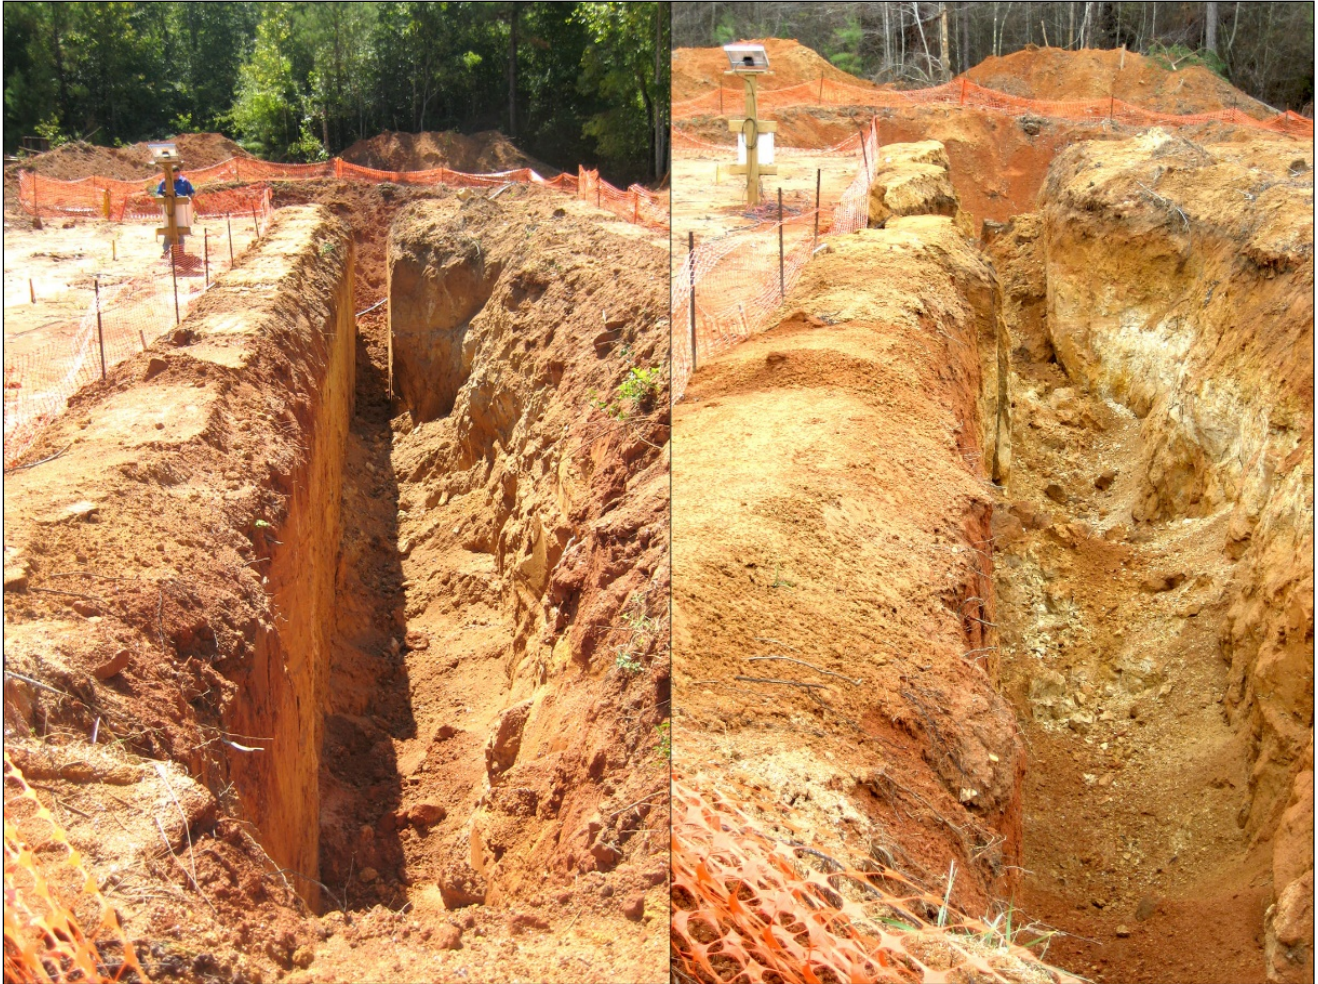
Figure 8. Excavation #1 before and after failure.

Photos taken of Excavation #1 before and after failure are shown in Figure 8. Time-lapse photos of Excavation #2 before and after each failure are shown in Figure 9. An enlargement of Excavation #2 after the initial failure can be seen in Figure 10. Also, the progression of the tension cracks over time leading up to the time of failure can be seen in Figure 11. In general, the tension cracks started as small cracks, and grew larger over time, even in areas where failure had not occurred.

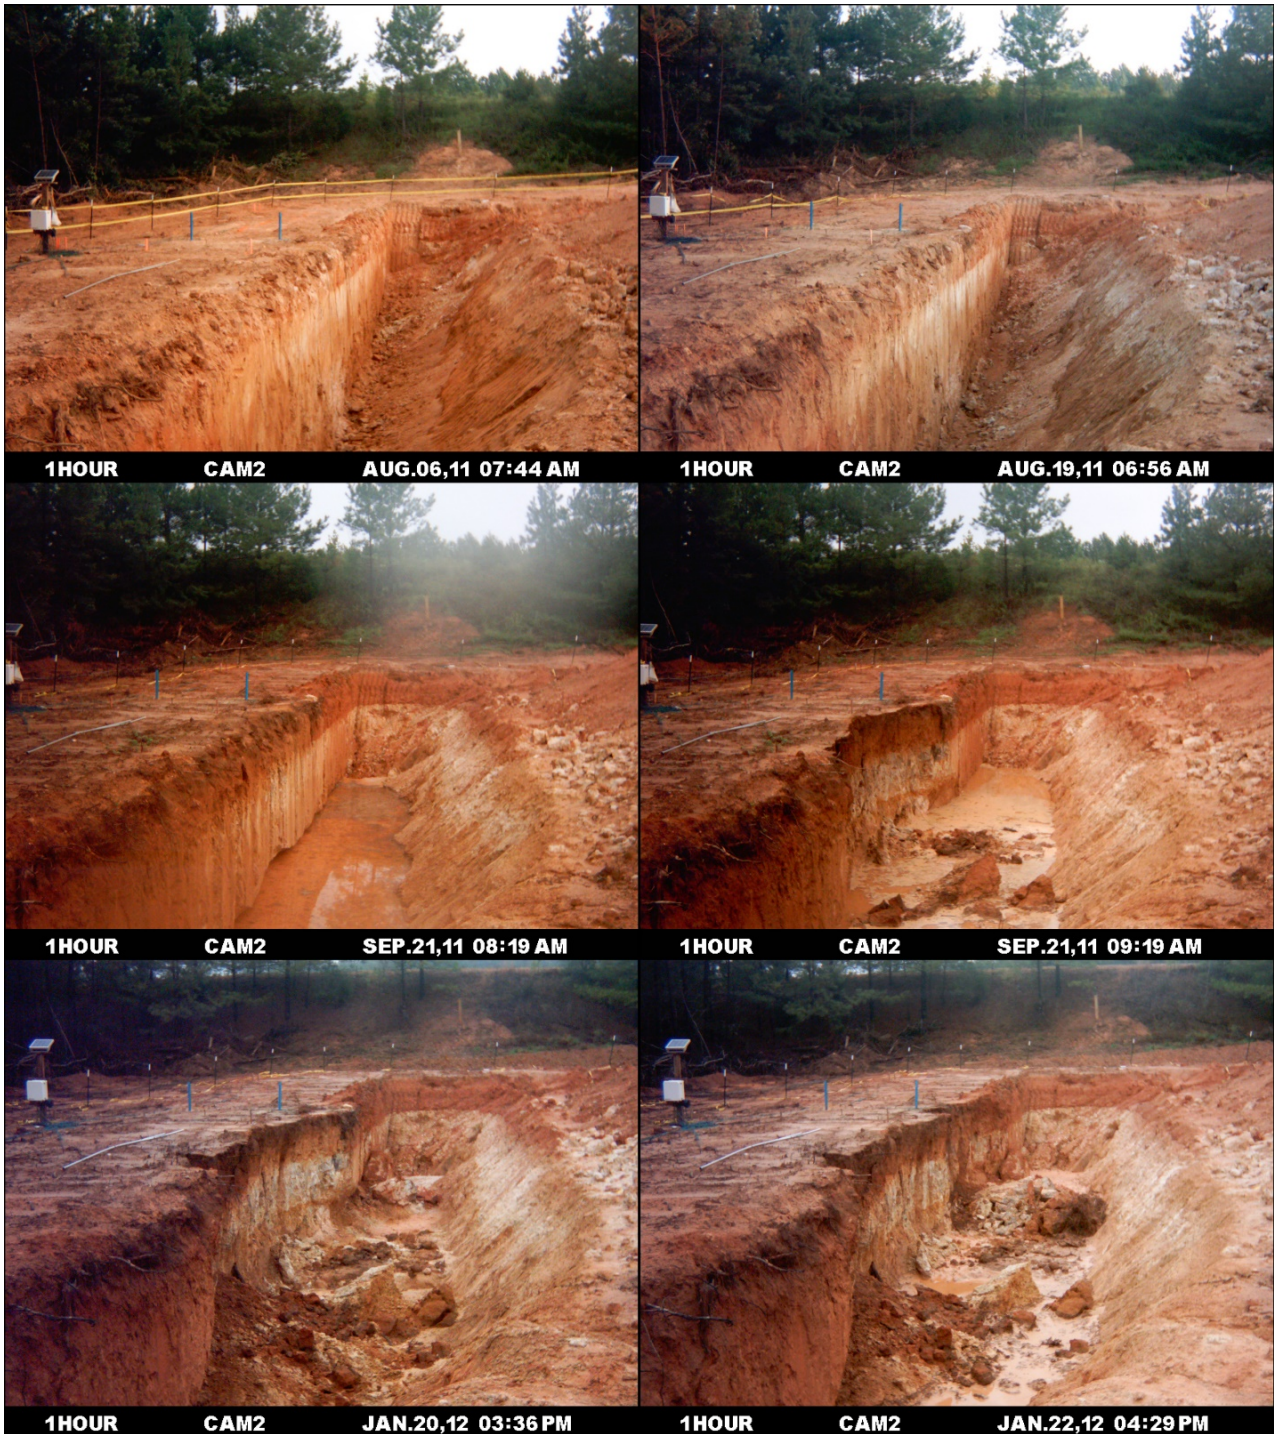
Figure 9. Excavation #2 time-lapse photos before and after failure.

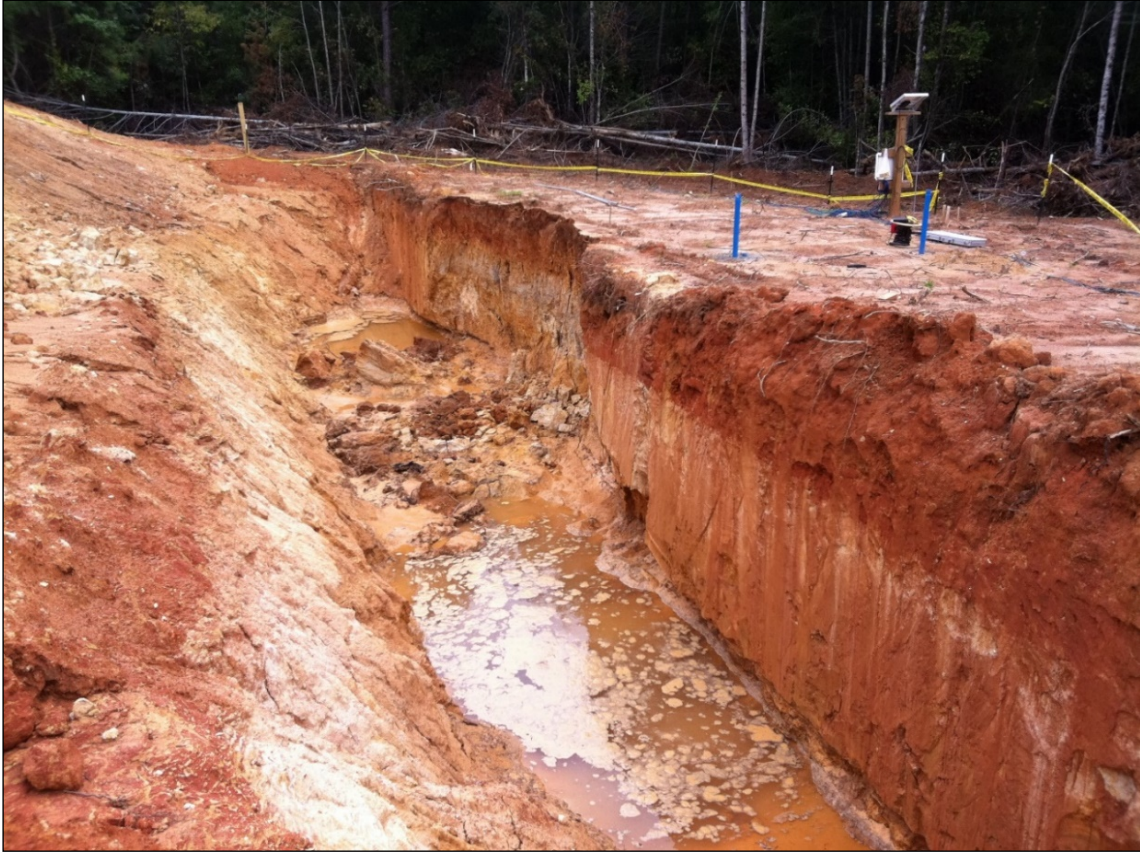
Figure 10. Excavation #2 after initial failure on 9/21/11.

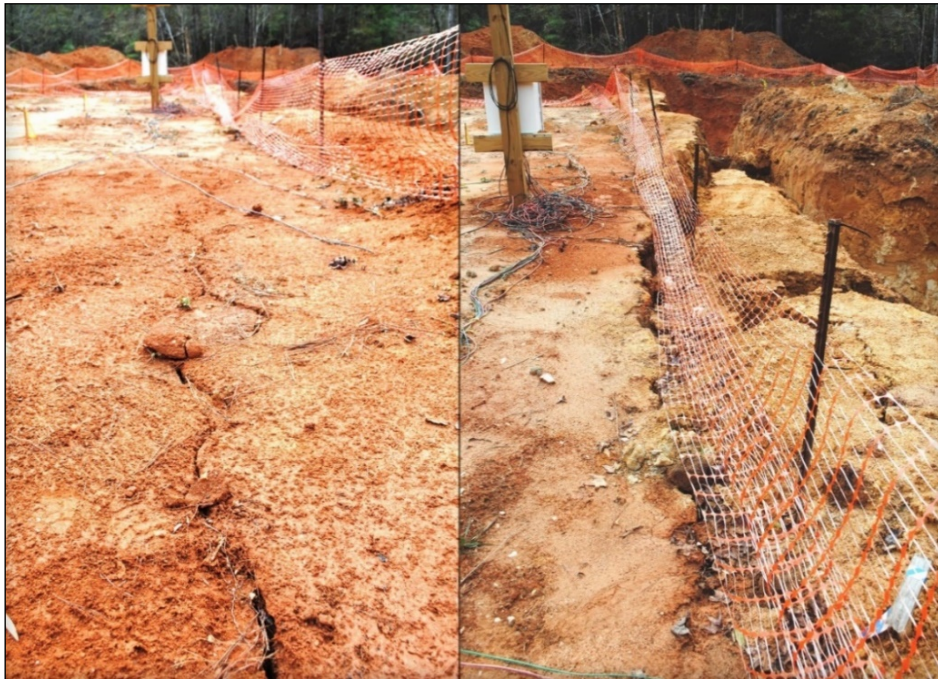
Figure 11. Tension crack progression over time (Excavation #1).
