Research article

Natural limestone discolouration triggered by microbial activity—a contribution

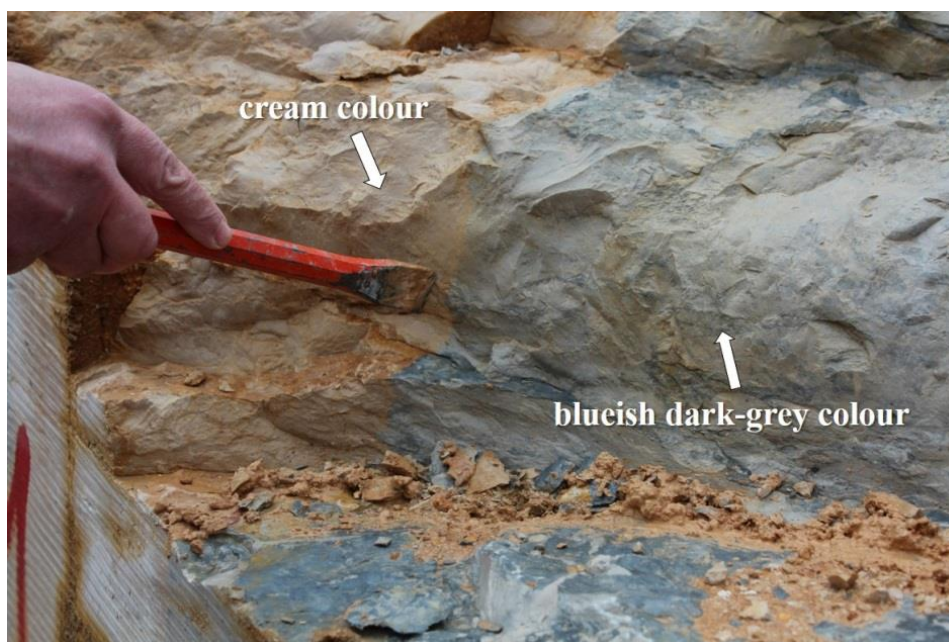
Figure 1. “Blue” limestone with blueish dark-grey and cream colour in the same outcrop.

“Blue” limestone is a building rock, with different geological ages, typically used in several countries, like Portugal, Belgium, China, Ireland and Vietnam. The name is derived from the blueish dark-grey colour associated with the presence of organic matter. This good quality natural stone coexists with a cream-coloured limestone, sometimes in the same outcrop (Figure 1), and it remains unclear which factors lead to the occurrence of each colour.

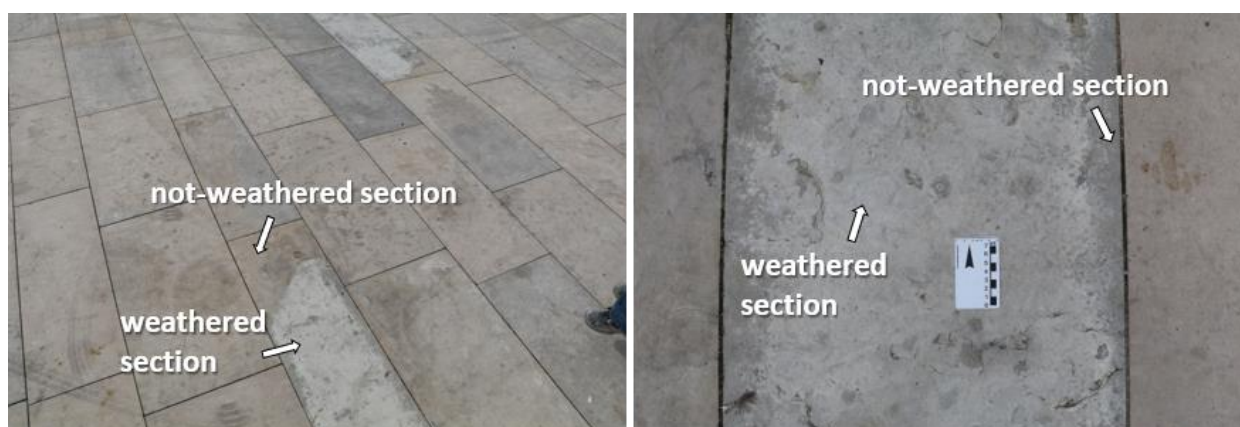
Figure 2. Outdoor pavement in “blue” limestone with visible alteration.

“Blue” limestone is also susceptible to unknown weathering processes, that cause colour change and promote the occurrence of unaesthetic patterns (Figure 2). The main objective of this study is to identify how the changes in chemical and mineralogical composition in the “blue” limestone can be correlated with the microbial colonisation state. Considering the same micro-climatic conditions, sections of weathered rock are compared with not-weathered sections to determine both chemical and mineralogical changes and evaluate the biocolonisation susceptibility.

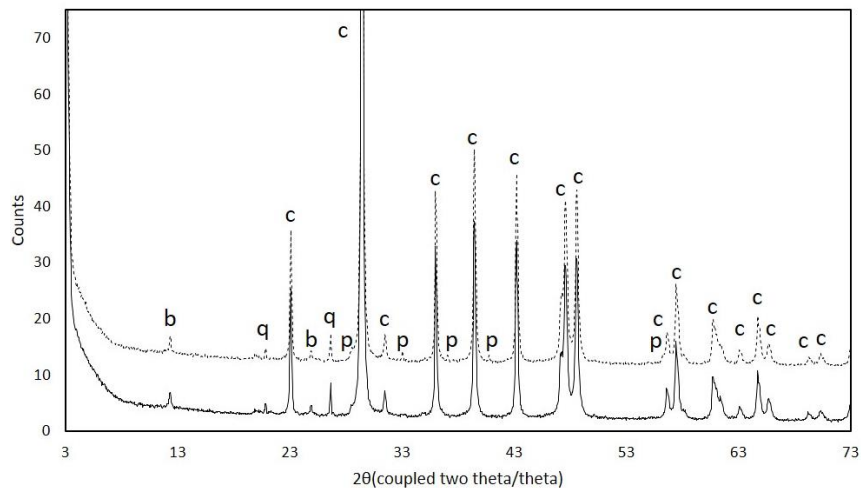
Comparative data between blue and cream coloured zones of the samples recovered from the “blue” limestone outcrop show that calcite is, as expected, the most abundant mineralogical phase, quartz is always present, and pyrite (FeS₂) and birnessite (Na_{0.55}Mn₂O₄ · 1.5H₂O) are present in the

darker fraction of the stone (Figure 3). X-ray fluorescence data showed a slight increment in sulphur in the darker fraction, corroborating the presence of pyrite.

Figure 3. Diffractograms showing the presence of different mineralogical phases in cream coloured zones (—) and blue coloured zones (----) of the samples recovered from the “blue” limestone outcrop. Abbreviations: b—birnessite; q—quartz; c—calcite; p—pyrite.

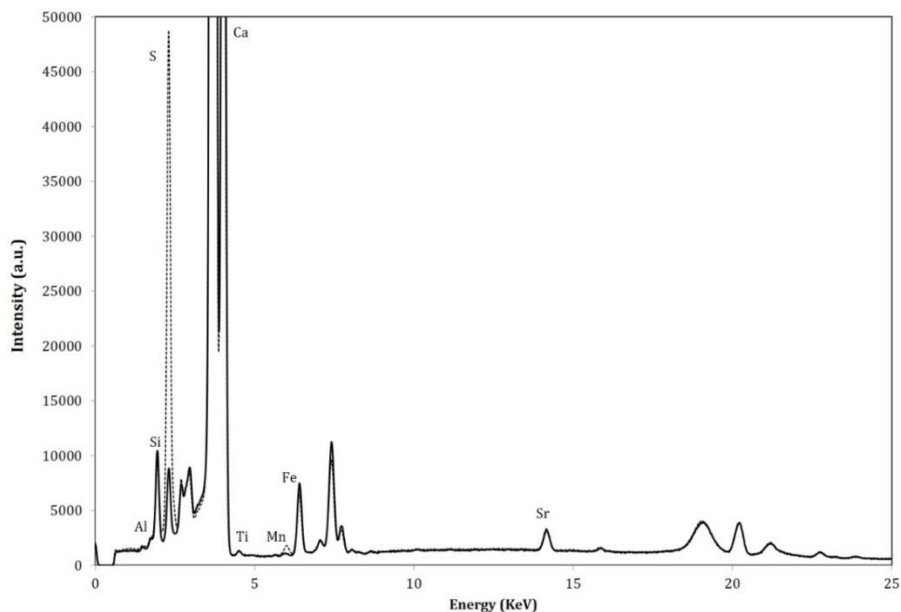
Samples from outdoor building stone were firstly analysed by portable X-ray fluorescence, in chromatic altered and non-altered areas. The elements found, such as Ca, Si, Al, K, Sr, Fe and Mn are common in limestones and seems to be present in similar quantities both with or without chromatic alteration areas. Nevertheless, in the spectrum from chromatically altered area stands out a clear enrichment in sulphur (Figure 4).

Figure 4. Compositional spectra by X-ray fluorescence from the sample with chromatic alteration in outdoor building stone, in altered (----) and non-altered areas (—).

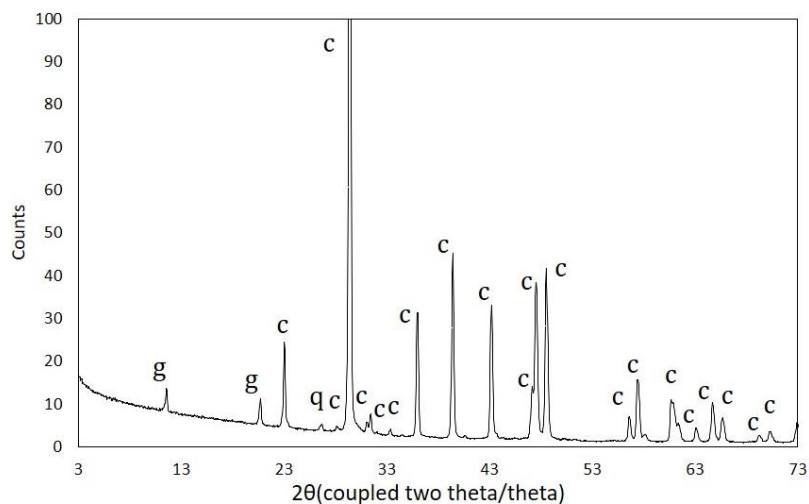
Micro-X-ray diffraction performed on chromatically altered areas revealed an enrichment in gypsum ($\text{CaSO}_4 \cdot 2\text{H}_2\text{O}$), as demonstrated in Figure 5. The presence of gypsum in altered surface zones was confirmed by VP-SEM-EDS, with the coexistence of calcium and sulphur in the same regions, as it is shown in bi-dimensional elemental mapping and point analysis (Figure 6).

Figure 5. Micro-X-ray diffractogram obtained on the altered area from building stone. Abbreviations: g—gypsum; c—calcite; q—quartz.

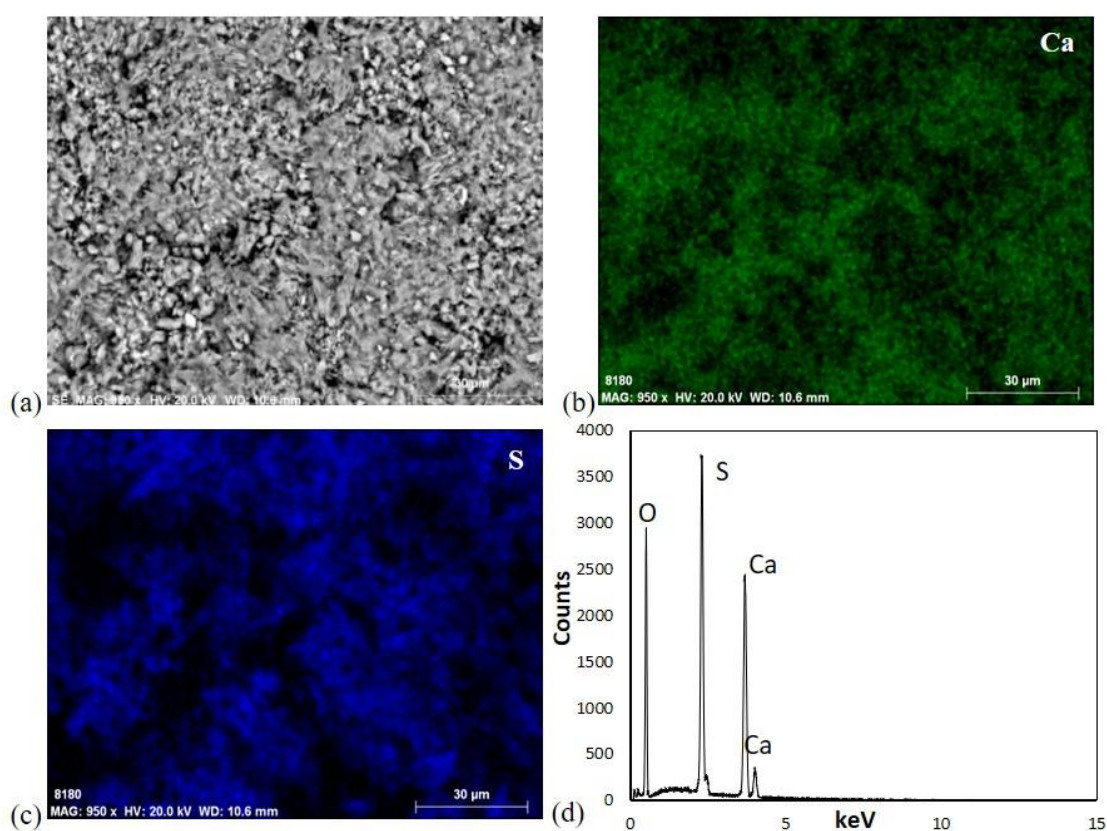
Figure 6. (a) Microstructure, element mapping of (b) calcium and (c) sulphur, and point analysis in limestone weathered section, performed by VP-SEM-EDS.

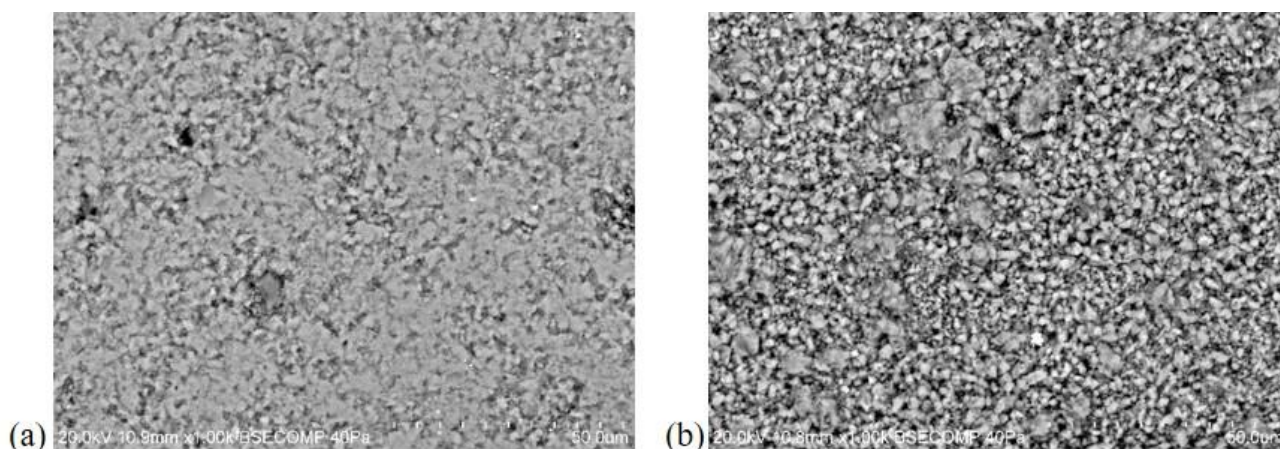
Additionally, this technique also evidenced differences in the surfaces' microstructure, where the surface with chromatic alterations seems less compact (Figure 7), possibly due to the polishing loss. This may lead to a favourable condition to microbial proliferation on the stone surface [23].

Figure 7. Limestone microstructure in (a) non-altered surface and (b) altered surface, by VP-SEM-EDS.

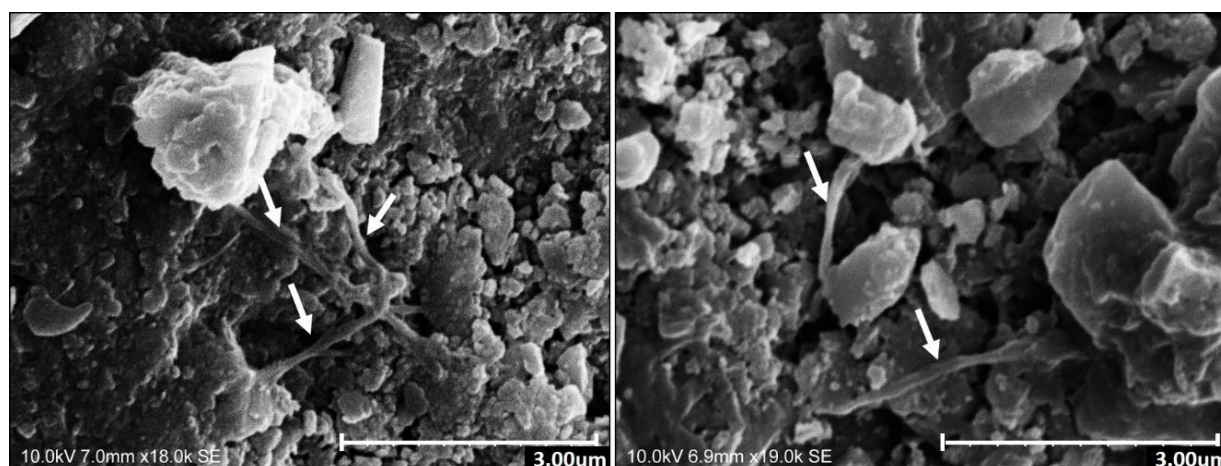
SEM analysis allowed a further insight into the presence of microbial communities thriving on the studied outdoor building stones with chromatic alteration and their capacity to proliferate within the stone surface (Figure 8). The micrographs show the presence of filamentous fungi and spores on these surfaces. Using this technique, no microorganisms were found in non-altered surfaces.

Figure 8. SEM micrographs in weathered sections. Arrows signalize hyphae of filamentous fungi proliferating around calcite crystals.

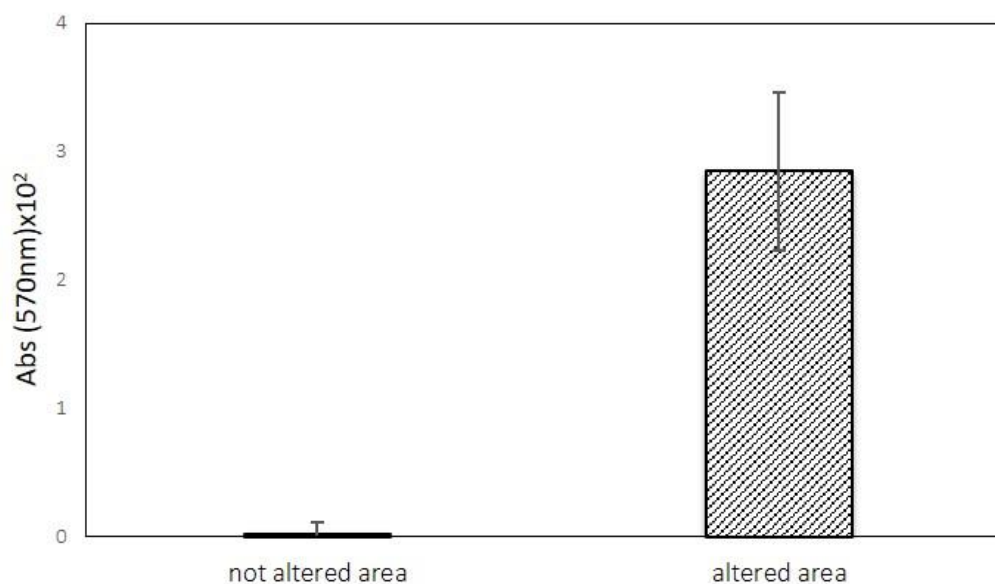
Regarding the cell viability index, the method used showed that samples from chromatically altered areas seem to have higher CVI levels, than that of the non-altered areas (Figure 9). High CVI

degree potentiates metabolic activity. This method was previously optimised to biodeterioration on cultural heritage materials and has been found to be simple, fast, and very sensitive [24], giving an overview of the presence of microorganisms and also a preliminary screening of their metabolic activity.

Figure 9. Cell viability of the microbial population present in altered areas and non-altered areas, of building stone. Error bar corresponds to \pm standard deviation ($n = 21$).

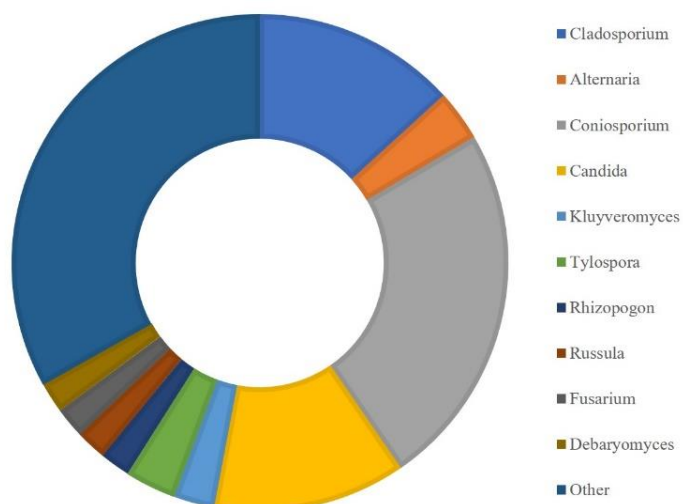
HTS allowed the detailed characterisation of the microbial population present on limestone altered areas (Figures 10 and 11). For eukaryotic population around 55,000 OTU were generated and the predominant genera identified (Figure 10) were *Coniosporium* (3.6%) and *Cladosporium* (2.0%), both belonging to Ascomycota phylum commonly associated with rock substrate [25]. On the other hand, the prokaryotic population generated around 70,800 OTU, whose dominant phyla (Figure 11a) were Actinobacteria (87.2%) and Proteobacteria (7.1%), while the prevalent families (Figure 11b) were Geodermatophilaceae (36.8%), Micrococcaceae (19.4%) and Nocardiodaceae (10.9%). Actinobacteria was previously associated with biofilms formation in siliceous stone as major colonisers [26]. Other less representative phyla, like Firmicutes, were found. Some bacterial strains of the Firmicutes phylum have been found to reproduce biodeterioration in laboratory studies [27]. The most abundant genus is *Modestobacter* (25.3%) and has been previously correlated with deterioration of cultural heritage limestones [28], and in other types of stone and has been shown to be capable of surviving on extreme environmental conditions [29]. Other less representative genera were also identified, such as *Geodermatophilus*, *Agrococcus*, *Arthrobacter* and *Deinococcus*. According to these results, it seems that the main biocolonisers of these materials are bacterial communities.

Figure 10. Characterisation of the eukaryotic population at genera level present in limestone altered areas.

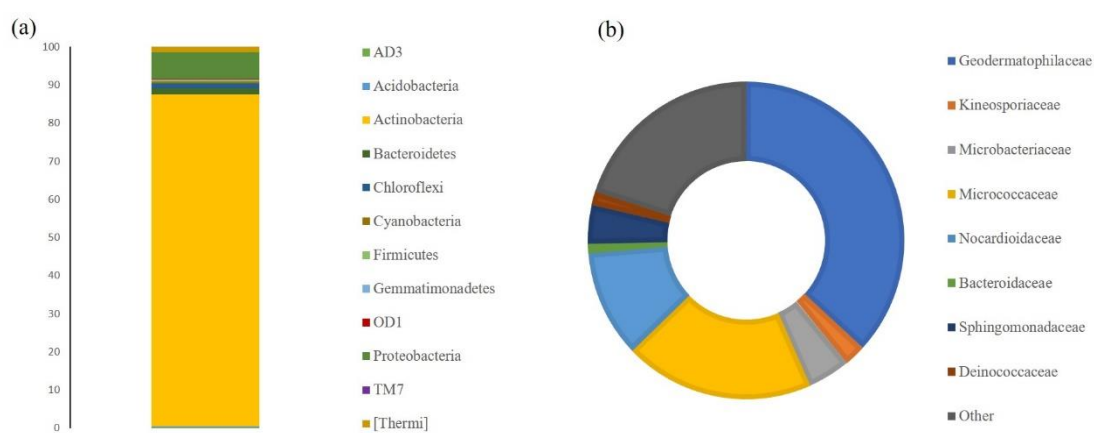
Figure 11. Characterisation of the prokaryotic population present in limestone altered areas at (a) phylum and (b) family levels.
