## **Utilizing Vegetation Indices as a Proxy to Characterize the Stability of a Railway Embankment in a Permafrost Region**

**Priscilla Addison<sup>1,\*</sup>, Pasi Lautala<sup>2</sup> and Thomas Oommen<sup>1</sup>**

**Abstract:** Degrading permafrost conditions around the world are posing stability issues for infrastructure constructed on them. Railway lines have exceptionally low tolerances for differential settlements associated with permafrost degradation due to the potential for train derailments. Railway owners with tracks in permafrost regions therefore make it a priority to identify potential settlement locations so that proper maintenance or embankment stabilization measures can be applied to ensure smooth and safe operations. The extensive discontinuous permafrost zone along the Hudson Bay Railway (HBR) in Northern Manitoba, Canada, has been experiencing accelerated deterioration, resulting in differential settlements that necessitate continuous annual maintenance to avoid slow orders and operational interruptions. This paper seeks to characterize the different permafrost degradation susceptibilities present at the study site. Track geometry exceptions were compared aga

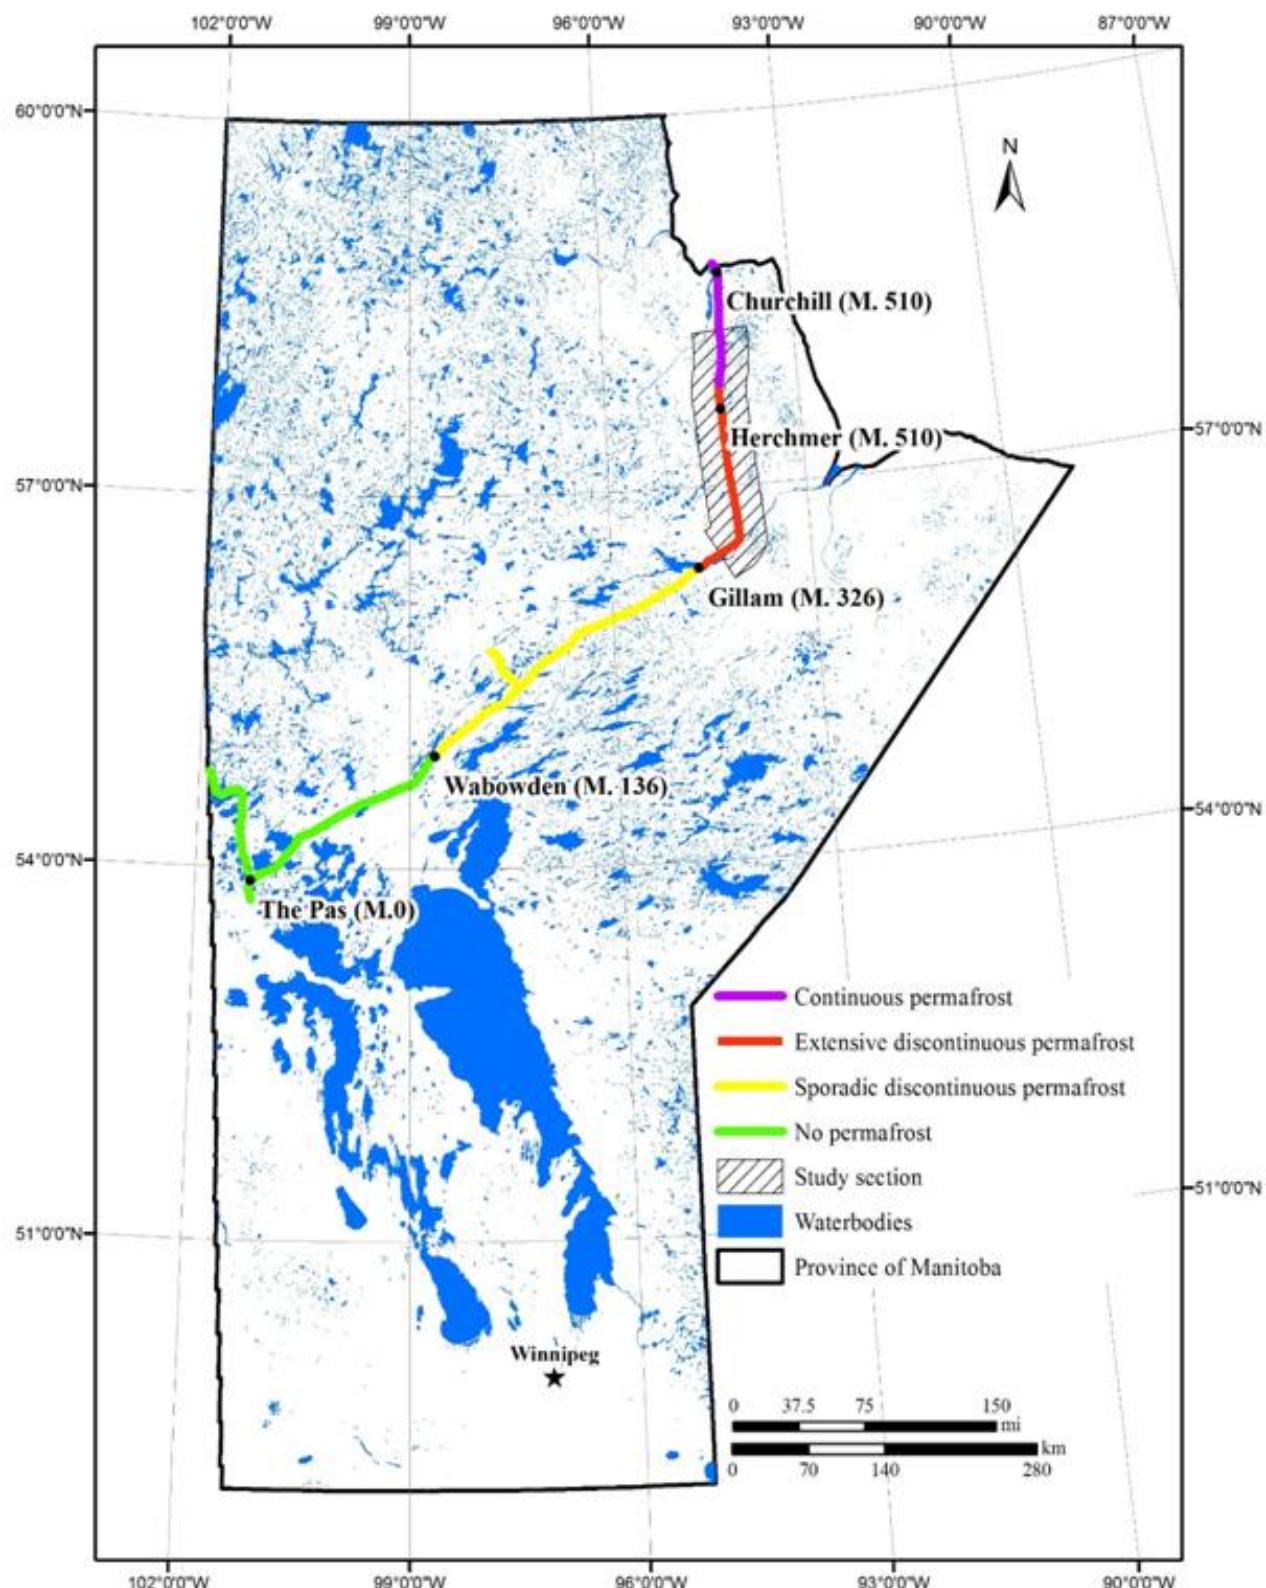
**Figure 1. Location of the HBR from The Pas to Churchill showing the varying permafrost conditions.**

This study focused on the Hudson Bay Railway (HBR), a 510-mile track constructed within the permafrost region of northern Manitoba, Canada. The HBR, owned by OmniTRAX Inc. at the time of this study, serves as a critical linkage for passengers and freight from The Pas (milepost 0) to Churchill (milepost 510), connecting locations in North America to international destinations through the Port of Churchill. All three permafrost types occur along the HBR route. From The Pas to Churchill, there is a gradual northward transition from no permafrost zone, to sporadic discontinuous, to extensive discontinuous, and finally to continuous permafrost (Figure 1).

Since the completion of the HBR in 1929, sinkhole formation has been an increasingly recurrent phenomenon during the summer thawing season. From 1976–1991, an engineering consulting company, EBA Engineering Consultants Limited (from here onwards referred to as EBA), was tasked to undertake extensive research along the rail corridor to understand the geothermal regime of the subsurface and to uncover the mechanism of sinkholes formation [9]. The reports produced by EBA indicate that the extensive discontinuous permafrost region between mileposts 330 and 430 is the most problematic segment of the HBR [12,13]. Recent track surfacing records, increases in slow orders (speed restrictions placed on a section of track to limit train speeds below regular limits due to unfavourable track conditions) [14], and interviews with OmniTRAX personnel confirmed that this section remains the most problematic, depicting increasing structural instability. Hence this section of the HBR, as well as an overlap in the continuous permafrost region to milepost 473, was chosen as the focus of the study (Figure 1).

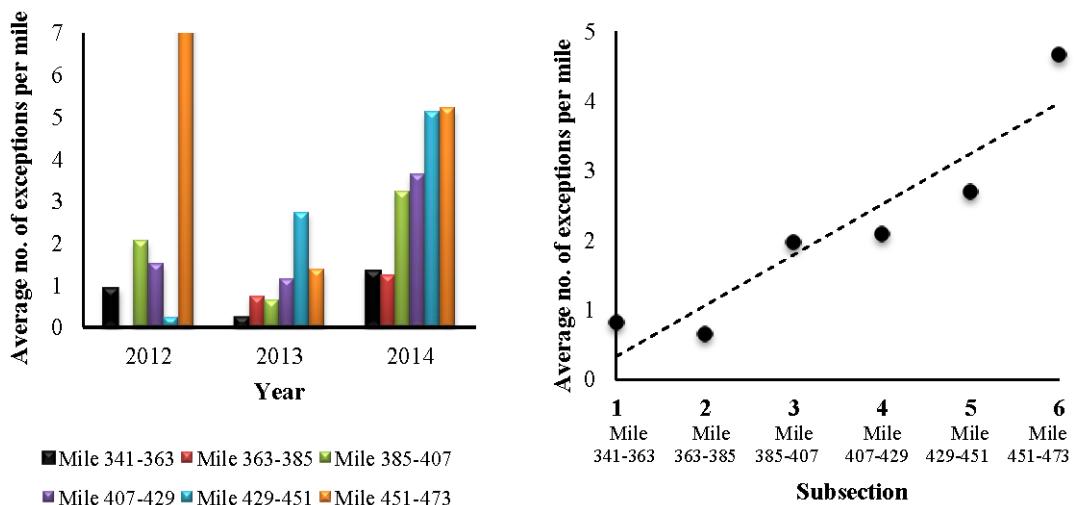
**Figure 3. A plot of track exceptions recorded for the six subsections in 2012–2014 (left); and a plot of the average track exception recorded for the investigative period for each subsection (right).**

A plot of the six subsections against their recorded average geometry exceptions indicated a general increasing trend in exceptions from subsection 1 to 6 (Figure 3) which confirms worsening track conditions from south to north.

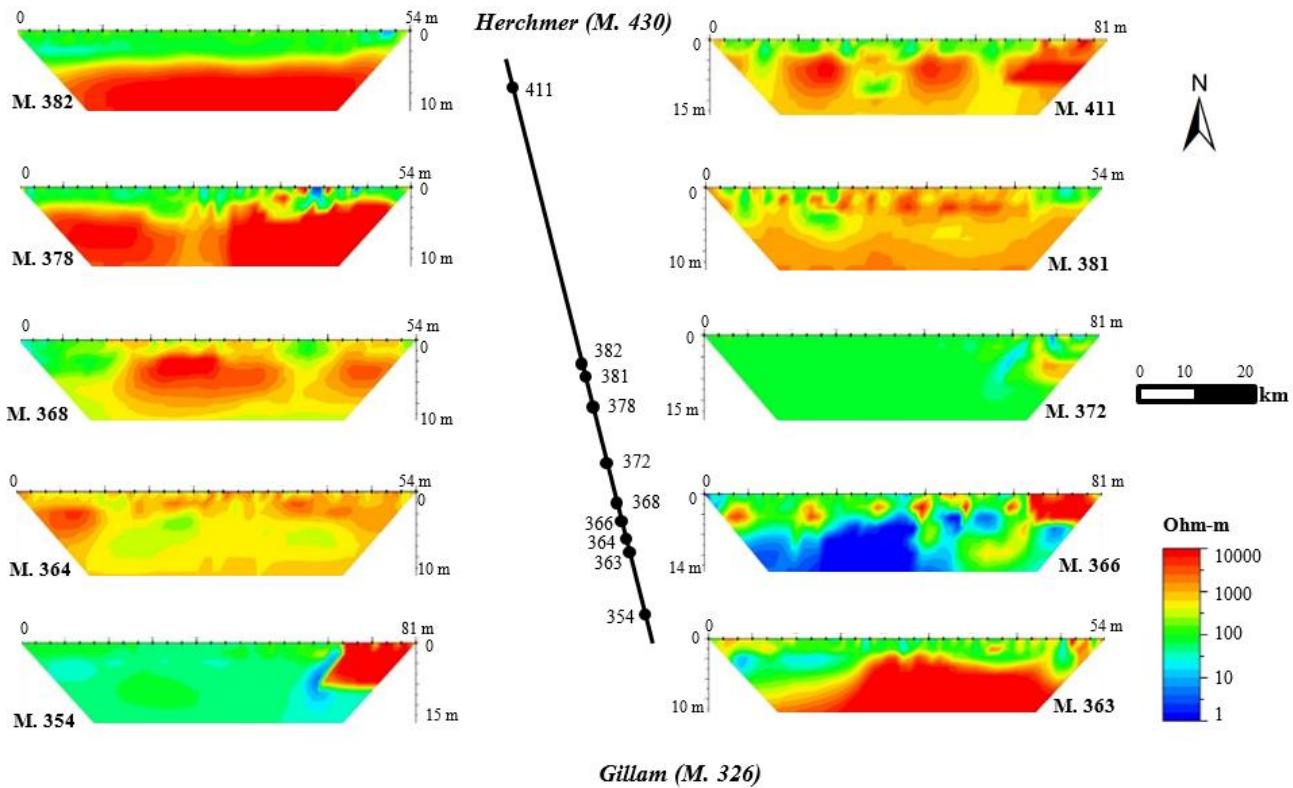
**Figure 4. Subsurface profiles from the ERT investigation displayed along the track route of the study section, showing ground resistivities from low resistive thawed soils in blue to highly resistive permafrost layers in red color.**

Results of the subsurface profiles from the ERT investigation are displayed along a plot of the study section in Figure 4. The legend at the bottom right of the figure provides an explanation of the color scheme from blue to red, representing low to high resistivities. Palacky and West [32] found that the average resistivity for permafrost materials is 10,000 ohm. Figure 4 shows that several

locations recorded a resistivity of 10,000 ohm indicating the presence of permafrost (indicated by the red color).

From Figure 4, it can be seen that the only site underlain by well-defined continuous permafrost is milepost 382. For all other sites, various degrees of permafrost degradation were observed. Particularly noteworthy is that excluding the subsurface profile of milepost 363, the southern sections of the study area were found to be almost devoid of permafrost. The lack of permafrost in the southern sections correlate with lower records of track exceptions in the south as observed in Figure 3. The northern sections, which recorded higher track exceptions, have permafrost present but they seem to be actively thawing, as indicated by the profusion of thawing transition zones. These subsurface profiles suggest that permafrost zones classification by EBA (shown in Figure 1) is changing, as permafrost degradation appears to be moving northward. It is likely that the southern boundary of the extensive discontinuous permafrost zone is transitioning into a sporadic discontinuous zone, whereas the southern boundary of the continuous permafrost zone may also be converting into extensive discontinuous zone. The results also confirm EBA's hypothesis that sinkholes develop at the permafrost transition zones, as thawing northern sections with the most transition zones also recorded the high occurrences of track exceptions.

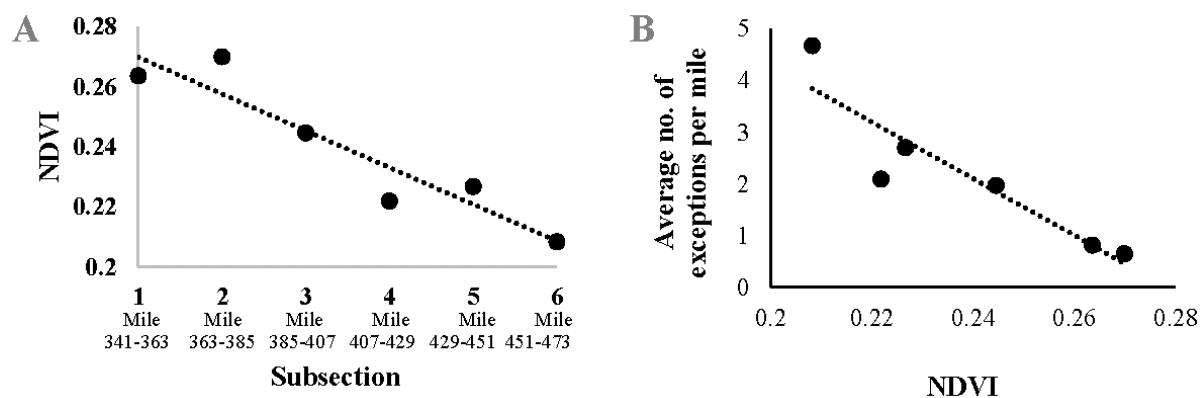
**Figure 5.** A plot of track sections versus NDVI showing the tendency to find less vegetation as you move northwards (left); and NDVI versus track exceptions showing that it is more likely to find track exceptions in locations with little vegetation and vice versa (right).

NDVI was compared against the corresponding average number of track exceptions recorded for each of the six subsections. A plot of the NDVI against subsection shows a general negative correlation from section 1 to 6 (Figure 5A), which indicates a decrease in the vegetation density as one moves northward. A plot of the NDVI versus the track exception also shows a negative correlation indicating that as vegetation decreases, the number of track exceptions increases and vice versa (Figure 5B).

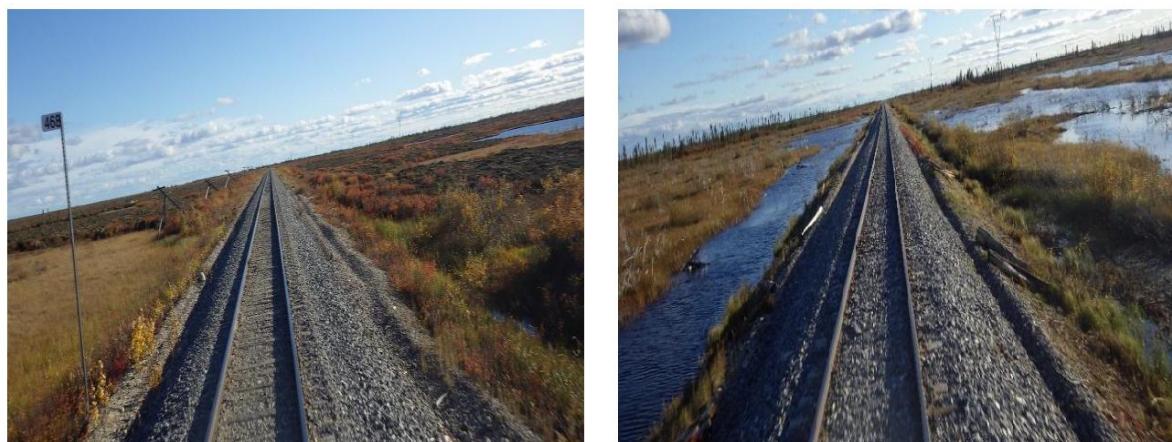
**Figure 6.** Photos of milepost 468 (left) and milepost 448 (right) showing no tree cover and ponded water close to embankment shoulders.

Photo images were taken in 10-second intervals while traversing the entire study area by a hi-rail truck. A comparison between the photos and research findings revealed that the northernmost sections with the lowest NDVIs (Subsections 5 and 6) are generally devoid of tree cover. This is intuitive; however, a more noteworthy finding was that these sections had substantial amounts of ponded surface water close to the embankment shoulders. Figure 6 shows two such typical images for milepost 468 (Subsection 5) and milepost 448 (Subsection 6). Conversely, the southernmost sections, which recorded the highest NDVIs, had denser vegetation with no surface water close to the embankment shoulders (Figure 7). From these photos, it was realized that the low NDVIs obtained for this particular study site translate not only to low vegetation densities but also to high percentage of ponded surface water.

These photos also reinforced the perceived relationship between the NDVI and track exceptions, as past literature have shown collected waterbodies in the form of ponds and lakes have deleterious effects on underlying permafrost. Ponded water absorbs the sun's heat and transfers it to the permafrost table [33], which explains why the northernmost sections recorded higher frequencies of track exceptions, indicative of permafrost degradation.

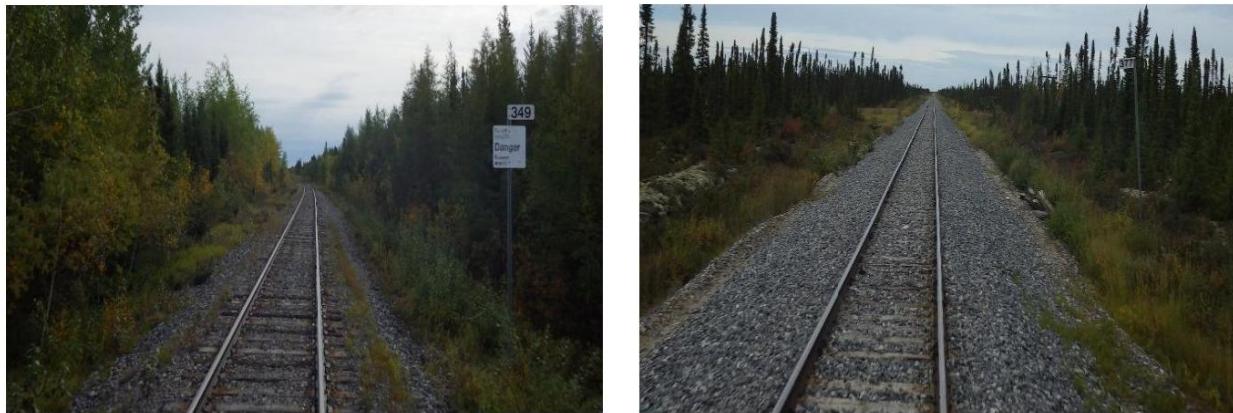
**Figure 7. Photos of milepost 349 (left) and milepost 377 (right) showing population of trees and no surface water ponded close to the embankment shoulders.**

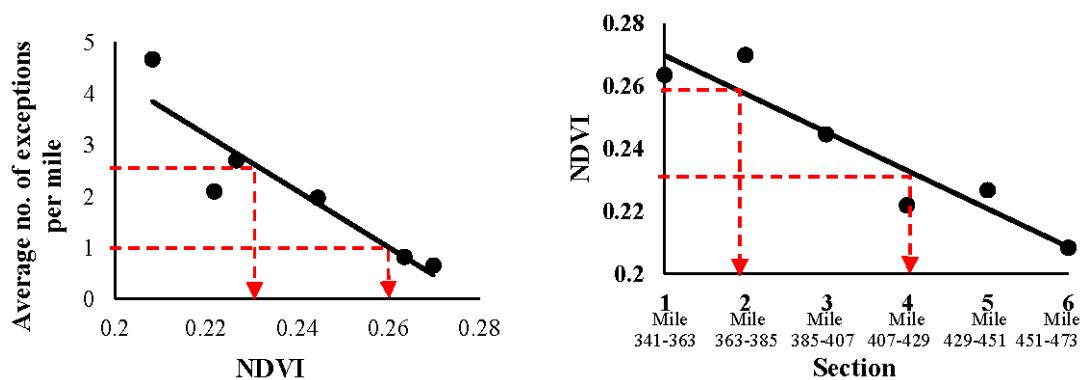
**Figure 8. Defining percentiles for developing severity chart.**

The average number of exceptions recorded was used as the basis of the chart. Locations that developed a maximum of one exception per year were generally considered stable and within acceptable performance levels, whereas locations that developed more than 2.5 exceptions are of concern and need to be mitigated [31]. Using these two track exception limits, a three-level severity chart was developed. The results are summarized in Figure 8 and Table 1.
