Research article

Surface characteristics and damage distributions of diamond wire sawn wafers for silicon solar cells

Bhushan Sopori^{1,*}, Srinivas Devayajanam^{1,2}, and Prakash Basnyat^{1,2}

¹ National Renewable Energy Laboratory, Golden, CO 80401, USA

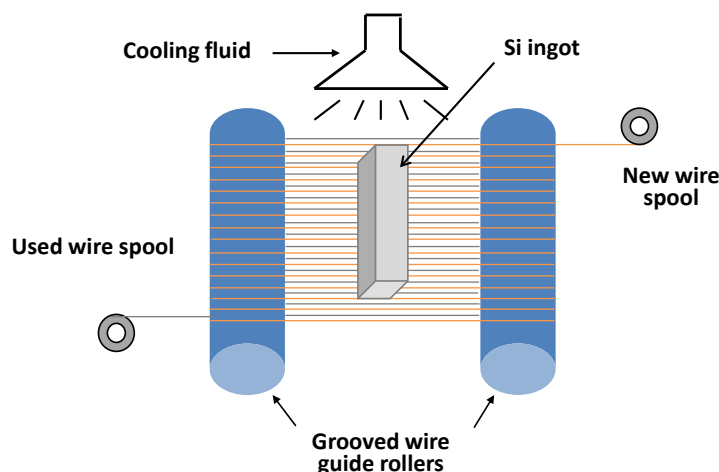
Figure 1. An illustration of the diamond wire cutting process.

Diamond wire sawing uses a long (typically 50–100 kilometers) wire, impregnated with diamond flakes (grit) as a cutting medium. The cutting wire is made up of a stainless steel core (80–120 μm in diameter) that is coated with diamond flakes (8–25 μm in size) which are then bonded to the wire by a layer of electroplated Ni or a layer of a resin material [6,7]. The diamond chips typically have a tight size distribution and as expected, smaller chip sizes are used with smaller wire sizes. Thus, DWS constitutes a fixed abrasive cutting approach (as compared to free abrasive slurry cutting). The diamond wire saw consists of a wire-web formed by feeding the wire from a feeding-spool into a take-up spool and winding the wire over a set of wire-guide-rollers, as shown in Fig. 1. The wire-guides precisely maintain the distance between the wires, which corresponds to the center-to-center distance between the wafers (equal to wafer thickness + kerf). The motion of the wire is controlled to follow certain algorithms. One of them involves feeding a predetermined length of the wire in the forward direction, cutting a given depth of the ingot [7]. The direction of the wire is then reversed but the length traversed is shorter than the forward direction. This length is made up by feeding the additional fresh wire length in the forward direction. The parameters of this reciprocation process control the length of the wire used in cutting a given ingot (also termed as wire use and defined as average length of wire used per wafer). To perform the wafering, the silicon ingot, cut into brick(s), is fed into the wire web (either from the top or bottom) in small steps. The wire tension and the force on the ingot exert a force on diamond particles thereby embedding tips of the particles into Si ingot. In addition, the directional motion of the wire produces shear stresses on Si ingot causing the diamond grit to “plow-through” Si, dragging chips of Si along the wire direction. The swarf is removed by a water-based cutting fluid, which also stabilizes the wire web by providing adequate surface tension-related forces between the wire and the slot walls [6].

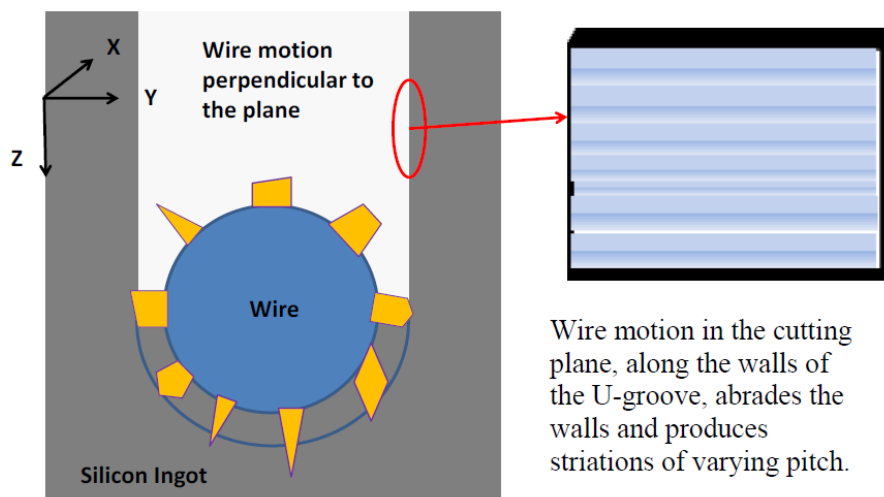
Figure 2. An illustration of the “U-groove” formation, produced by each segment of the diamond wire. The inset shows a sketch of striations produced on the walls of the U-groove.

The surface characteristics of as-cut wafers are strongly controlled by the wire movement with respect to the ingot. Hence, to understand the formation of surface features of the as-cut wafers, it is useful to go into some further details of wire movement and its path within the ingot during cutting. Figure 2 shows typical cutting path of each wire segment as it moves into the ingot, along the ingot cutting direction, Z, forming a “U-shaped” channel. The inset in Fig. 2 illustrates schematically that the walls of the groove, which constitute the wafer surfaces, have surface features produced by the motion of the cutting wire. These features are formed by the wire motion with respect to the ingot during cutting in response to various forces. As the ingot is pushed with a force F, into the moving wire having a tension force T, it experiences deflections within the cutting plane as well as within the plane perpendicular to it. First consider the wire path in X-Z cutting plane. In this plane, the wire acquires a concave-up (if the ingot is pushed from the top downward) path as illustrated in Fig. 3a, indicating that in-plane cutting forces are not uniform. At the bottom of the U-groove, the downward force drives grit particles into Si (in Z direction) creating a drag force against the wire motion, while the velocity of the wire creates a shear force on diamond chips. When the shear stress exceeds the

critical shear stress, it causes microcleavage of small chips of Si. As the cutting in Z-direction progresses, material is continuously being removed at the bottom of the U-groove exposing fresh Si. Also, some of the grit above the bottom of the groove (near the center of the wire) is also driven into the walls (Y-Z plane) of the partially-cut wafers, which results in the abrasion of the wafer surfaces along the direction of the wire velocity (X direction). This interaction of the grit (and wire) along the walls of the U-groove leaves features on the wafer surfaces that remain “imprinted” on as-cut wafers.

Thus, even though the primary material removal occurs along Z-direction, there is surface roughness and damage on the vertical walls that form the wafer surfaces. One of the surface features arises due to systematic ingot motion. Because the ingot is fed by a stepping motor, each step of the motor causes grains of grit to be dragged over the wafer surfaces, leaving tracks corresponding to stepping motor. Hence, diamond wire sawn wafers have pseudo-periodic surface morphologies that appear as striations with a range in the spatial wavelengths from microns to many centimeters. This causes a pseudo-periodic surface undulation on the wafer surfaces, creating a grating like pattern with the period of the step size.

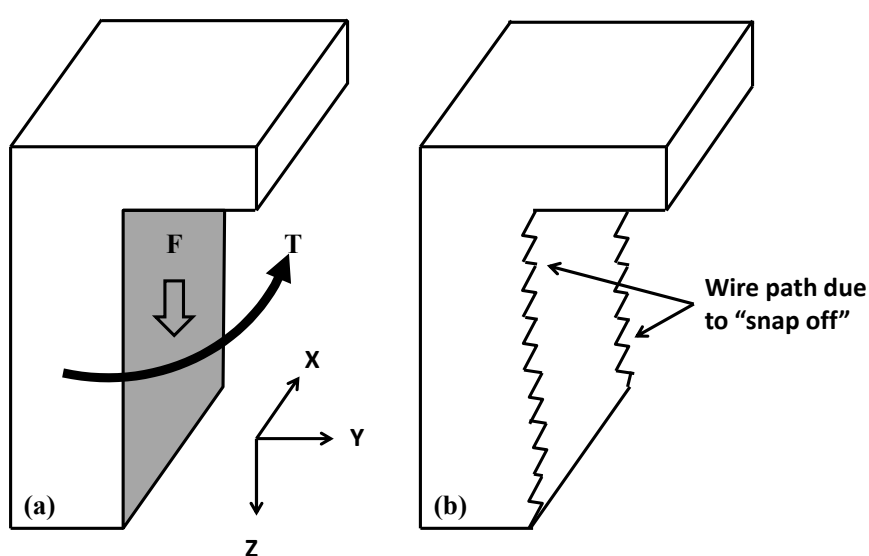
Figure 3. (a) Illustration of wire path in X-Z plane of a U-groove during cutting for an ingot fed from the top (b) Illustration of wire path in Y-Z plane with wire snap-off during cutting (ingot fed from the top).

Now, we consider the motion of wire in the YZ plane (perpendicular to the walls of the U-groove): Ideally, one would expect the wire path to be perfectly normal to the ingot with no deflection in the YZ plane. However, at reasonable cutting speeds, the wire path can deviate from being perfectly planar, causing inclination of wire path with respect to the ingot. This causes lateral forces on the wire leading to its movement along Y direction. The dynamics of the wire suggests that as the wire will depart from an ideal condition, it builds up energy to a point and thereafter the wire will snap back to a vertical configuration. An excellent description of this snap-off mechanism that uses energy conservation and its modeling has been done in reference [8]. Figure 3b illustrates path of the wire in Y-Z plane. An important result of this motion is that the surface of each wafer has a long wavelength spatial roughness (few cm) that primarily controls the total thickness variation (TTV) of cut wafers.

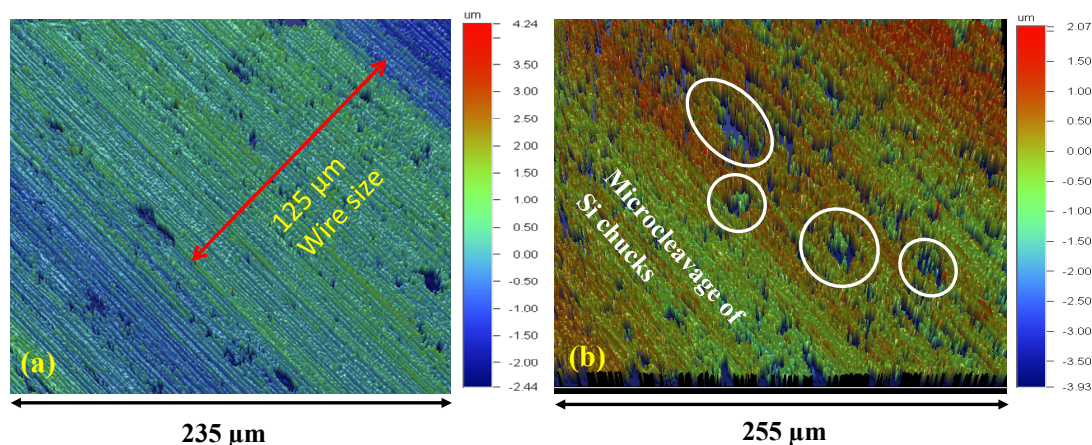
Figure 4. (a) Short pitch surface pattern on wafers cut with a wire size of $100\ \mu\text{m}$, diamond size = $10\text{--}20\ \mu\text{m}$; (b) Surface pattern on a wafer cut with a wire size of $120\ \mu\text{m}$, diamond size = $12\text{--}25\ \mu\text{m}$. Some regions of micro-cleavage are marked by circles.

Because of the different pitches of the pseudo-periodic variations, observation of the surface profiling requires a variety of equipment such as an optical interference microscope, SEM, and Dektak. We will start with discussion of surface morphologies having the smallest pitch (highest spatial frequency) and then proceed toward larger pitches. Figure 4 shows interference microscope images of very fine features seen on various DWS wafers. The wafer whose pattern is shown in Fig. 4a was sawn by a wire of 100 μm core diameter with grit size in the range of 10–20 μm . As described earlier, this grating-like pattern is caused by “plowing” by the grit along the sides of the wafer and the step motion of feed mechanism. This figure shows a nearly uniform surface structure with almost no microcleavage. Figure 4b is a similar image on a wafer that was cut with 120 μm diameter wire with grit size 12–25 μm distribution (other cutting parameters remaining same). It can be seen that increased grit size causes large chunks of Si to be removed by micro-fracturing (labelled in Fig. 4b). It should be noted that the pitch of the grating-like pattern is only 1–2 μm and is not directly related to wire size.

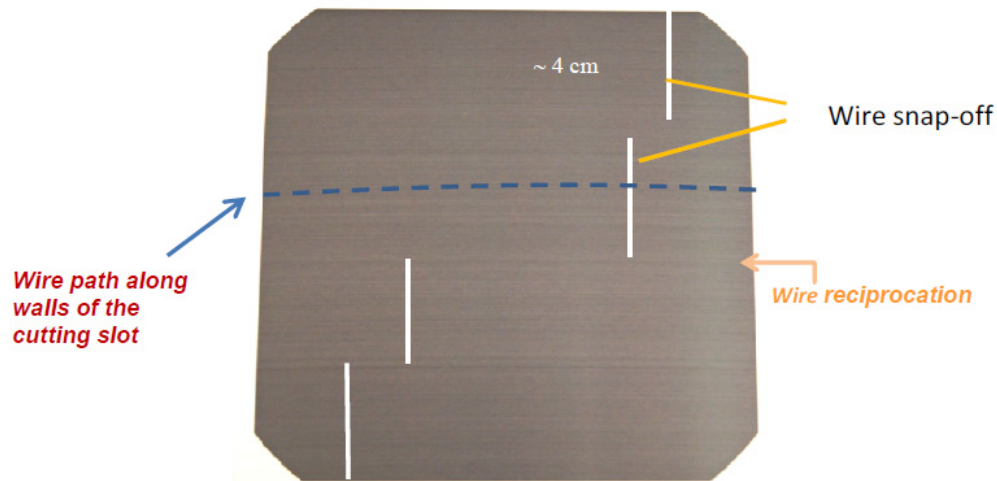
Figure 5. A photograph of a DWS wafer showing striations of different wavelengths.

However, in many cases, one can also see the manifestation of the wire size as steps in the pattern, perhaps due to low frequency vibrations causing changes in the lateral force. This indication of the wire size can be seen in the interference image of Fig. 4a as change in color due to height variations. In addition to the fine structure described above, the wafer surface has striations that can be visually seen. Figure 5 is a photograph of a $156\ \text{mm} \times 156\ \text{mm}$, monocrystalline DWS wafer showing a variety of striations of different spatial wavelengths that are visible to the naked eye. One can see narrow bands, typically between $700\ \mu\text{m}$ to $1000\ \mu\text{m}$, which correspond to wire reciprocation. In addition, we have labelled the snap-off periods by white lines ($\sim 4\ \text{cm}$ wavelength) and the wire path along the cutting groove. It should be noted that the visibility of surface features is due to reflectance changes because of changes in the surface height. Hence, these can also be quantified using a profilometer such as Dektak. Surface profiles of two DWS wafers (#1 and #2) measured by Dektak are shown in Fig. 6a. These two wafers belong to ingots cut with different wire usage parameter values— $1.2\ \text{m/wf}$ and $0.8\ \text{m/wf}$ for #1 and #2, respectively. An easy way to see the periodicity of different spatial wavelengths is to perform a FFT of the Dektak trace. Figure 6b shows Fast Fourier Transform (FFT) for the Dektak profile of Fig. 6(a). It clearly shows a number of FFT peaks of different amplitudes due to nearly-periodic modulation of surface. We have labelled peaks corresponding to various pseudo-periodic movements. It may be noted that some of the FFT peaks of wafer #2 are not as well defined as that of the wafer #1. In particular, the reciprocation peak is small and there are many small peaks in the spatial wavelength range around $1000\ \mu\text{m}$. We believe that low wire usage causes diamond grit to become blunt and lose its directional effect. In an earlier publication [9], we have also shown that the damage depth is much deeper for lower wire usage (although the wafer surface can appear rather shiny).

Earlier we saw that the surface modulations of different spatial frequencies are generated by DWS process, as seen in Fig. 5. As mentioned earlier in this paper, the mechanisms that cause surface roughness also cause corresponding variations in the damage [9]. Consequently, one expects

strong variations in the depth of damage over each wafer - variations that resemble striations seen in Fig. 5. To observe the spatial variations in the damage, we isotropically etched 2 μm from each surface of wafers and made minority carrier lifetime maps. Figure 15(a) is a MCLT map of such a wafer, showing damage variations in the MCLT. Because presence of damage reduces the effective MCLT, the damage depth is deeper in the regions of lower MCLT (red regions). This figure indicates striations similar to the surface roughness are also occurring in the damage depth. A similar variation can be observed by photoluminescence map shown in Fig. 15(b); but these are only qualitative depictions of the residual damage after uniform etching. Variations in lateral damage can be quite detrimental to solar cell performance and must be prevented. This is particularly important during texture etching step, where care must be taken to etch sufficiently deep to prevent occurrence of any residual damage. This also poses challenge in producing a uniform texture because higher degree of damage causes formation of larger texture peaks [21].

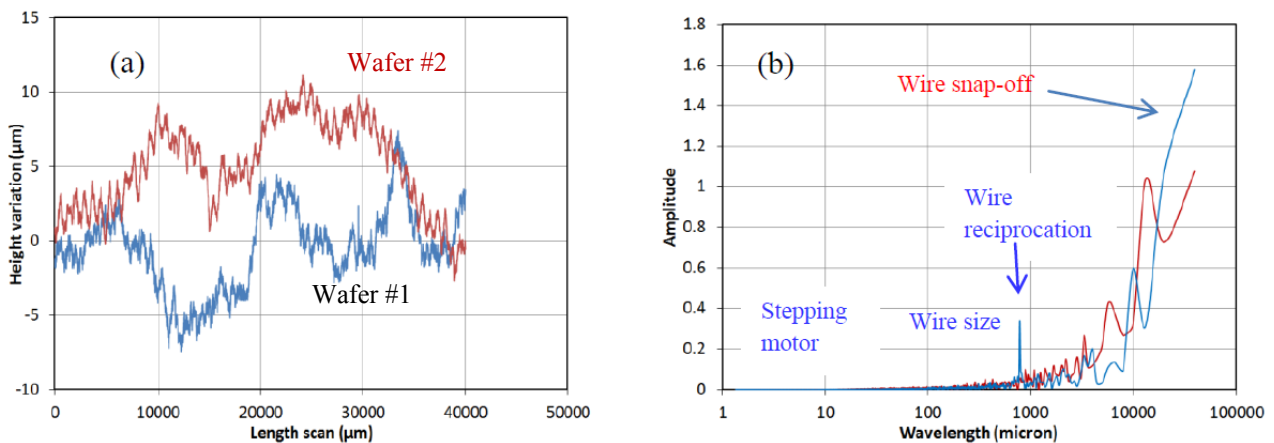
Figure 6. (a) Dektak scans of two DWC wafers cut with two different wire usage values
(b) Corresponding FFT plots.

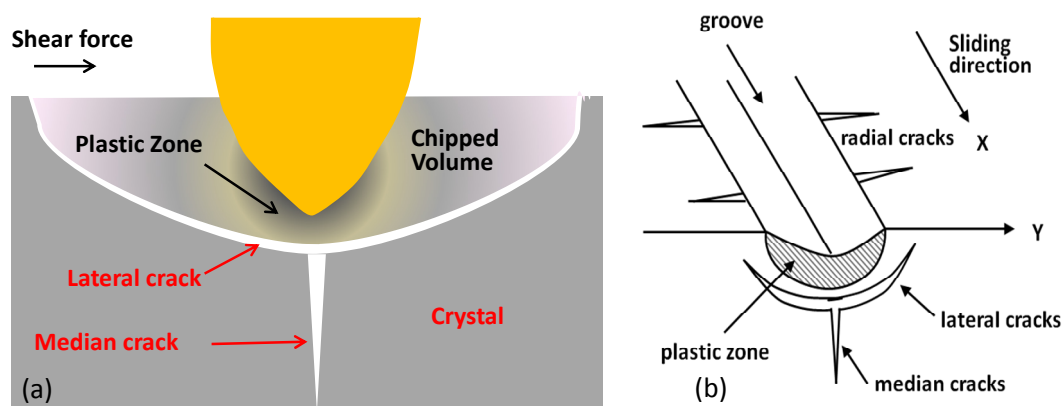
Figure 7. (a) Illustration of brittle fracture produced by an indentation tip (static case). (b) Illustration of damage configurations produced by a directional scribe, showing 2-dimensional damage that would be produced by each diamond grit.

that local stresses developed on the ingot and wafer surfaces vary within a wide range because of variation in grit size, nonuniformities in the cutting force, and system vibrations. Because of a broad range of stress, the cutting process invokes both brittle and ductile modes of fracture despite the fact that Si is essentially a brittle material. Furthermore, although the cutting process is dynamic, it is useful to first consider the nature of damage due to static loading, such as during indentation of a Si wafer. This is because the mechanisms occurring at each of the diamond grit are akin to that of an indenter where a force is applied to the indenter tip. First we consider brittle fracture of Si. Figure 7a illustrates a case where the indenter tip is forced into Si. It is known that the pressure under the tip causes formation of a plastic zone directly below the tip and that crack formation takes place in both median and transverse directions, as illustrated in the figure. The average pressure required for this occurrence of brittle fracture for Si is $\sim 10\text{--}15$ GPa. Under the loading (and as a function of time) the crack size increases, the lateral cracks expand and reach the surface causing formation of a chip. It should be noted that lateral cracks are generated not only in the plane of paper as shown in the figure, but also along the other planes (typically in the cleavage planes) [10]. If the indenter tip is dragged over the Si surface (resembling one diamond chip being dragged by the wire), there will be a continuous generation of both lateral and median cracks as shown in Fig. 7b. Importantly, it can be seen that lateral cracks propagate into the wafers and can go below the wafer surface. However median cracks are continually removed as the Si material is cut.

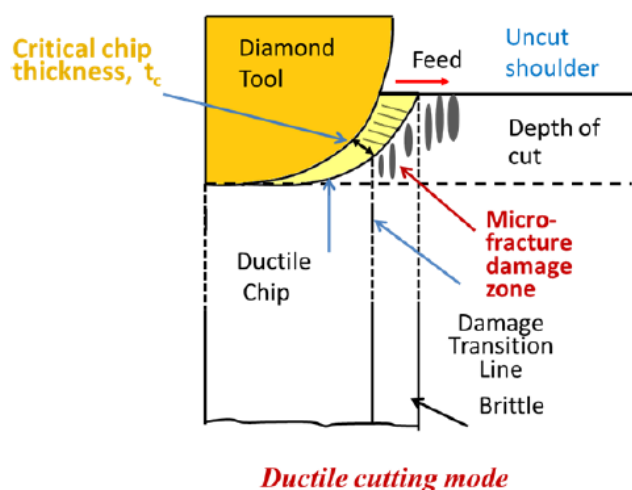
Figure 8. An illustration of various mechanisms in ductile mode cutting of Si, after reference [13].

Figure 8 is an illustration of ductile mode cutting in which a diamond tool is being drawn over a workpiece. This figure shows various phases of material ahead of the tool as the tool compresses the material. It is seen that the ductile mode is accompanied by generation of a thin layer of a metallic phase of Si (up to a critical thickness) without any defect formation, and deformation of the material (above the critical thickness) caused by cracking [11,12,13]. Furthermore, micro-fractures are formed preceding the cut. However, as the diamond tool (grit) moves over the damaged layer, it continually removes the damaged layer. The important feature is that the ductile mode cutting can, in principle, occur without generation of microfractures and damage, but because it occurs at lower stresses than the brittle fracture mode, the cutting rate can be very low.

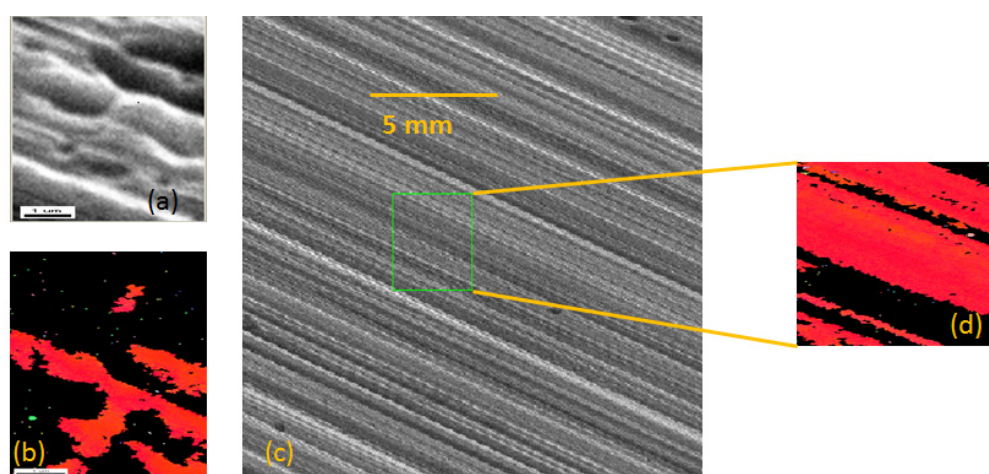
Figure 9. (a) An SEM image and (b) Raman image of a region of an as-sawn wafer. The red color shows crystalline phase. (c) An SEM image of a part of a wafer without microchipping. (d) A Raman image of a small region shows no correlation to fine structure of the grating-like features.

The damage is manifested as: (a) **Pressure-induced phase change into crystalline and amorphous phases.** A significant amount of work has been done to establish changes in the crystal structure of Si under hydrostatic pressure as well as by indentation techniques. It has been determined that the standard crystalline phase have been determined to be six crystalline and the amorphous Si phase. A big part of the phase change is the transformation into amorphous Si. We have examined this change using EBSD and Raman imaging to investigate if there is a pattern to regions that show amorphization. Figure 9 shows an EBSD image of a region of a wafer, which has chipping due to microcleavage. Also shown is Raman image of the same region, where red regions represent crystalline and black represent amorphous phases. Although this picture shows chipped

regions have an amorphous layer on the surface, our large data base indicates that this probability is only about 60%. Likewise, in the regions that only have deformations and no microfracture, there is no specific trend in regions that show amorphization. We should point out that phase changes are not very significant for solar cells because the thickness of phase changed material (including oxidized material) is typically quite small and get etched away in standard solar cell processing. However, one has to be careful because they can cause nonuniformities in solar cells.

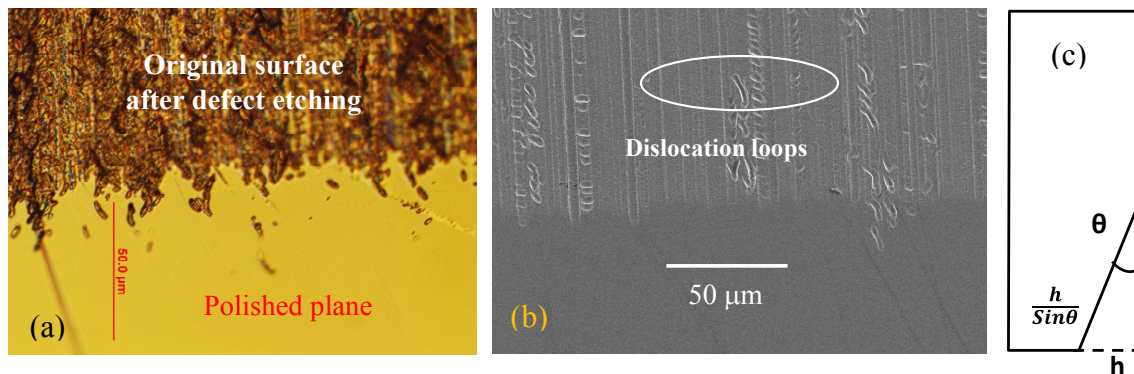
Figure 10. (a) Optical microscope image of a polished sample, (b) SEM image of similarly angle polished and defect etched samples showing dislocations generated by grit and their penetration below the surface. (c) Illustration of angle polishing and associated vertical magnification.

Figure 10a is an optical microscope image of an angle-polished and defect etched sample showing locally deep penetration of dislocations under the original surface. An SEM image of a similar angle-polished and defect etched sample (Fig. 4b) shows detailed delineation of dislocations loops that are frozen-in around the regions chipped by the diamond grit. This sample was polished at 10 degrees angle (giving a vertical magnification of ~ 6 times, see Fig. 10c).

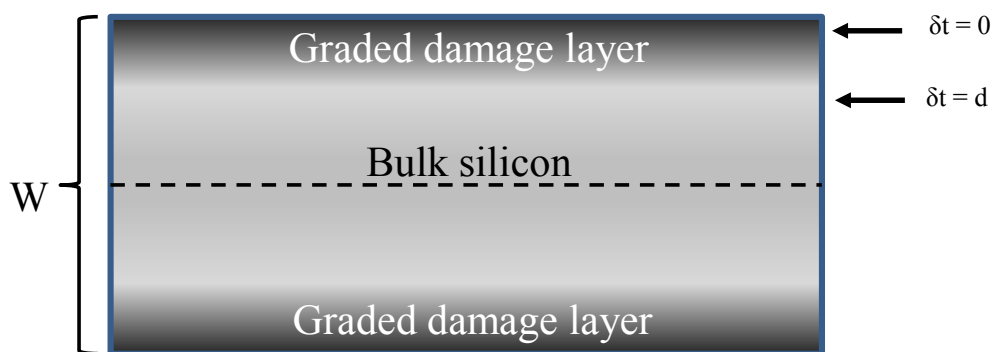
Figure 11. An illustration of representation of damage as surface recombination.

The methods mentioned above for measuring depth of damage such as TEM, SEM, angle polishing and defect etching, and RAMAN imaging, only provide qualitative and local information on depth of damage. We have recently developed a technique for measuring an average damage depth over a large area using minority carrier lifetime measurement [16–19]. This method is an improvement over previous approach, based on measurement of surface photovoltage as a function of etches depth, which was published quite long back [20]. In the new method, thin layers from the wafer surfaces are sequentially etched using a 1:1:5 (HF:HNO₃:CH₃COOH) solution and the effective minority carrier lifetime (MCLT) is measured after each etch step. Figure 11 illustrates a

wafer having graded damage at each surface due to sawing. Because the electronic effect of damage is manifested as increased minority carrier recombination at the surface, its effect can be lumped into surface recombination (as an approximation). Hence one can express the effective lifetime (τ_{eff}) as:

$$\frac{1}{\tau_{eff}} = \left(\frac{1}{\tau_B}\right) + 2 \frac{s_{eff}(\delta t)}{W} \quad (1)$$

where τ_B is the bulk lifetime, w is the wafer thickness, and s_{eff} represents recombination effect due to left over damage layer after etching a thickness δt . Because s_{eff} will decrease as thickness from the surface is etched, τ_{eff} will increase with δt till $\delta t=d$.

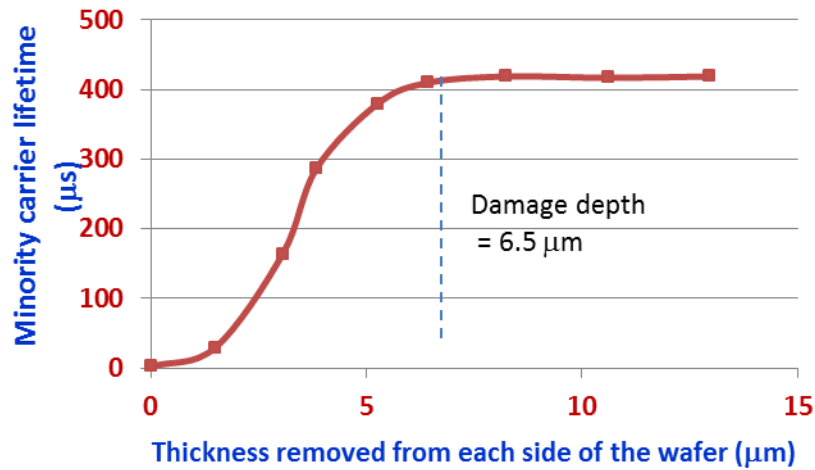
Figure 12a. Lifetime as a function of thickness removed from each side of the wafer, showing peak lifetime is reached when the damage is fully removed.

Figure 12a shows a typical plot of lifetime vs thickness removed from each surface. As seen, the lifetime reaches a maximum value when the damage is fully removed and typically stays constant. The damage depth in Fig. 12a is 6.5 μm . An important feature of this technique is that one can use equation 1 to calculate effective surface recombination velocity as a function of depth, to get an indication of damage distribution.

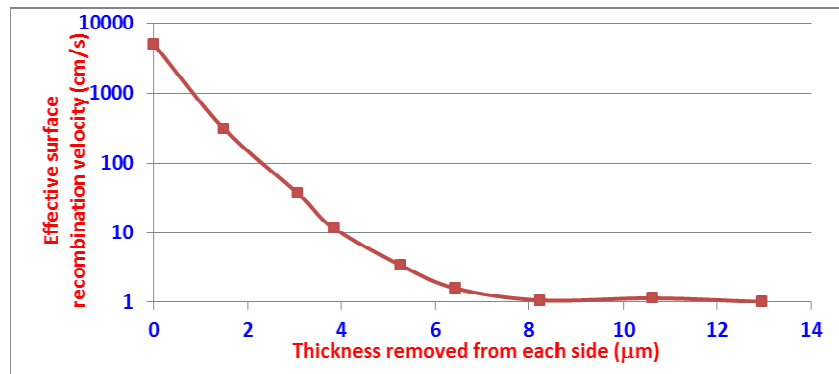
Figure 12b. Effective surface recombination as a function of depth below the surface, derived from the data of Figure 12a, ref [16]. The surface recombination velocity represents a quantitative measurement of degree of damage.

Figure 12b is a plot of s_{eff} vs thickness etched corresponding to the measured MCLT of Fig. 12a. It should be noted that s_{eff} represents contribution of the entire damage layer thickness, which must be deconvolved to determine actual damage distribution. But, in most cases, it is sufficient to compare s_{eff} vs δt to get a qualitative profile of damage.

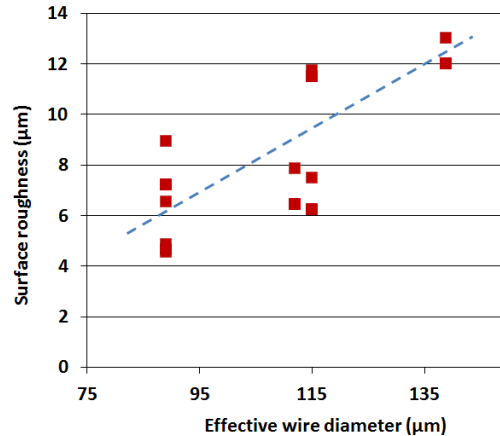
Figure 13. Measured surface roughness (as average peak-to-peak height variation) as a function of average effective diameter of the wire. A line is drawn to guide the eye. The effective wire diameter = actual wire diameter + maximum grit size.

Now we describe some results that relate the surface roughness and damage depth to some important, basic cutting parameters, such as wire diameter and grit size. Figure 13 shows dependence of surface roughness on the effective wire diameter (wire diameter + maximum grit size). These data are generated by cutting different ingots with different wire and grit sizes. However, wire size and grit size are typically not independent - larger grit size goes with the larger wire size. This is shown on the axis as effective wire size. The results in Fig. 13 show that surface roughness increases with the increase in effective-wire diameter.

It is important to note that the surface roughness also depends on other parameters such as vibration in the wafer stack, quality of the guides, tension in the wire, and rocking motion the wafer surface. These parameters were kept constant as much as possible.

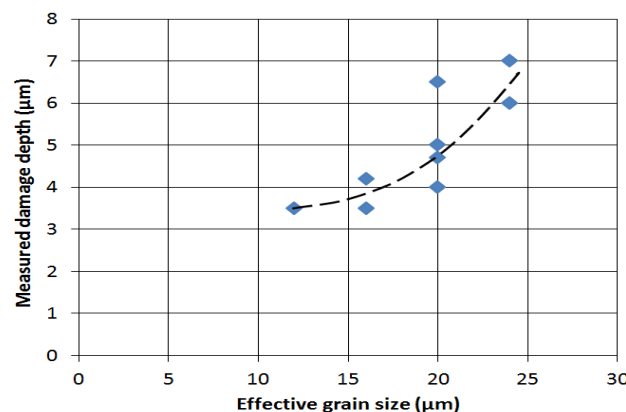
Figure 14. Measured surface roughness for different grit size. These data represent values averaged over many wafers.

Figure 14 shows the depth of damage created by grit size. Here we have used the maximum value of the grit size because, as expected, the deepest damage is created by the largest grit size and that our new technique based on MCLT measurement identifies damage depth to be the deepest value. It is clear that the depth of damage increases with increase in the grit size. The small scatter of the data points can be understood as the measured damage depth can vary due to the lateral non-uniformities in each wafer.

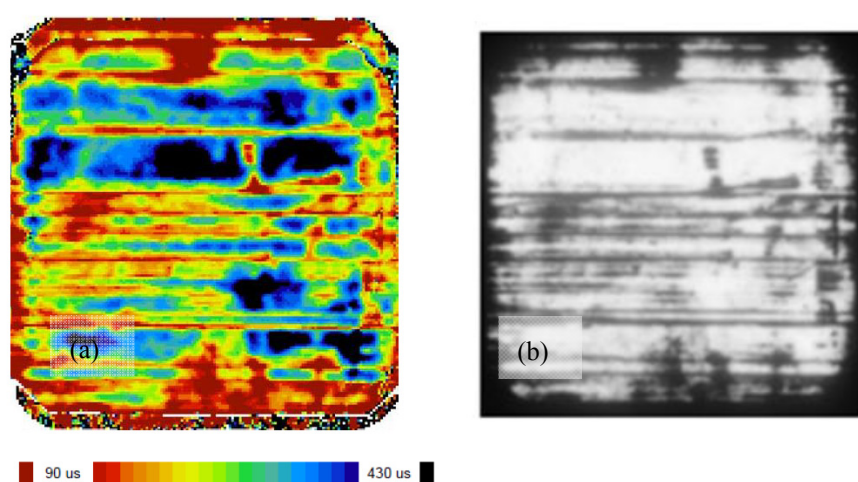
Figure 15. (a) A MCLT map of a DWS, 156 mm x 156 mm monocrystalline Si wafer showing striations because of variations in damage depth; (b) a photoluminescence map of the same wafer. Note that the resolution of the photoluminescence map is higher but the image is only qualitative (darker regions have higher damage).
