Research article

Influence of dirt and coating deterioration on the aging of solar reflectance of high-reflectance paint

Taizo Aoyama^{1,*}, Takeshi Sonoda¹ and Hideki Takebayashi²

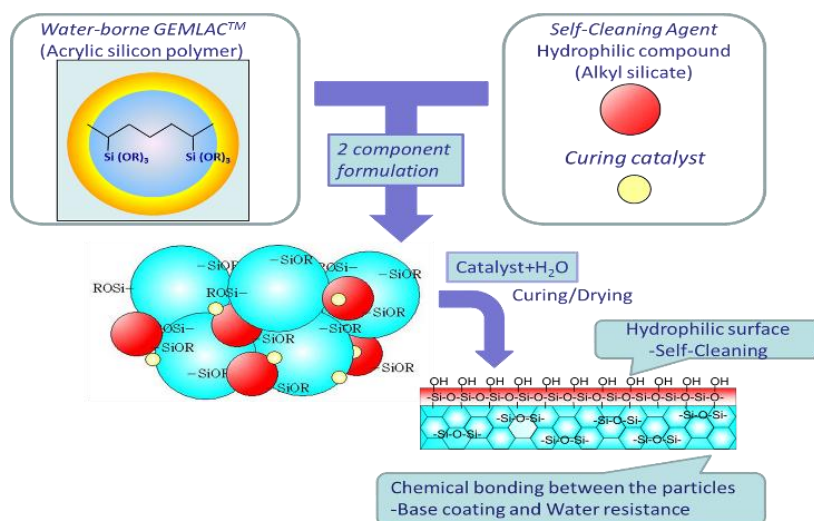
The self-cleaning property means that dirt, including the oil component, is raised away by rainwater to enhance the cleaning effect by increasing the cross-link density of the coating film surface to a hydrophilic coating. Figure 1 shows the outline of the type of low-contamination paint used in this study. The paint binder consists of an aqueous two-component acrylic silicone resin composed of a base material of an alkoxy-group-containing acrylic resin emulsion and a low-contamination imparting agent containing an alkyl silicate and a hydrolysis-condensation catalyst [24,27].

Figure 1. Outline of self-cleaning paint.

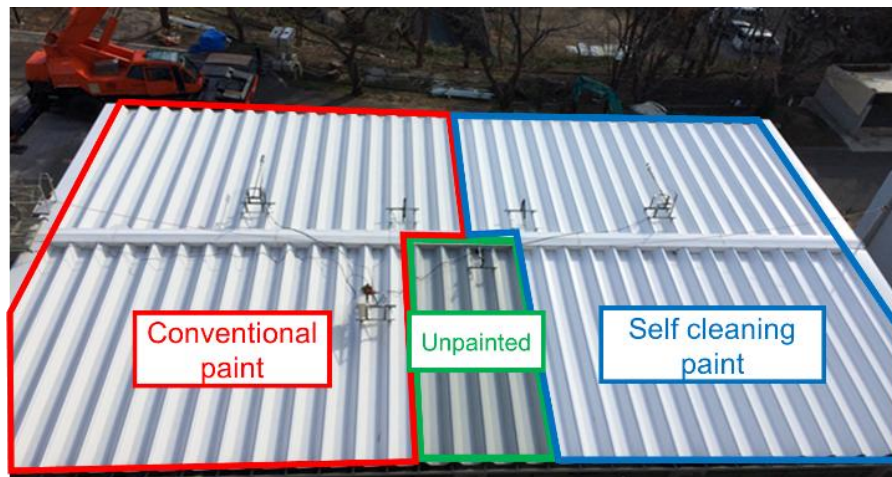
the north, east, and west sides. The height of the roof top of this one story flat building is 6.2 m, and there are trees across the road on the south side, but shadows do not fall on the rooftop. Figure 2 shows a picture of the rooftop after painting. The roof is made of corrugated sheet metal. The solar reflectance is influenced by the shape, and in this case is smaller than the reflectance of a flat plate due to multiple reflections (absorption). The solar reflectance corresponding to the test roof was calculated based on the roof shape (dimension) and the position of the sun; it was calculated to be about 6% lower than the flat roof [29].

Figure 2. Roof coated with high-reflectivity paint with and without self-cleaning function.

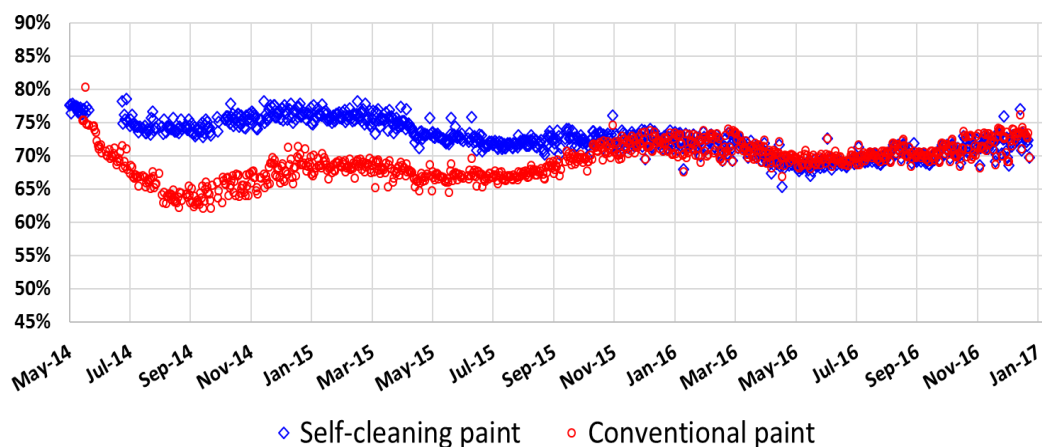
The solar reflectance of the parts painted with self-cleaning and conventional paints was measured starting on May 10, 2014 using pyranometers (Kipp & Zonen CNR 1, wavelength range 305 to 2800 nm, accuracy $\pm 10\%$, installation height 50 cm). Measurements were made continuously at 1-minute intervals. Data for the area with the self-cleaning paint is missing from June 3, 2014 to July 2, 2014 because of a poor connection in the measuring equipment. Figure 3 shows the daily solar reflectance (after correction for the roof shape) (May 10, 2014 to January 17, 2017) of the areas with self-cleaning and conventional paints averaged from 10 a.m. to 2 p.m. Data was only used when the amount of solar radiation was 500 W/m^2 or more. The initial values of solar reflectance of the self-cleaning and conventional paints were 87.5% and 87.7%, respectively. The solar reflectance of the self-cleaning paint continued to decrease gradually for two years after the surface was painted. The solar reflectance of the conventional paint sharply decreased in the first 4 months after painting and then rose again.

Figure 3. Daily average solar reflectance of self-cleaning and conventional paint (averaged from 10 a.m. to 2 p.m.).

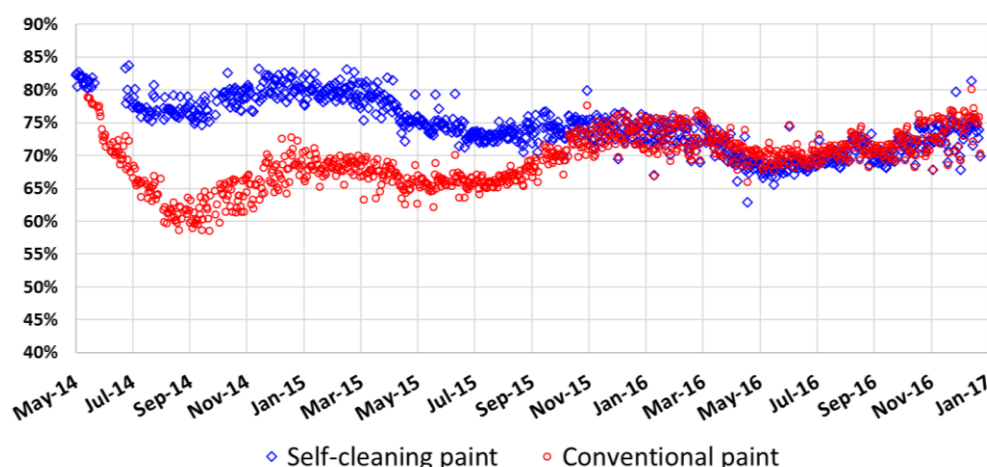
We examined the error when the calibration formula (Eq 1) of solar reflectance using the standard plate was applied to the self-cleaning and conventional paints. The form factor (the first term on the right side of Eq 1) is calculated to be 0.60. The form factor of the solar reflectance calibration formula using the standard plate was between 0.61 and 0.67. The form factor is 0.61 when the 1-cm² gap is opened on the standard board; it is 0.66 when calculating the distance from the lower end of the radiation budget meter to the surface as the height. From the above, the error is shown to be due to the installation position of the standard plate and the way the distance from the target surface to the equipment is measured. The influence of the surroundings of the measurement location (the second term on the right side of Eq 1) of the self-cleaning and conventional paints is equivalent in summer 2014 immediately after painting, but a decrease in reflectance is seen.

Figure 4. Solar reflectance with calibration formula based on the measurements made in winter 2014.

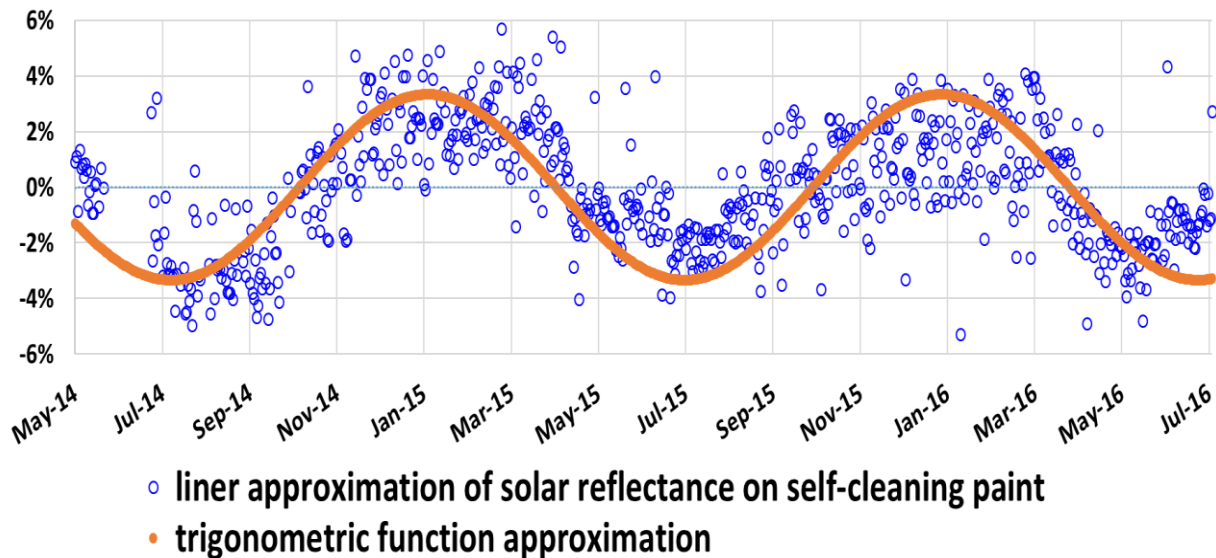
The influence of the altitude of the sun was extracted from the difference between the first-order approximation of the measurement of solar reflectance and the measurement, and its characteristics were analyzed. Figure 5 shows the difference between the measurements of solar reflectance of the self-cleaning paint and the first-order approximation and its trigonometric approximation. When the difference from the approximate straight line is approximated by a trigonometric function, in the Eq 4,

$$y = 0.0334\sin(\omega t + 0.026)(R = 0.67) \quad (4)$$

this is small in summer when the sun is high and large in the winter when the sun is low. It changed by almost the same amount in the first and second year.

Figure 5. Difference between linear approximation of solar reflectance of self-cleaning paint and its trigonometric approximation.

The analysis by the mean square error between approximate curve and actual measured value of Figures 6 and 7 were calculated and were 4.9% and 7.0%, respectively. The root mean square error was 2.2% and 2.6%, respectively. This is considered to be relatively small by removing the influence of the solar altitude, as compared with the fluctuation range including the influence of the solar altitude being about 6% in Figure 5.

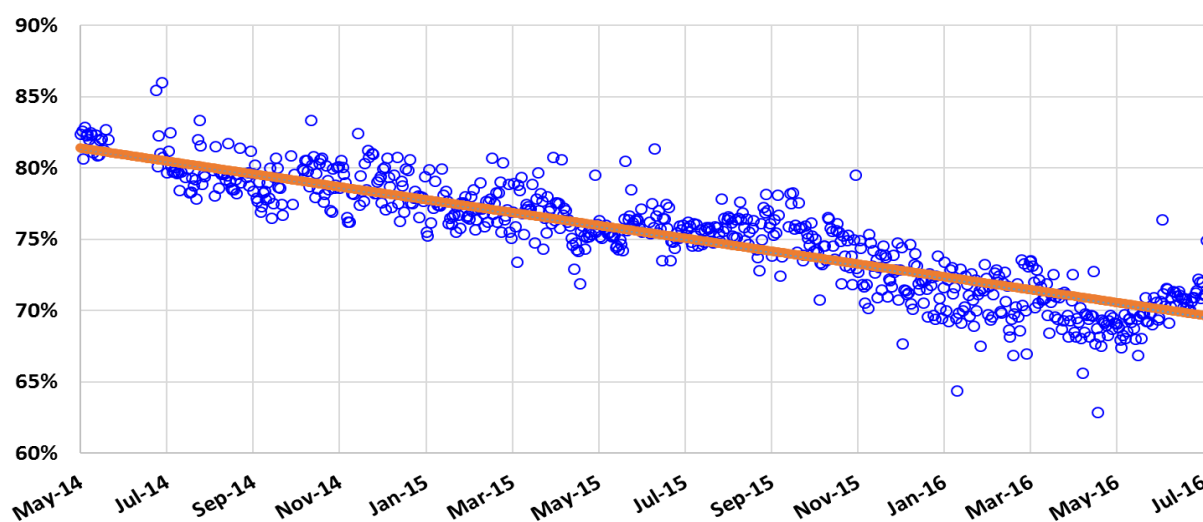
We analyzed the influence of dirt and coating deterioration on solar reflectance over time by using the data with the influence of the solar altitude removed. Figure 6 shows the solar reflectance and first-order approximation of the self-cleaning paint without the influence of the solar altitude. The approximate expression is Eq 12,

$$y = -0.000145x + 0.814 (R = 0.90) \quad (12)$$

The solar reflectance fell by 0.5% per month due to dirt. Figure 7 shows the solar reflectance and first-order approximation of the conventional paint without the influence of the solar altitude. It was approximated by separating the period into two parts: up to 4 months after painting and after 4 months. The approximate expression, up to 4 months after painting is Eq 13,

- Solar reflectance on self-cleaning paint removed the sun altitude effect

Figure 6. Solar reflectance and first-order approximation of the self-cleaning paint without the influence of the solar altitude.

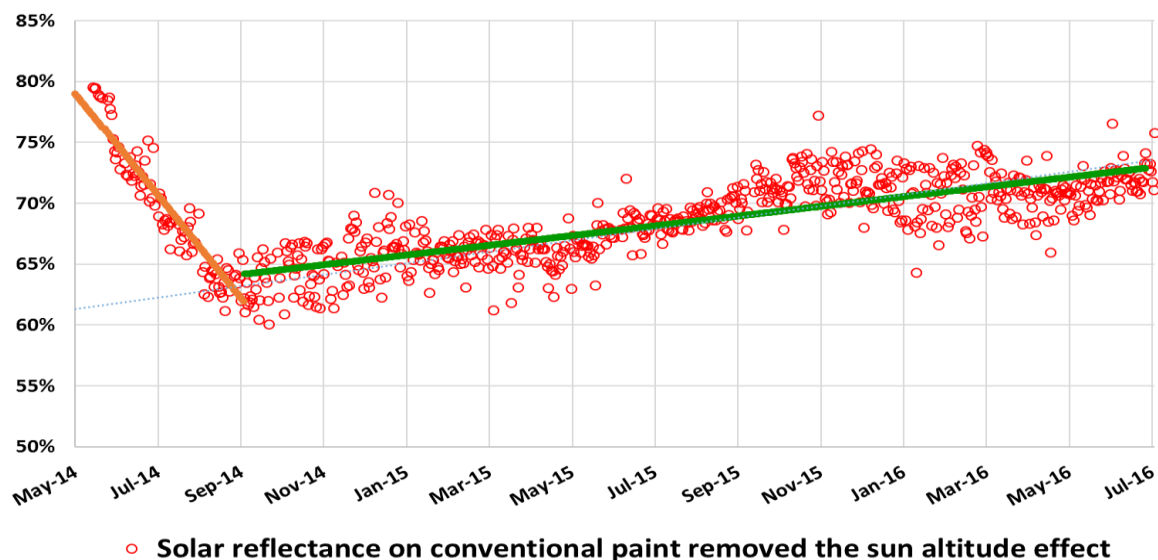
$$y = -0.00136x + 0.791 (R = 0.94) \quad (13)$$

$$y = 0.000129x + 0.625 (R = 0.80) \quad (14)$$

due to the effect of dirt, the solar reflectance decreased by 4% per month for up to 4 months after painting, rising at 0.4% per month after 4 months after painting owing to deterioration in the coating film.

Figure 7. Solar reflectance and first-order approximation of the conventional paint without the influence of the solar altitude.
